Report: TAB Report
Function: Test, Adjust, & Balance
Date: 09/23/2025
Completed By: National TAB

06-09-25 WAWA #6305 WAYCROSS, GA

1725 MEMORIAL DR

WAYCROSS, GA

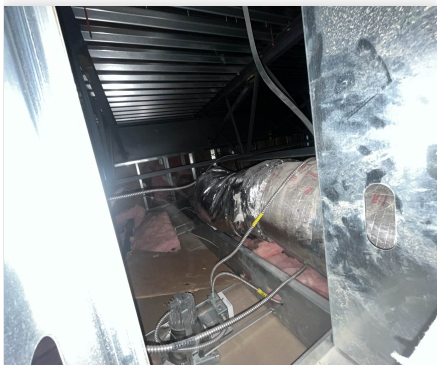
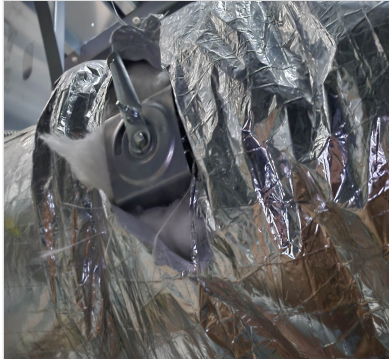
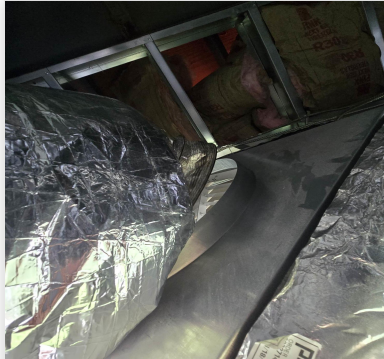
Issue Name : 1. Diffuser 3-8 is below design air flow
Description : Damper cannot be fully open due to screws blocking damper path. Damper opened as far as possible. Duct needs to be taped to diffuser in order to ensure maximum airflow.
Created By : National TAB **Assigned To :** National TAB - Will Turnbough
Status : Open
Priority : Urgent **Asset Tag :**
Originated Date : 06/10/2025 - Ian Fuller - National TAB

- **11/07/2025 National TAB - Stephen Tassinaro**
 - Unresolved. Airflow still very low to this air device. MC needs to ensure the damper is open and accessible. If there is a damper above a hard ceiling it will need to be verified to be full open and permanently secured there and a more accessible damper added. Check flex connections for restriction or leakage.

- **09/23/2025 National TAB - Stephen Tassinaro**
 - No resolution 9/22. Damper is above a hard ceiling and unsafe to access. Damper handle remains in the position shown in previous issues and airflow is unchanged. Previous pictures also show that the flex is not secured well to the damper and there is leakage present. Resolve ALL in order to balance to design airflow.

- Issue not resolved as of 6/30. Damper is still below design airflow. Damper still opened as much as possible without bending damper.

Asset	Notes	Date	Written By
SGRD8	DAMPER UNABLE TO FULLY OPEN. STUCK ON SCREWS.	06/11/2025	Ian Fuller

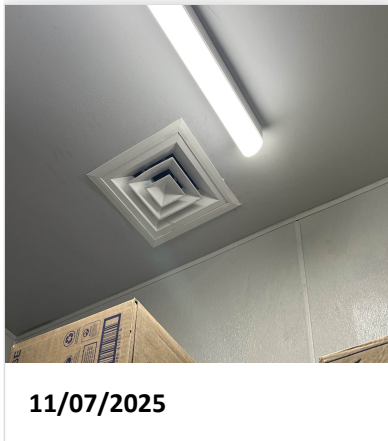
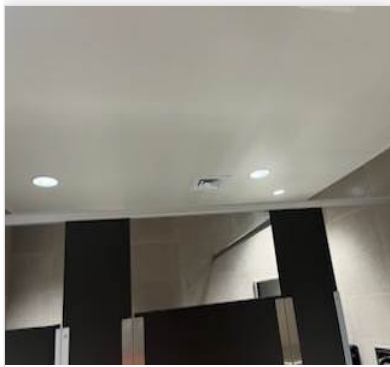
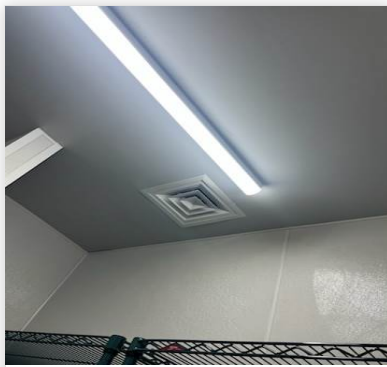
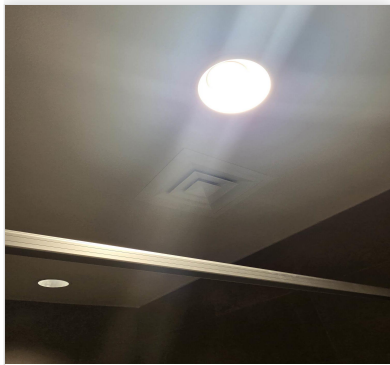
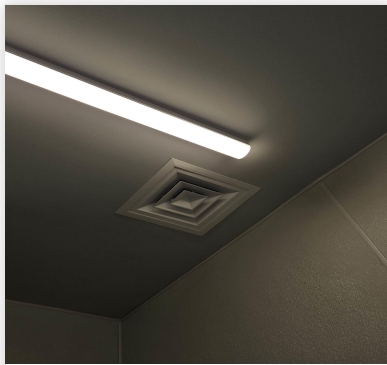
Issue Name : EF1-1and EF4-4 have wrong diffuser type installed
Description : Currently installed are CD-4 supply diffusers when GRD calls for G-3 exhaust diffusers.
Created By : National TAB **Assigned To :** National TAB - Will Turnbough
Status : Open
Priority : Urgent **Asset Tag :**
Originated Date : 06/10/2025 - Ian Fuller - National TAB

- **11/07/2025 National TAB - Stephen Tassinaro**
 - Supply type diffusers still installed on exhaust.

-
- **09/23/2025 National TAB - Stephen Tassinaro**
 - Unresolved 9/22.
-
- **06/30/2025 National TAB - Ian Fuller**
 - Issue not resolved as of 6/30. Supply type diffusers still installed.

Diffusers that are ducted to RTUs are per design. However EF-1 has two diffusers that do not match and the entry vestibule transfer grille does not match.

EF-1 diffuser types do not match design in women's RR and utility closet.

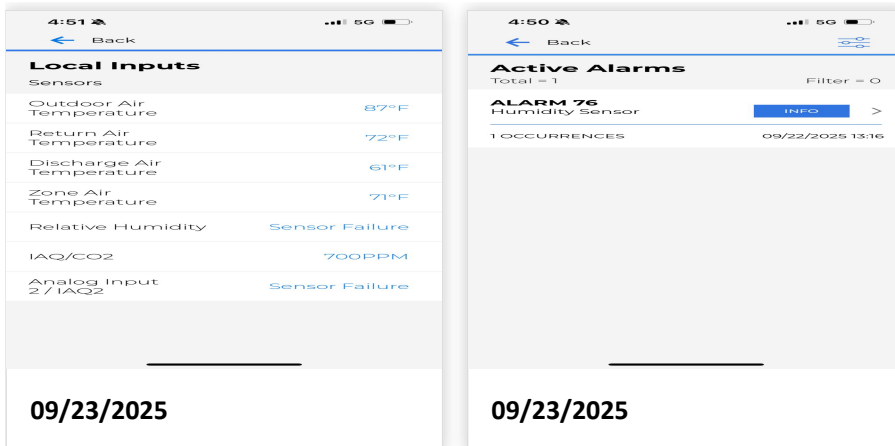
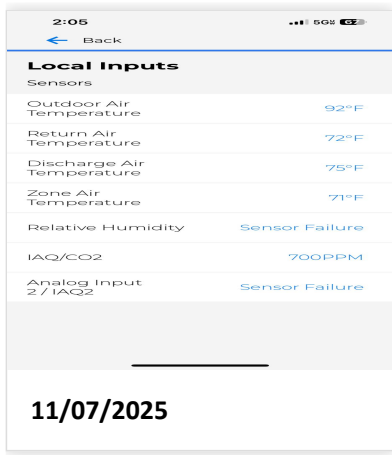
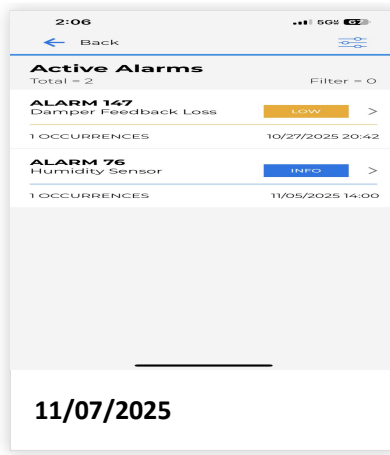
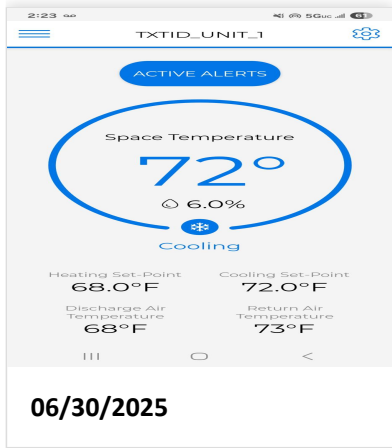
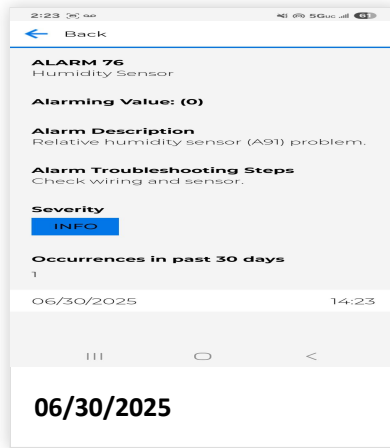
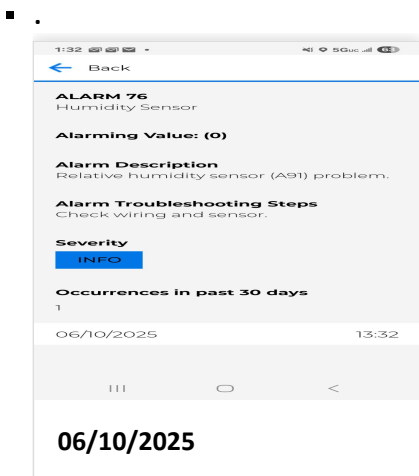
Issue Name : RTU-1 humidity sensor
Description : Humidity sensor is not reading correct humidity. Sensor starts to read at 8% then jumps to around 35% when humidity in the building is around 53 % RH. Humidity sensor wiring is per spec. **VERIFY ALL THREE UNITS ARE READING A REALISTIC RELATIVE HUMIDITY IN ORDER TO CLOSE ISSUE.**

- **11/07/2025 National TAB - Stephen Tassinaro**
 - Sensor still reading between 8% and then sensor failure. Likely a short in the wiring or terminals landed incorrectly.

- **09/23/2025 National TAB - Stephen Tassinaro**
 - RTU-1 is still alarming for humidity sensor. Unresolved.

- **06/30/2025 National TAB - Ian Fuller**
 - Issue nit resolved as of 6/30. Core alarm is still present on system.

RTU#1 ALARM 76

RTU1: 35% / ALARM GIVING INCORRECT HUMIDITY MEASUREMENT RTU2: NOT DISPLAYING READING RTU3: NOT DISPLAYING READING

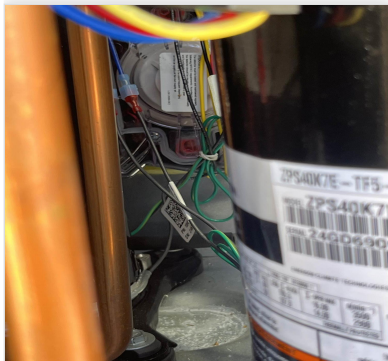
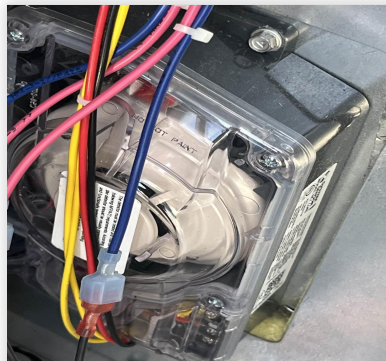
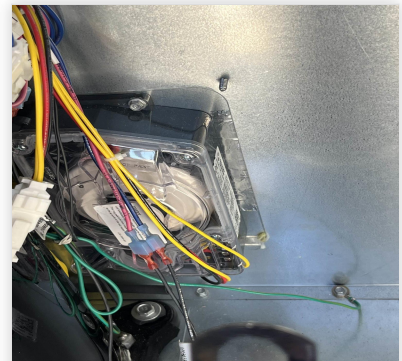
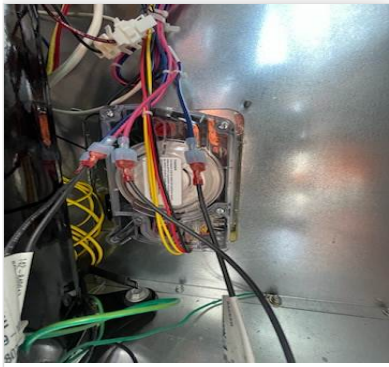
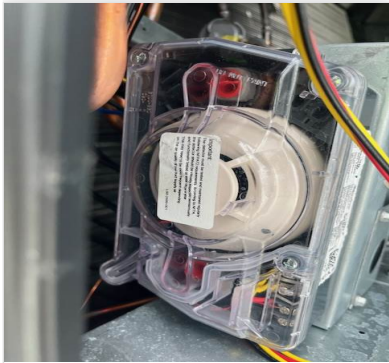
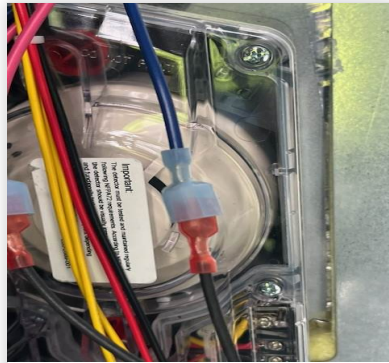
Issue Name : Smoke detector dust plugs are still in unit
Description : Recommended to remove dust plugs in all units before store operation.
Created By : National TAB **Assigned To :** National TAB - Will Turnbough
Status : Open
Priority : Medium **Asset Tag :**
Originated Date : 06/10/2025 - Ian Fuller - National TAB

- **11/07/2025 National TAB - Stephen Tassinaro**
 - Dust plugs still installed on return side smoke detector heads.

-
- **09/23/2025 National TAB - Stephen Tassinaro**
 - Unresolved 9/22.
-
- **06/30/2025 National TAB - Ian Fuller**
 - Issue not resolved as of 6/30.

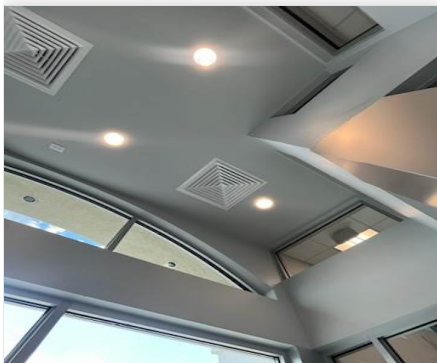
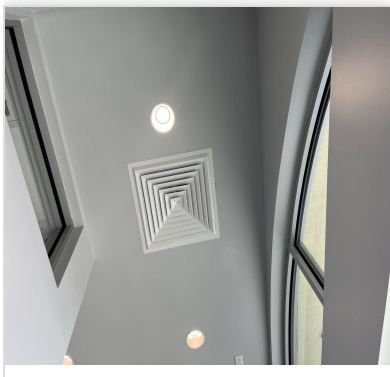
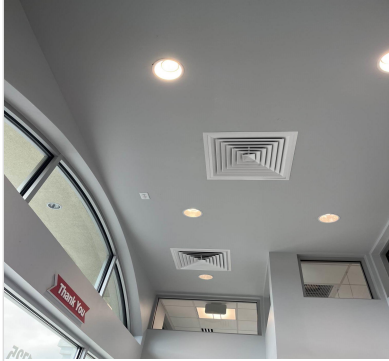
Issue Name : Transfer duct in vestibule has wrong diffuser installed.
Description : A supply type CD-2 diffuser is installed when the GRD specifies a return type G-2 diffuser is installed. The correct diffuser type needs to be installed.
Created By : National TAB **Assigned To :** National TAB - Will Turnbough
Status : Open
Priority : Medium **Asset Tag :**
Originated Date : 06/30/2025 - Ian Fuller - National TAB

- **11/07/2025 National TAB - Stephen Tassinaro**
 - Supply type diffuser still installed on vestibule transfer grille.

- Unresolved 9/22.
