**Report: TAB Report**  
**Function: Test, Adjust, & Balance**  
**Date: 11/07/2025**  
**Completed By: National TAB**

**06-09-25 WAWA #6305 WAYCROSS, GA**

Wawa  
260 West Baltimore Pike  
Wawa, PA 19063

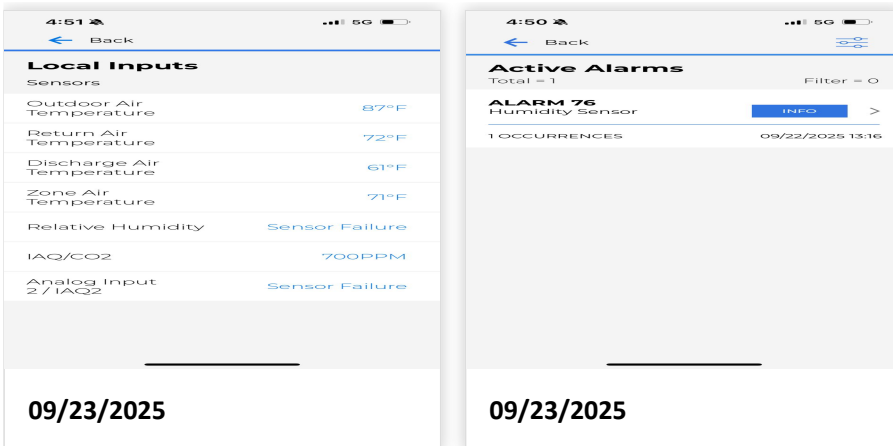
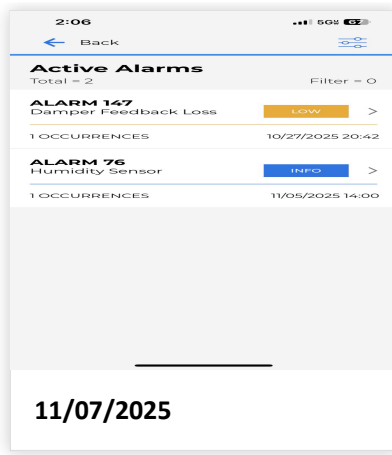
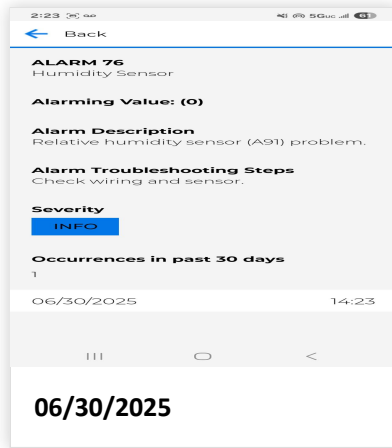
**Issue Name :** RTU-1 humidity sensor  
**Description :** Humidity sensor is not reading correct humidity. Sensor starts to read at 8% then jumps to around 35% when humidity in the building is around 53 % RH. Humidity sensor wiring is per spec. **VERIFY ALL THREE UNITS ARE READING A REALISTIC RELATIVE HUMIDITY IN ORDER TO CLOSE ISSUE.**

- **11/07/2025 National TAB - Stephen Tassinaro**
  - Sensor still reading between 8% and then sensor failure. Likely a short in the wiring or terminals landed incorrectly.

- **09/23/2025 National TAB - Stephen Tassinaro**
  - RTU-1 is still alarming for humidity sensor. Unresolved.

- **06/30/2025 National TAB - Ian Fuller**
  - Issue nit resolved as of 6/30. Core alarm is still present on system.

RTU#1 ALARM 76

RTU1: 35% / ALARM GIVING INCORRECT HUMIDITY MEASUREMENT RTU2: NOT DISPLAYING READING RTU3: NOT DISPLAYING READING

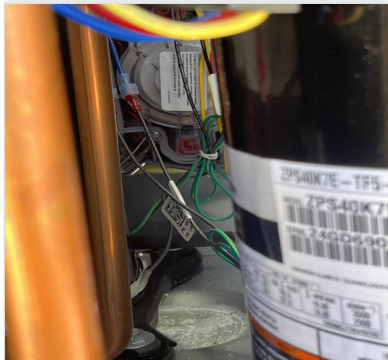
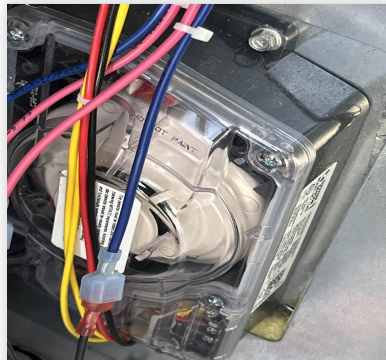
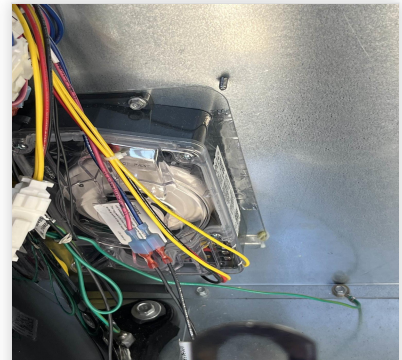
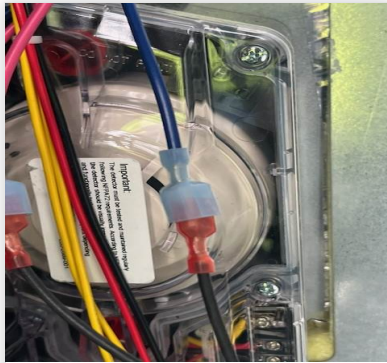
**Issue Name :** Smoke detector dust plugs are still in unit  
**Description :** Recommended to remove dust plugs in all units before store operation.  
**Created By :** National TAB **Assigned To :** National TAB - Will Turnbough  
**Status :** Closed  
**Priority :** Medium **Asset Tag :**  
**Originated Date :** 06/10/2025 - Ian Fuller - National TAB

- **11/07/2025 National TAB - Stephen Tassinaro**
  - Dust plugs still installed on return side smoke detector heads.

- **09/23/2025 National TAB - Stephen Tassinaro**
  - Unresolved 9/22.

- **06/30/2025 National TAB - Ian Fuller**
  - Issue not resolved as of 6/30.

- **12/19/2025 National TAB - Will Turnbough**
  - closing based on GC pics

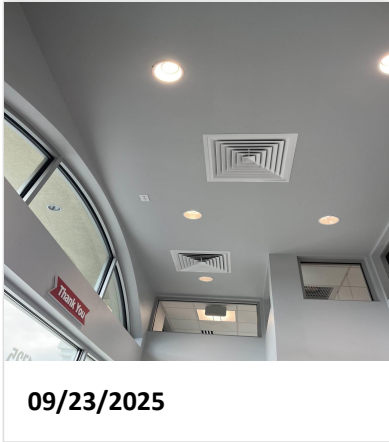
**Issue Name :** Transfer duct in vestibule has wrong diffuser installed.  
**Description :** A supply type CD-2 diffuser is installed when the GRD specifies a return type G-2 diffuser is installed. The correct diffuser type needs to be installed.  
**Created By :** National TAB                      **Assigned To :** National TAB - Will Turnbough  
**Status :** Open  
**Priority :** Medium                              **Asset Tag :**  
**Originated Date :** 06/30/2025 - Ian Fuller - National TAB

- **11/07/2025 National TAB - Stephen Tassinaro**
  - Supply type diffuser still installed on vestibule transfer grille.

- Unresolved 9/22.
