Report: TAB Report
Function: Test, Adjust, & Balance
Date: 09/23/2025
Completed By: National TAB

06-09-25 WAWA #6305 WAYCROSS, GA

Project: 06-09-25 WAWA #6305 WAYCROSS, GA

Table Of Contents

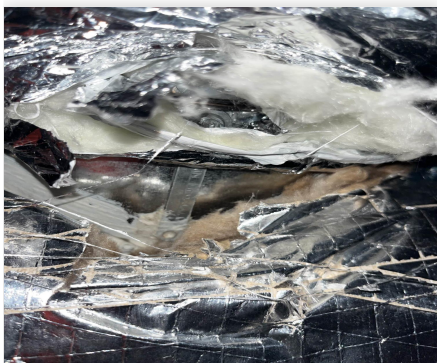
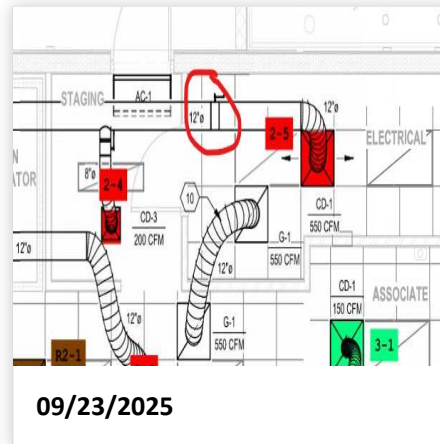
Issue Name : 1. UPDATED 9/22: Branch damper for diffuser 2-4 and 2-5 is broken
Description : Unable to balance both dampers with design air flow. Recommended to replace damper. UPDATE 9/22: Branch damper is now functional however there is no damper controlling only SGRD2-5. Total airflow for the branch has been set within design. SGRD2-4 damper is covered with mastic and draw band.
Created By : National TAB **Assigned To :** National TAB - Will Turnbough
Status : Open
Priority : Urgent **Asset Tag :**
Originated Date : 06/11/2025 - Ian Fuller - National TAB

- **06/30/2025 National TAB - Ian Fuller**
 - Issue not resolved as of 6/30. Diffusers on branch are reading same CFM readings, damper is still fully open.

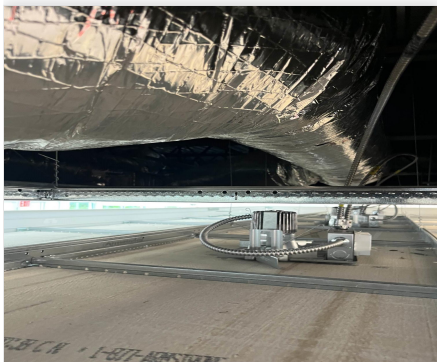
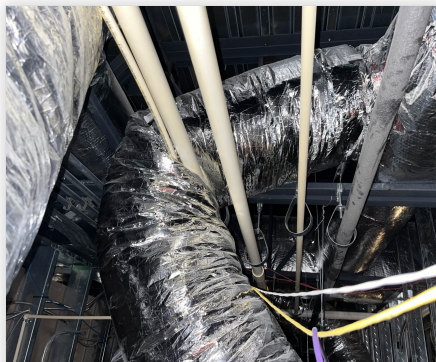
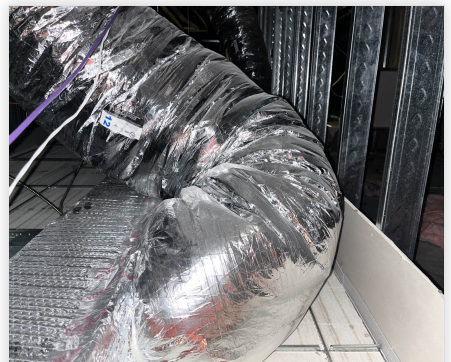
Issue Name : 2. RTU-2 Balancing Issues Cont.
Description : SGRD2-5 remains below design due to the flex duct being routed around electrical conduit causing it to collapse on itself and become restrictive. More duct supports or improved duct routing will be required to meet design airflow. SGRD 2-5 does not have a damper. SGRD2-8 does not have a damper. Install both dampers to complete balance.
Created By : National TAB **Assigned To :** National TAB - Will Turnbough
Status : Open
Priority : Urgent **Asset Tag :**
Originated Date : 09/23/2025 - Stephen Tassinaro - National TAB

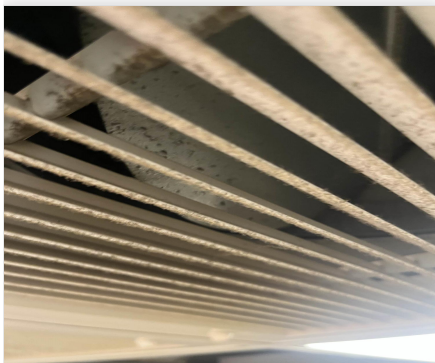
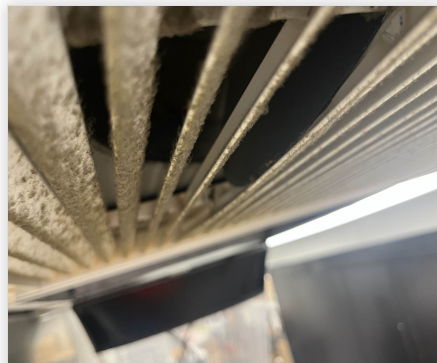
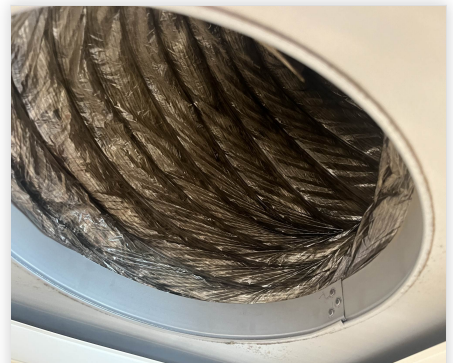
Issue Name : 3. RTU-2 return diffusers are missing dampers
Description : Return Diffuser 2-1, 2-3, and 2-4 are missing balancing dampers. Recommended to install damper in order to balance individual diffusers.
Created By : National TAB **Assigned To :** National TAB - Will Turnbough
Status : Open
Priority : Urgent **Asset Tag :**
Originated Date : 06/11/2025 - Ian Fuller - National TAB

- **09/23/2025 National TAB - Stephen Tassinaro**
 - Dampers have been installed on 4 out of the 5 returns. However they are installed in such a way that they cannot fully open. Instead they make contact with the face of the diffusers and remain restrictive and unable to be balanced.

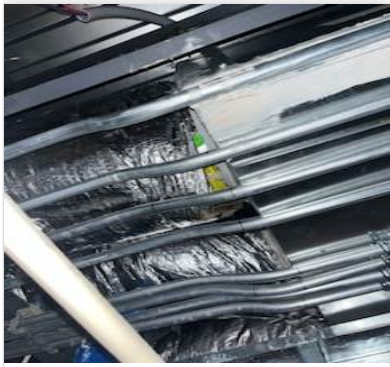
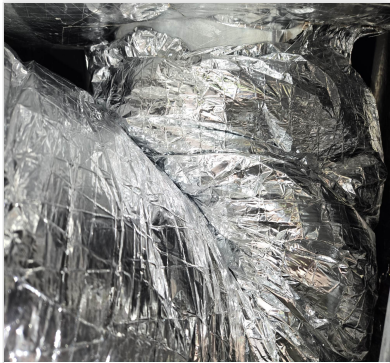
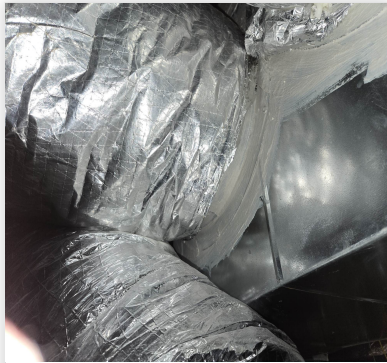
- **06/30/2025 National TAB - Ian Fuller**
 - Issue nit resolved as of 6/30. Dampers still missing on specified diffusers.

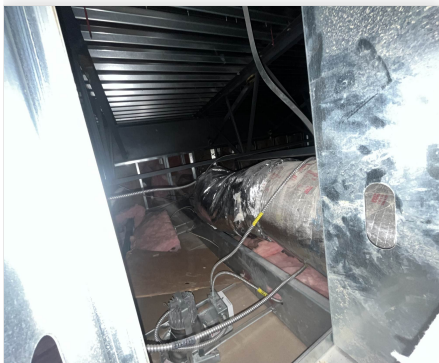
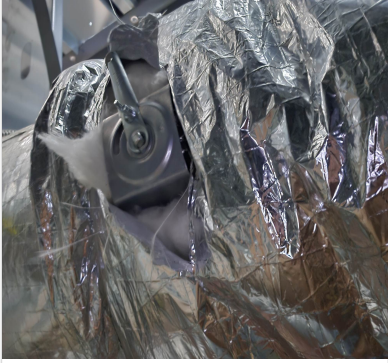
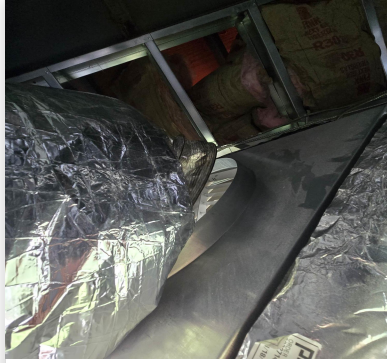
Issue Name : 4. Diffuser 3-8 is below design air flow
Description : Damper cannot be fully open due to screws blocking damper path. Damper opened as far as possible. Duct needs to be taped to diffuser in order to ensure maximum airflow.

- **09/23/2025 National TAB - Stephen Tassinaro**
 - No resolution 9/22. Damper is above a hard ceiling and unsafe to access. Damper handle remains in the position shown in previous issues and airflow is unchanged. Previous pictures also show that the flex is not secured well to the damper and there is leakage present. Resolve ALL in order to balance to design airflow.

- **06/30/2025 National TAB - Ian Fuller**
 - Issue not resolved as of 6/30. Damper is still below design airflow. Damper still opened as much as possible without bending damper.

Asset	Notes	Date	Written By
SGRD8	DAMPER UNABLE TO FULLY OPEN. STUCK ON SCREWS.	06/11/2025	Ian Fuller

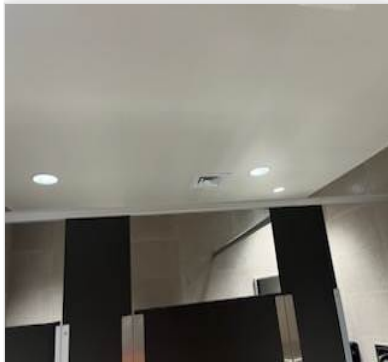
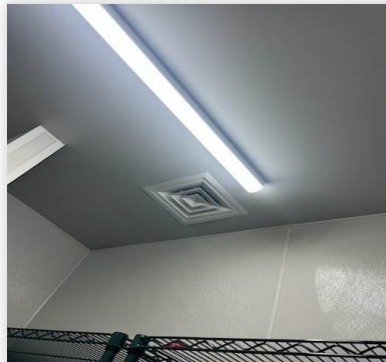
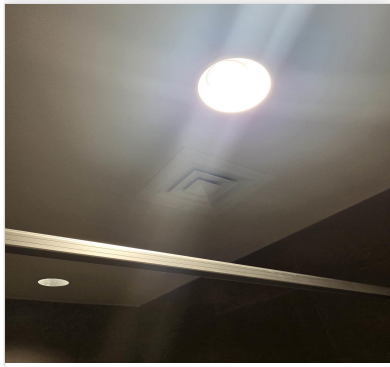
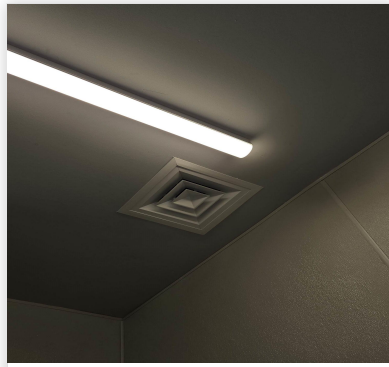
Issue Name : EF1-1and EF4-4 have wrong diffuser type installed
Description : Currently installed are CD-4 supply diffusers when GRD calls for G-3 exhaust diffusers.
Created By : National TAB **Assigned To :** National TAB - Will Turnbough
Status : Open
Priority : Urgent **Asset Tag :**
Originated Date : 06/10/2025 - Ian Fuller - National TAB

- **06/30/2025 National TAB - Ian Fuller**
 - Issue not resolved as of 6/30. Supply type diffusers still installed.

EF-1 diffuser types do not match design in women's RR and utility closet.

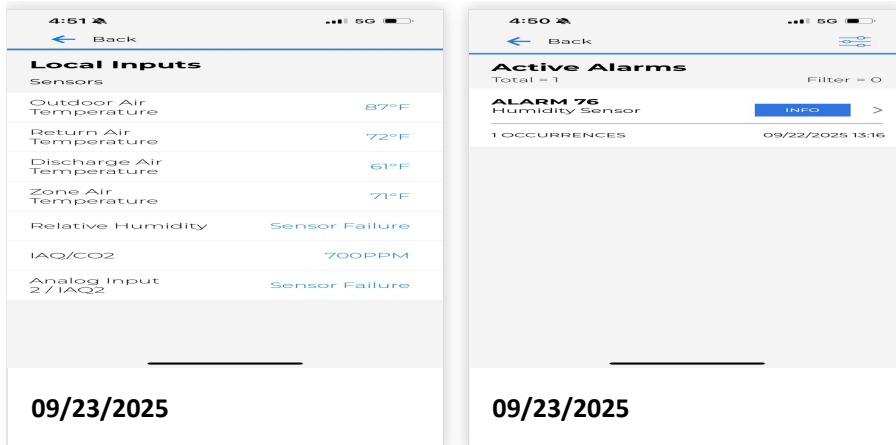
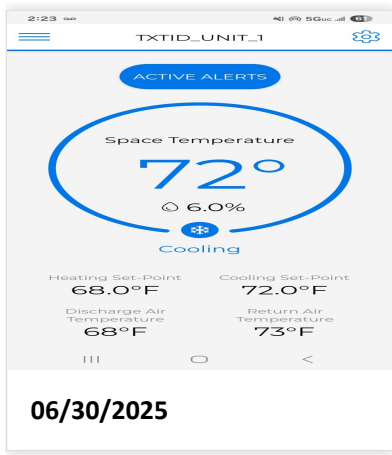
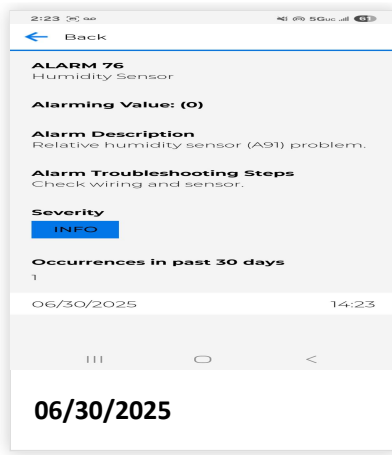
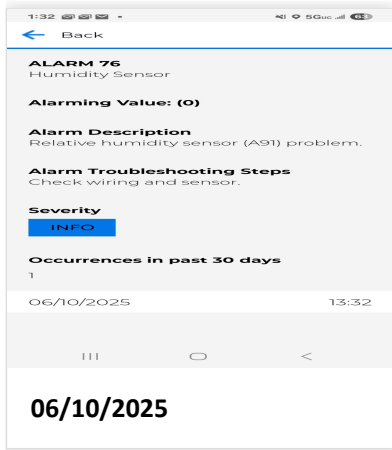
Issue Name : RTU-1 humidity sensor
Description : Humidity sensor is not reading correct humidity. Sensor starts to read at 8% then jumps to around 35% when humidity in the building is around 53 % RH. Humidity sensor wiring is per spec.
Created By : National TAB **Assigned To :** National TAB - Will Turnbough
Status : Open
Priority : High **Asset Tag :**
Originated Date : 06/10/2025 - Ian Fuller - National TAB

- **09/23/2025 National TAB - Stephen Tassinaro**
 - RTU-1 is still alarming for humidity sensor. Unresolved.

- **06/30/2025 National TAB - Ian Fuller**
 - Issue nit resolved as of 6/30. Core alarm is still present on system.

RTU1: 35% / ALARM GIVING INCORRECT HUMIDITY MEASUREMENT RTU2: NOT DISPLAYING READING RTU3: NOT DISPLAYING READING

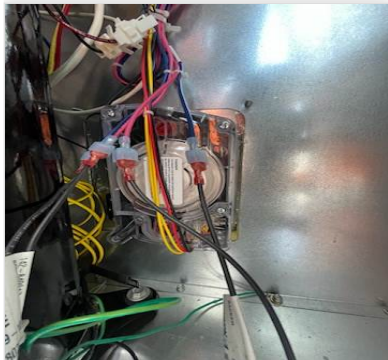
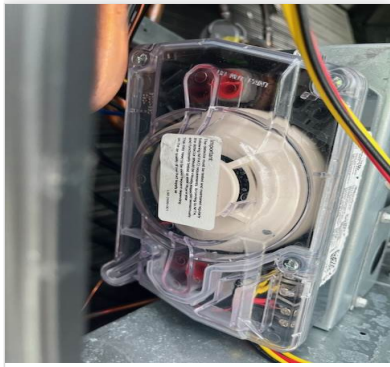
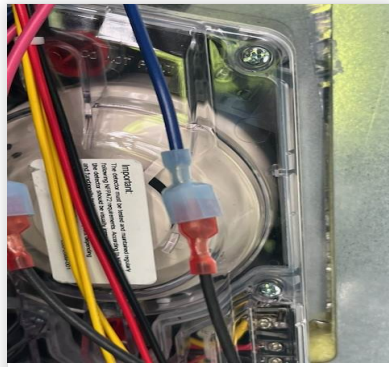
Issue Name : Smoke detector dust plugs are still in unit
Description : Recommended to remove dust plugs in all units before store operation.
Created By : National TAB **Assigned To :** National TAB - Will Turnbough
Status : Open
Priority : Medium **Asset Tag :**
Originated Date : 06/10/2025 - Ian Fuller - National TAB

- **06/30/2025 National TAB - Ian Fuller**
 - Issue not resolved as of 6/30.

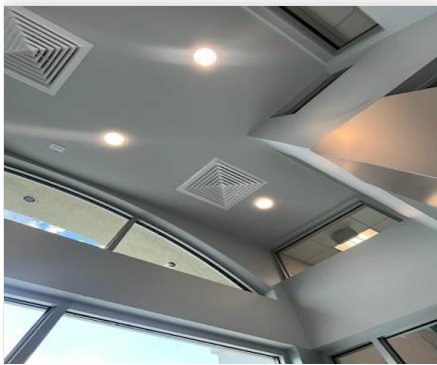
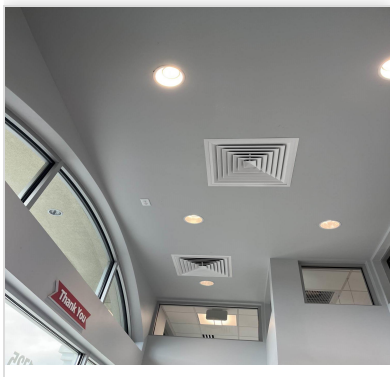
Issue Name : Transfer duct in vestibule has wrong diffuser installed.
Description : A supply type CD-2 diffuser is installed when the GRD specifies a return type G-2 diffuser is installed. The correct diffuser type needs to be installed.
Created By : National TAB **Assigned To :** National TAB - Will Turnbough
Status : Open
Priority : Medium **Asset Tag :**
Originated Date : 06/30/2025 - Ian Fuller - National TAB

- **09/23/2025 National TAB - Stephen Tassinaro**
 - Unresolved 9/22.
