**Report: TAB REPORT**  
**Function: Test, Adjust, & Balance**  
**Date: 08/12/2025**  
**Completed By: National TAB**

## 08-04-25 NIKE #202 CHESTERFIELD, MO

Project: 08-04-25 NIKE #202 CHESTERFIELD, MO

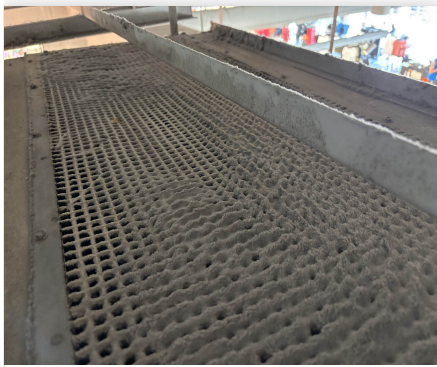
**Issue Name :** RTU-1: Clogged/Dirty Return Grille  
**Description :** The return grille for RTU-1 is clogged/very dirty. Supply airflow is low and the pressure is and causing duct to cave in. Recommend cleaning.  
**Created By :** National TAB                      **Assigned To :** National TAB - Dan Hertenstein  
**Status :** Open  
**Priority :** Urgent                                      **Asset Tag :** RTU1  
**Originated Date :** 08/06/2025 - Kalen Kemp - National TAB

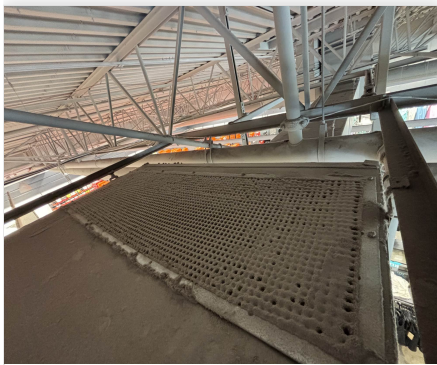
**Issue Name :** RTU-2: Clogged/Dirty Return Grille  
**Description :** The return grille for RTU-2 is clogged/very dirty. Supply airflow is low and the pressure is and causing duct to cave in. Recommend cleaning.  
**Created By :** National TAB                      **Assigned To :** National TAB - Dan Hertenstein  
**Status :** Open  
**Priority :** **Urgent**                                      **Asset Tag :** RTU2  
**Originated Date :** 08/06/2025 - Kalen Kemp - National TAB

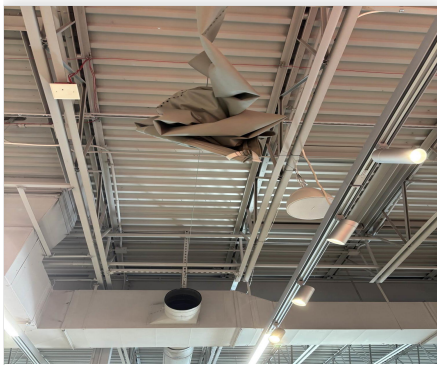
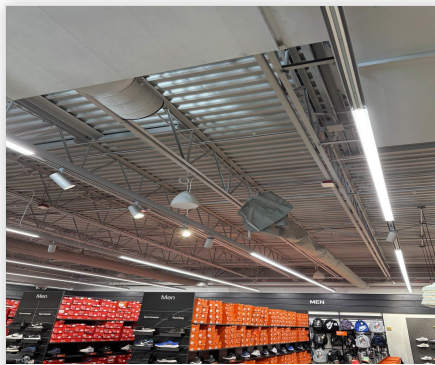
**Issue Name :** RTU-2: Duct Disconnected  
**Description :** The soft duct (Duct Sox) has disconnected from the main trunk of the RTU.  
**Created By :** National TAB                      **Assigned To :** National TAB - Dan Hertenstein  
**Status :** Open  
**Priority :** **Urgent**                                      **Asset Tag :** RTU2  
**Originated Date :** 08/06/2025 - Kalen Kemp - National TAB

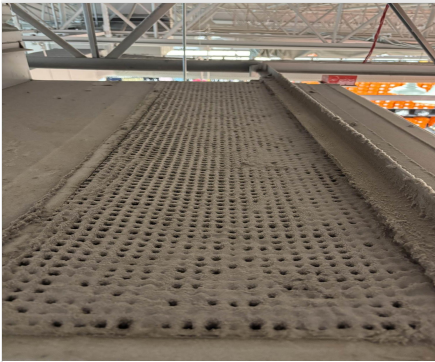
**Issue Name :** RTU-3: Clogged/Dirty Return Grille  
**Description :** The return grille for RTU-3 is clogged/very dirty. Supply airflow is low and the pressure is and causing duct to cave in. Recommend cleaning.  
**Created By :** National TAB                      **Assigned To :** National TAB - Dan Hertenstein  
**Status :** Open  
**Priority :** Urgent                                      **Asset Tag :** RTU3  
**Originated Date :** 08/06/2025 - Kalen Kemp - National TAB

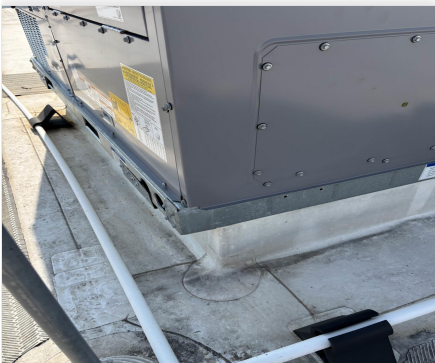
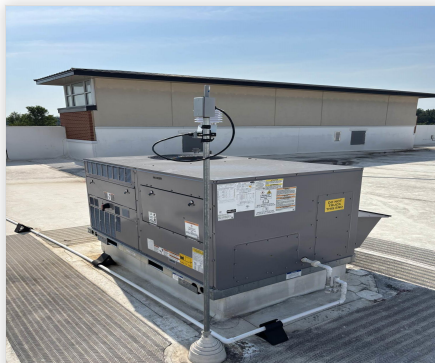
**Issue Name :** RTU-4: Curb Leakage  
**Description :** There is a small amount of air leaking from the curb of RTU-4. It can be felt at the corner closest to the supply fan compartment door. It is not a significant amount of airflow.  
**Created By :** National TAB                      **Assigned To :** National TAB - Dan Hertenstein  
**Status :** Open  
**Priority :** Low                                      **Asset Tag :** RTU4  
**Originated Date :** 08/06/2025 - Kalen Kemp - National TAB

RTU-4 has small leakage at corner near supply fan compartment

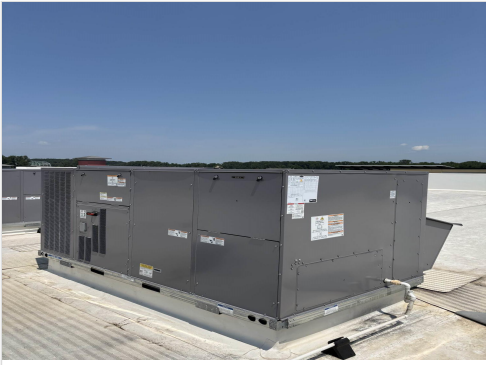
Asset: RTU1

- Return Grilles Dirty/Clogged. Balanced RTU with OA method. Put OA damper at 100% and adjusted fan speed accordingly. Set OA once fan speed was balanced.
- Initial Airflow Calculation: 2589

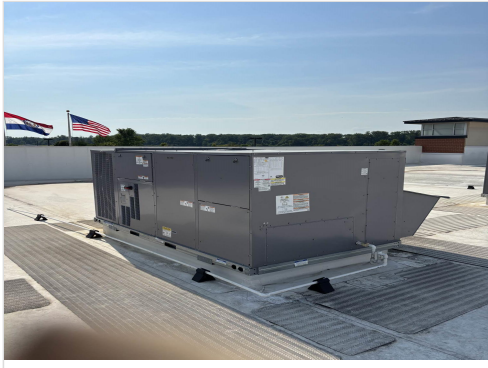
Asset: RTU2

- Return Grilles Dirty/Clogged. Balanced RTU with OA method. Put OA damper at 100% and adjusted fan speed accordingly. Set OA once fan speed was balanced.
- Initial Airflow Calculation: 2999

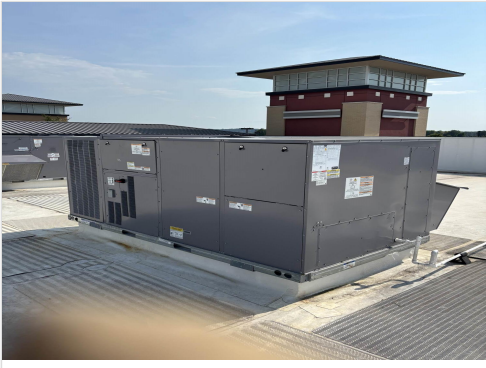
Asset: RTU3

- Return Grilles Dirty/Clogged. Balanced RTU with OA method. Put OA damper at 100% and adjusted fan speed accordingly. Set OA once fan speed was balanced.
- Initial Airflow Calculation: 3399
