Report: TAB Report
Function: Test, Adjust, & Balance
Date: 12/10/2025
Completed By: National TAB

PROJECT
12-08-25 Freddys - Ada, OK

KT Ventures

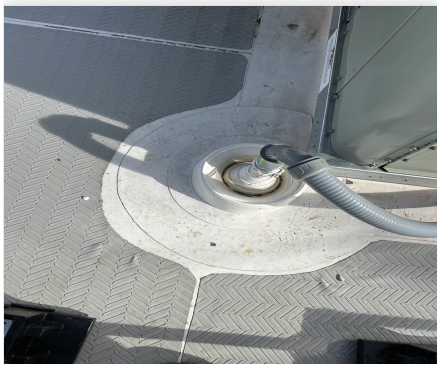
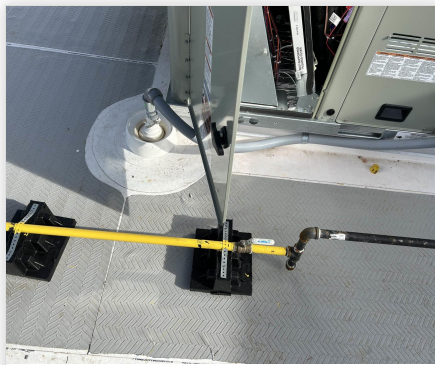
Issue Name : RTU-1 main power flex conduit.
Description : RTU-1 main power flex conduit obstructs MA door of RTU-1 from fully opening. Additionally water collects at escutcheon at roof penetration.
Created By : National TAB **Assigned To :** National TAB - Dan Hertenstein
Status : Open
Priority : Low **Asset Tag :**
Originated Date : 12/10/2025 - Cody Collett - National TAB

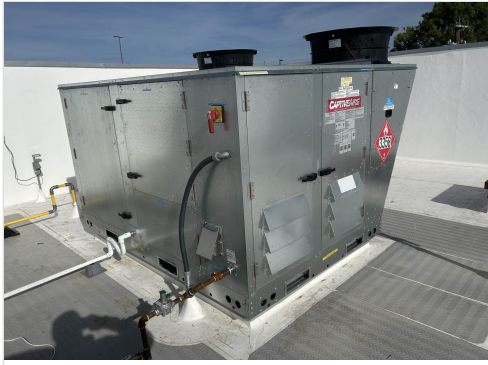
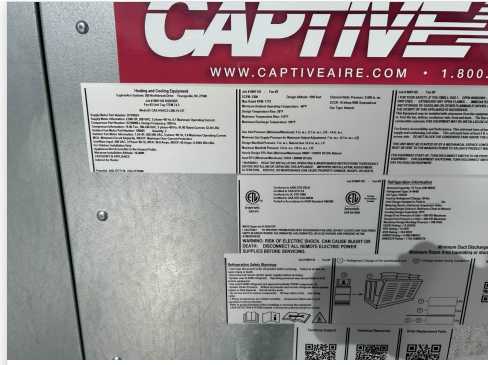
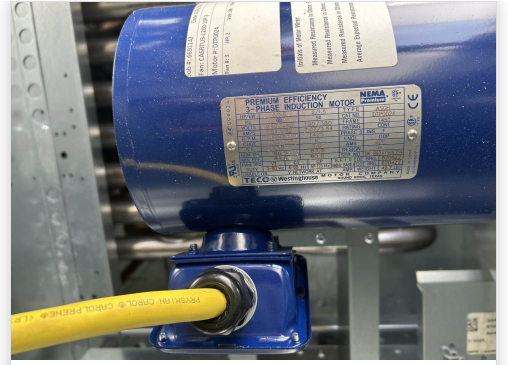
Asset: DOAS2

Unit CFM measured at roof due to leakage.

Diffuser CFM does not match UNIT total due to duct leakage.
