Report: TAB Report

Function: Test, Adjust, & Balance

12-08-25 Freddys - Ada, OK

KT Ventures

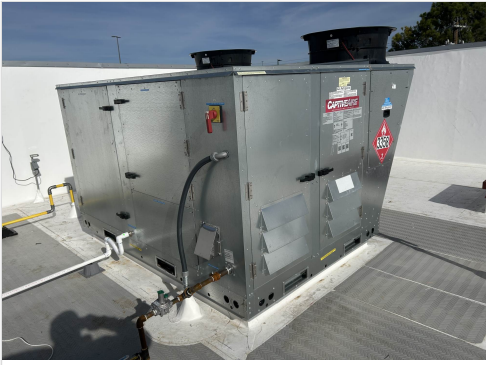
Asset: DOAS2

Issue Name : DOAS severe duct leakage.
Description : On return visit duct leakage was mostly sealed and now no longer leaks out of the building but now leaks into the space(after patch diffusers did not increase but building pressure did. Unit speed reduced to bring building pressure back into balance. Due to present duct leakage state diffusers do not meet design but unit total does.
Created By : National TAB **Assigned To :** National TAB - Dan Hertenstein
Status : Open
Priority : Urgent **Asset Tag :** DOAS2
Originated Date : 12/24/2025 - Cody Collett - National TAB

Unit CFM measured at roof due to leakage.

Diffuser CFM does not match UNIT total due to duct leakage.

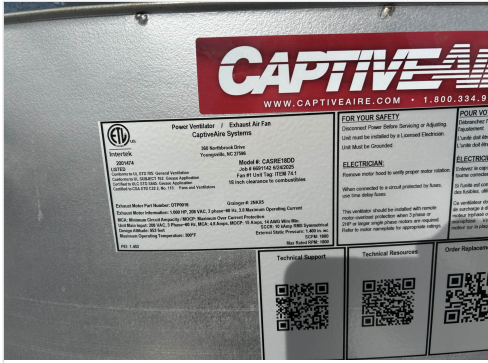
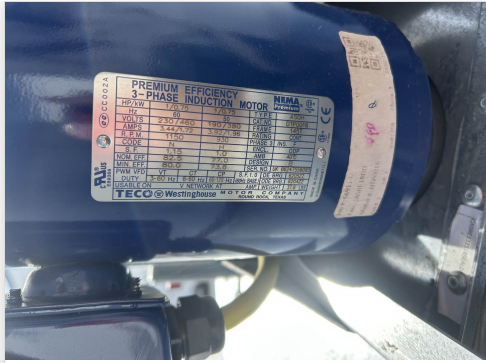
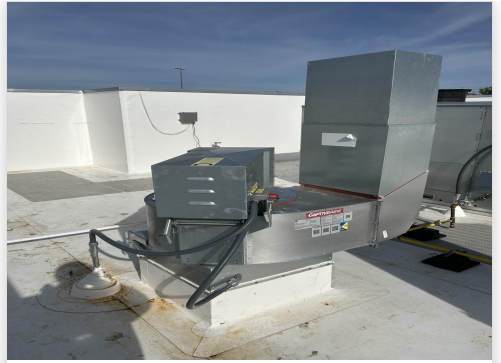
Asset: KEF1

Issue Name : KEF-1 and KEF-2 flex conduit.
Description : KEF-1 and KEF-2 flex conduit prevent their respective fans from fully tilting/using the hinge kit. Reinstall high and low voltage flex conduit to allow hinge kits to function.
Created By : National TAB **Assigned To :** National TAB - Dan Hertenstein
Status : Open
Priority : Urgent **Asset Tag :**
Originated Date : 12/10/2025 - Cody Collett - National TAB

Unable to fully tilt KEF-1 or KEF-2 due to flex conduit installation. Technician was able to tilt fans back enough to see duct and duct to fan alignment.
