Summary

Purpose of the visit to Naya 1 NY Plaza was to address concerns of poor hood capture.

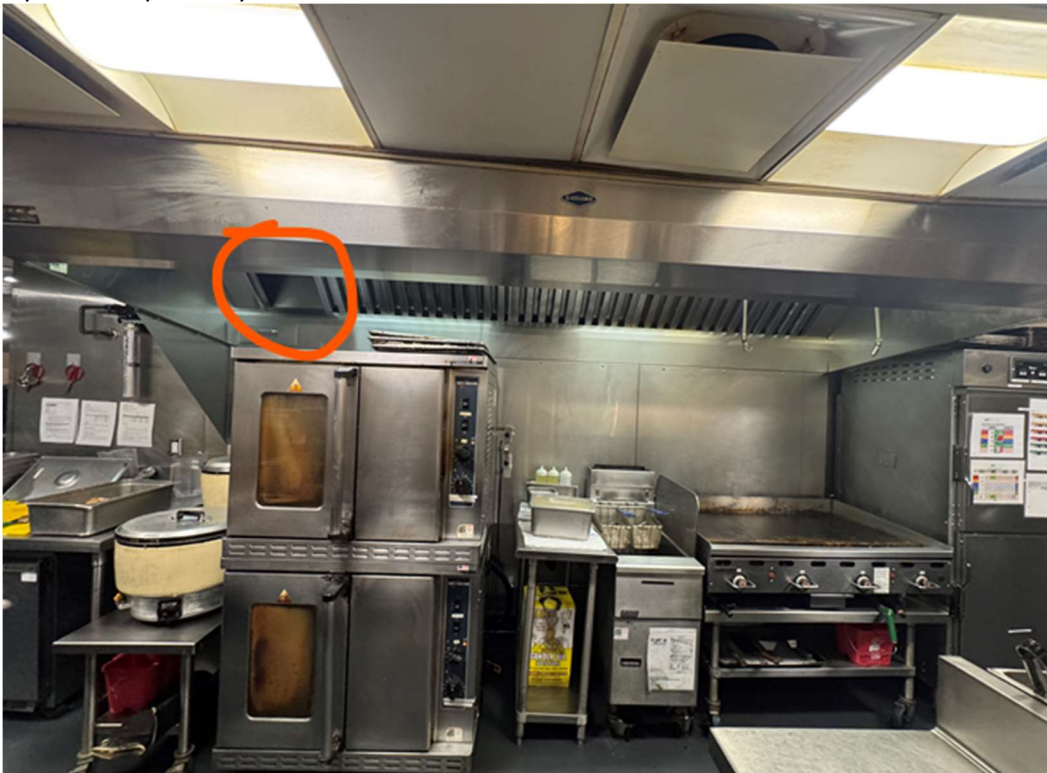
1. There is a missing filter that needs to be installed. The missing filter will cause more exhaust to be pulled from the hole where it's missing and will cause the exhaust to be lower over the grille and fryer which probably create more smoke.

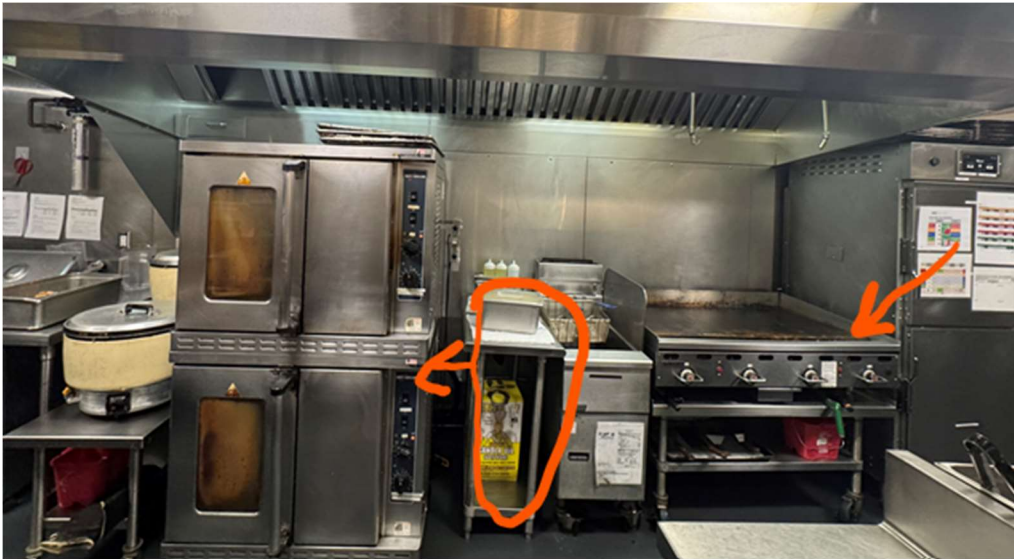
2. There is no hood overhang on the right side above the flat top grill. There ideally needs to be at least 6" of overhang. If possible the little table and fryer should be moved down so that the grill

can be moved down as well.

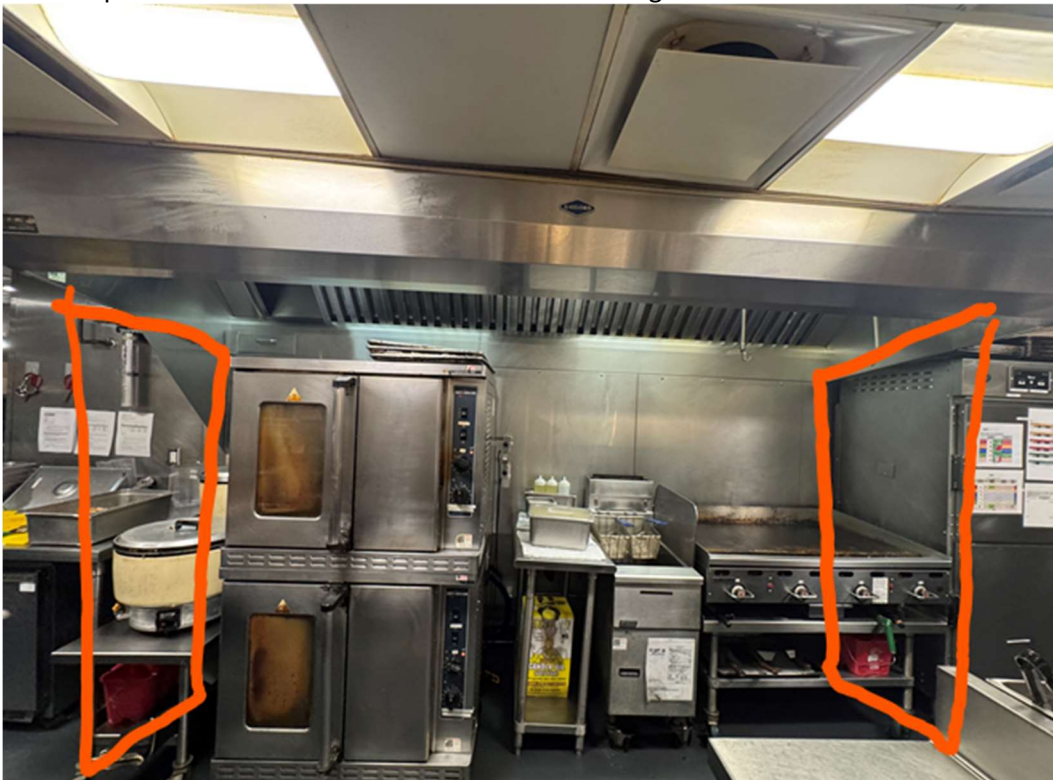
3. Full end panels should be added to both the left and right sides of the hood.

4. Based on the hood length and cooking application, the airflow likely needs to be 2300 CFM minimum for the hood to work. (Ideally it would be closer to 2700 CFM) For it to work at this exhaust rate, full end panels are needed as shown above. Consult the landlord to see if more airflow can be provided.

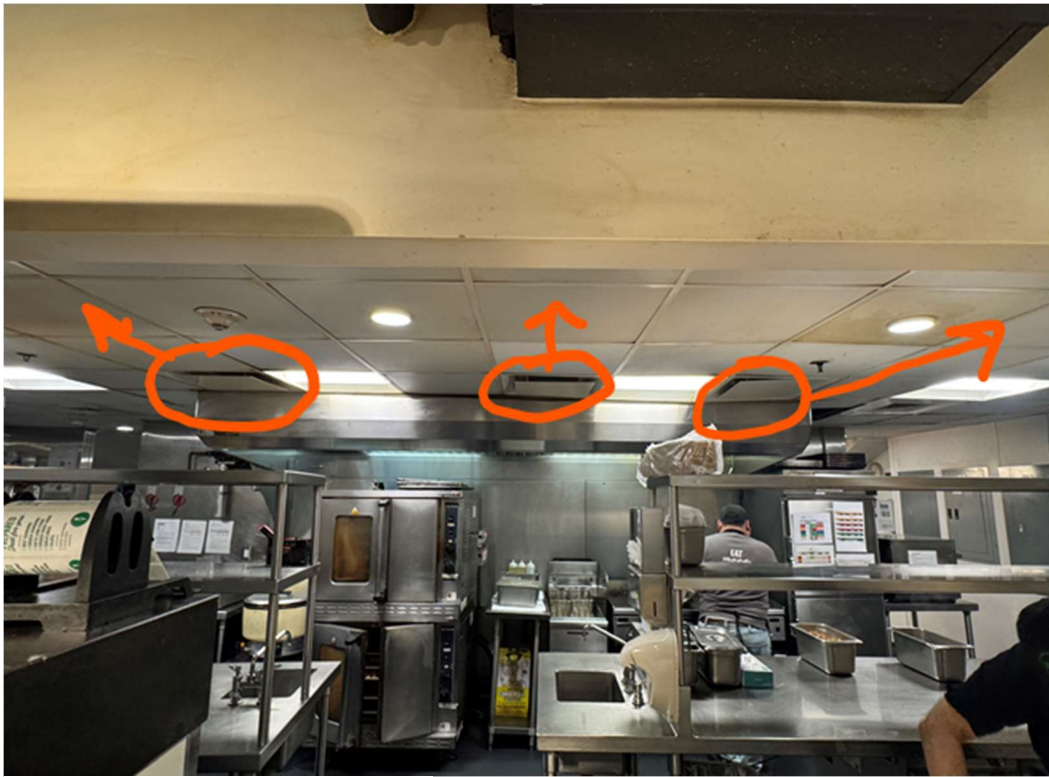
5. Right in front of the hood there are three 4-way diffusers. These should be changed to perforated diffusers (typical of Titus model PAR) with no deflection blades and then they should be moved 2 ceiling tiles away.
