Report: TAB REPORT
Function: Test, Adjust, & Balance
Date: 07/07/2023

PROJECT
07-03-23 RIPPLE - CINCINNATI, OH

2000 MADISON RD

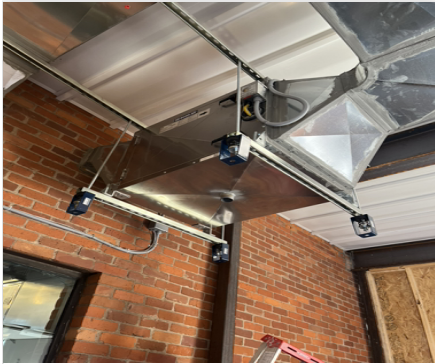
**Nogreasetrap
07/07/2023**

Issue Name : EF-1 Missing Grease Trap
Description : Ef-1 is missing the grease trap/drain
Created By : National TAB **Assigned To :** National TAB - Tyler Youells
Status : Open
Originated Date : 07/07/2023 - Tyler Youells - National TAB

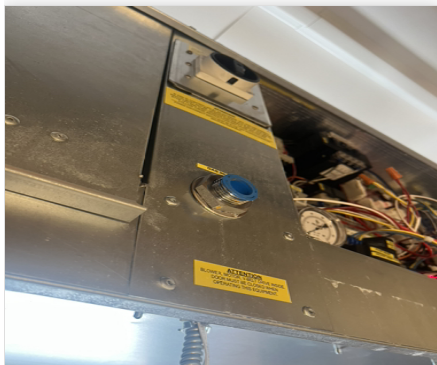
**MUAgasline
07/07/2023**

Issue Name : MUA Gas piping
Description : Gas piping to the MUA has not yet been completed. This unit will not be able to heat until gas line is installed. Recommend resolving before Fall/Winter seasons.
Created By : National TAB **Assigned To :** National TAB - Tyler Youells
Status : Open
Originated Date : 07/07/2023 - Tyler Youells - National TAB
