Report: TAB REPORT
Function: Test, Adjust, & Balance
Date: 07/07/2023

PROJECT
07-03-23 RIPPLE - CINCINNATI, OH

2000 MADISON RD

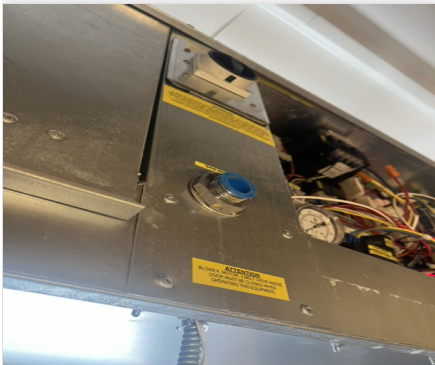
**MUAgasline
07/07/2023**

Issue Name : MUA Gas piping
Description : Gas piping to the MUA has not yet been completed. This unit will not be able to heat until gas line is installed. Recommend resolving before Fall/Winter seasons.
Created By : National TAB **Assigned To :** National TAB - Tyler Youells
Status : Open
Originated Date : 07/07/2023 - Tyler Youells - National TAB
