**Report: TAB REPORT  
Function: Test, Adjust, & Balance  
Date: 07/07/2023**

**PROJECT  
07-03-23 RIPPLE - CINCINNATI, OH**

Project: 07-03-23 RIPPLE - CINCINNATI, OH

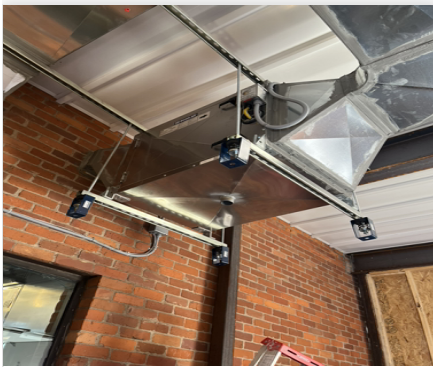
Nogreasetrap  
07/07/2023

**Issue Name :** EF-1 Missing Grease Trap  
**Description :** Ef-1 is missing the grease trap/drain  
**Created By :** National TAB **Assigned To :** National TAB - Tyler Youells  
**Status :** Open  
**Originated Date :** 07/07/2023 - Tyler Youells - National TAB

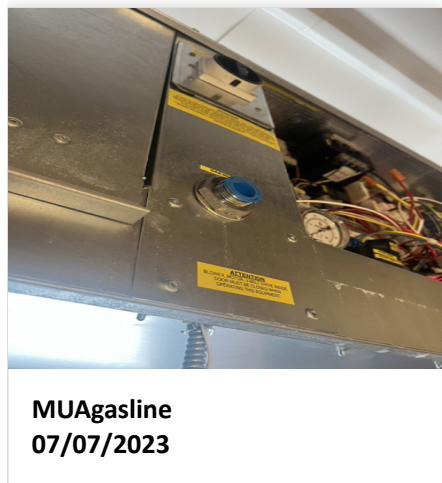
**Issue Name :** MUA Gas piping  
**Description :** Gas piping to the MUA has not yet been completed. This unit will not be able to heat until gas line is installed. Recommend resolving before Fall/Winter seasons.  
**Created By :** National TAB                      **Assigned To :** National TAB - Tyler Youells  
**Status :** Open  
**Originated Date :** 07/07/2023 - Tyler Youells - National TAB
