Report: PERLIM

Function: Test, Adjust, & Balance

**04-08-24 RALPHS #703-004 LAGUNA
BEACH, CA**

Issue List

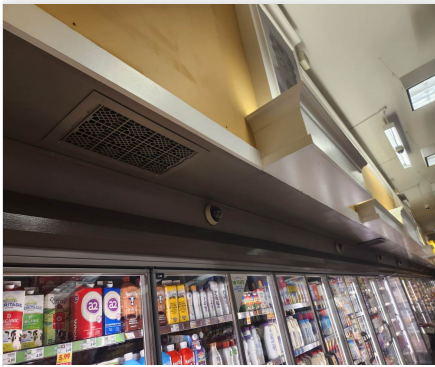
20240411_101152
04/11/2024

Issue Name : RETURN DUCT IS UNABLE TO BE FULLY MAPPED
Description : Return ductwork is inaccessible and cannot be accurately mapped. A rough estimate of the return duct is shown on the drawing attached.
Created By : National TAB **Assigned To :** National TAB - Will Turnbough
Status : Open
Priority : InfoOnly **Asset Tag :**
Originated Date : 04/11/2024 - Zack Eismin - National TAB

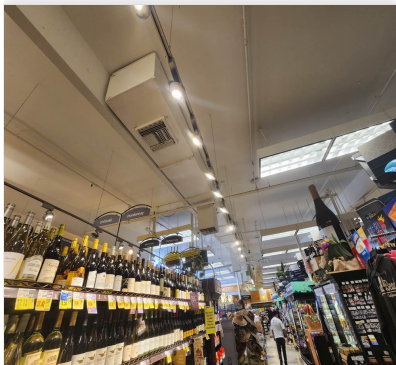
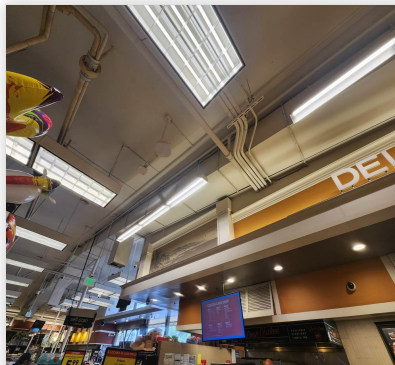
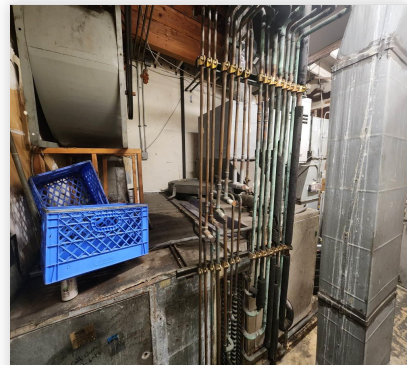
AHU

| General | | |
|---|---|---|
| Unit free of Damage | - | NO, VERY RUSTY |

6560CFM@FILTERS
 5647CFM TRAVERSE @0.091" SP
 4581CFM @ DIFFUSERS
 COOLING NOT OPERATIONAL
