Report: TAB Report
Function: Test, Adjust, & Balance
Date: 09/03/2025
Completed By: National TAB

PROJECT
09-01-25 WAWA #7401 PLAINFIELD, IN

Project: 09-01-25 WAWA #7401 PLAINFIELD, IN

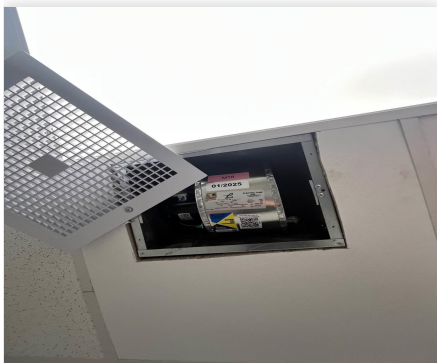
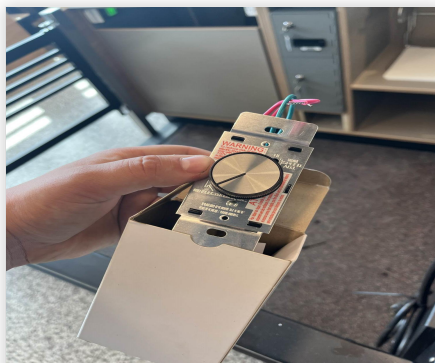
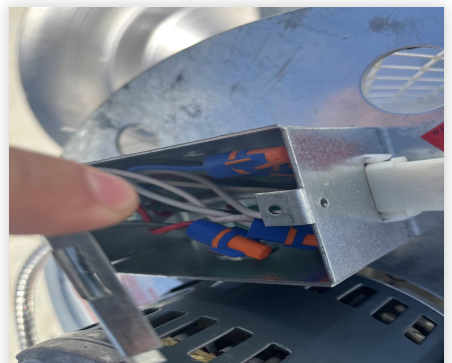
Issue Name : EF-1/EF-2/EF-3 missing speed controllers
Description : EF-1/EF-2/EF-3 missing speed controllers. EF-1/EF-2 are low on flow at EF-1: 312/375CFM EF-2: 226/400CFM Unable to increase due to direct wiring. EF-3 is high on flow at 329/200CFM. Unable to decrease due to direct wiring. Recommend installing speed controllers to properly balance to design airflow.
Created By : National TAB **Assigned To :** National TAB - Dylan Crisman
Status : Open
Priority : Urgent **Asset Tag :**
Originated Date : 09/03/2025 - Dylan Crisman - National TAB

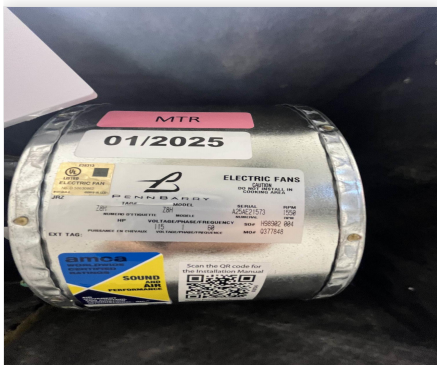
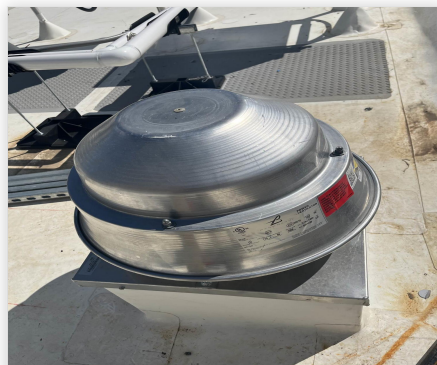
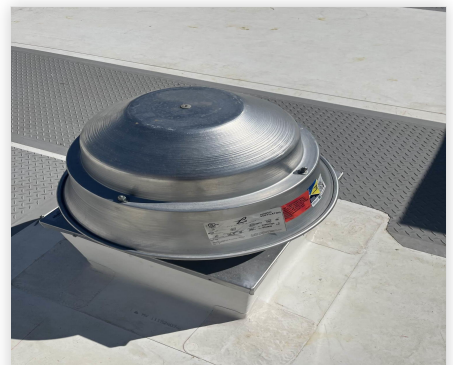
Issue Name : EF-1/EF-2/EF-3 wrong fans installed
Description : Fans per plans show Greenheck fans to be installed. Fans installed on site are PennBarry exhaust fans. Could not confirm with GC/Construction group on if this was an approved change.
Created By : National TAB **Assigned To :** National TAB - Brianna Biggs
Status : Open
Priority : InfoOnly **Asset Tag :**
Originated Date : 09/03/2025 - Dylan Crisman - National TAB

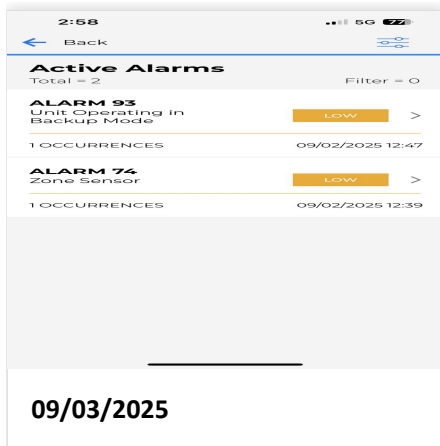
Issue Name : RTU-1/RTU-2/RTU-3 missing space sensors
Description : Missing space sensors and wiring for sensors to RTUs. Wires will need to be ran and sensors installed in proper places per plans on MSET. Units are operating on return air back up currently due to this and shows an alarm for space sensors.
Created By : National TAB **Assigned To :** National TAB - Dylan Crisman
Status : Open
Priority : Urgent **Asset Tag :**
Originated Date : 09/03/2025 - Dylan Crisman - National TAB

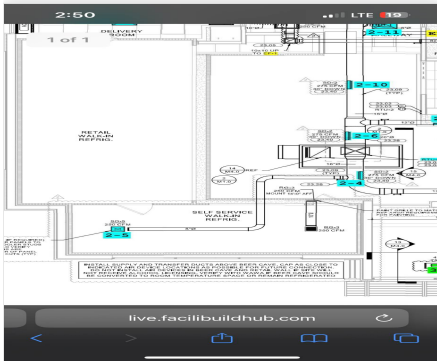
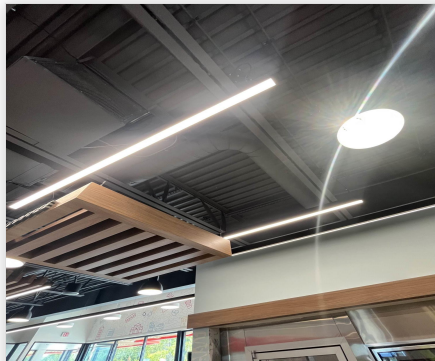
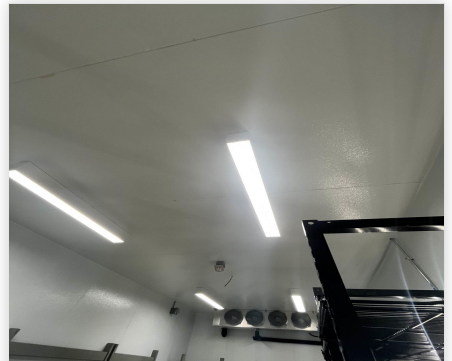
Issue Name : RTU-2 diffuser 2-5 Deleted
Description : RTU-2 diffuser 2-5 to walk in cooler has been deleted per GC/Construction group, Duct has been added for future considerations but confirmed that the diffuser has been deleted and damper for duct has been fully closed. Balanced rest of units diffusers to design.
Created By : National TAB **Assigned To :** National TAB - Dylan Crisman
Status : Open
Priority : InfoOnly **Asset Tag :**
Originated Date : 09/03/2025 - Dylan Crisman - National TAB

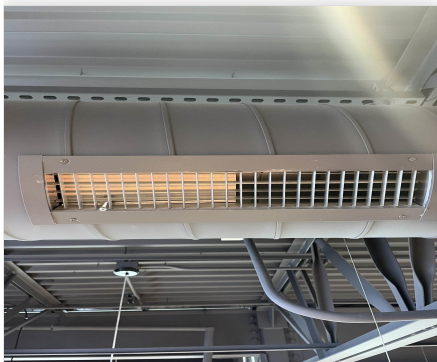
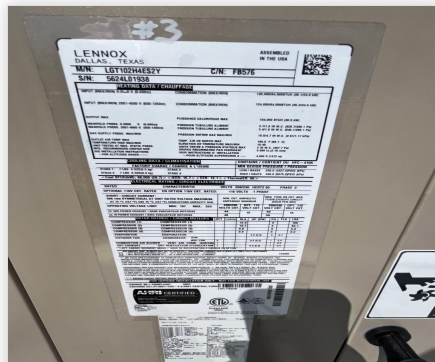
Issue Name : RTU-2 Spiral duct Diffusers
Description : Spiral duct diffusers in open sales floor are unable to be balanced due to having the incorrect damper type installed. They have a deflector plate that only covers half of the free area of the diffuser grille. When fully closed it doesn't lower CFM value, rather pushes all air to one side of the register. OBD dampers are to be installed per spec.
Created By : National TAB **Assigned To :** National TAB - Dylan Crisman
Status : Open
Priority : Urgent **Asset Tag :**
Originated Date : 09/04/2025 - Dylan Crisman - National TAB

RTU-2 Spiral duct on sales floor could not be balanced due to wrong damper type.

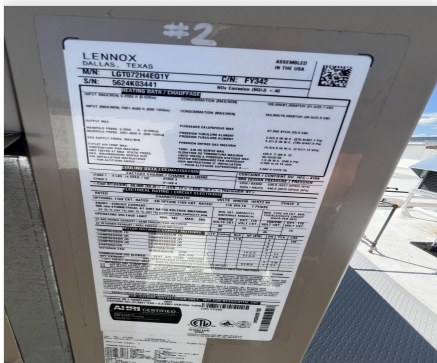
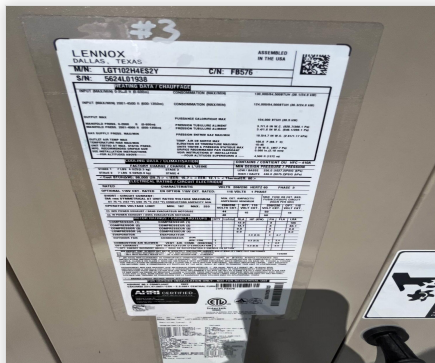
Issue Name : RTU-2/RTU-3 incorrect labeling
Description : RTU-2 and RTU-3 are labeled incorrectly. 3 is labeled as #2 2 is labeled as #3 on rooftop and within the core app for the units controller. This could cause some confusion for anyone performing maintenance on the units.
Created By : National TAB **Assigned To :** National TAB - Dylan Crisman
Status : Open
Priority : InfoOnly **Asset Tag :**
Originated Date : 09/04/2025 - Dylan Crisman - National TAB

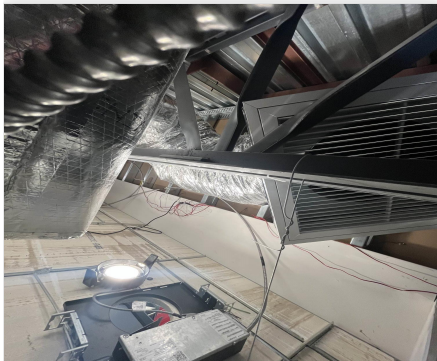
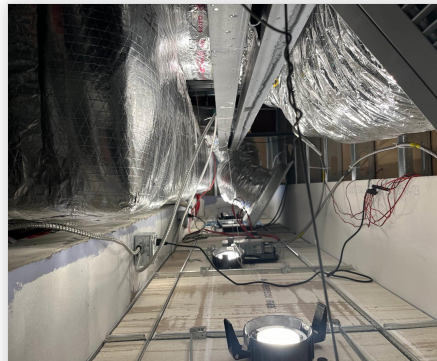
Issue Name : RTU-3 return grilles
Description : Return grilles/ducts are tucked up above ceiling in office spaces. These need to be properly dropped into drop ceiling per plans above soda machines.
Created By : National TAB **Assigned To :** National TAB - Dylan Crisman
Status : Open
Priority : High **Asset Tag :**
Originated Date : 09/03/2025 - Dylan Crisman - National TAB

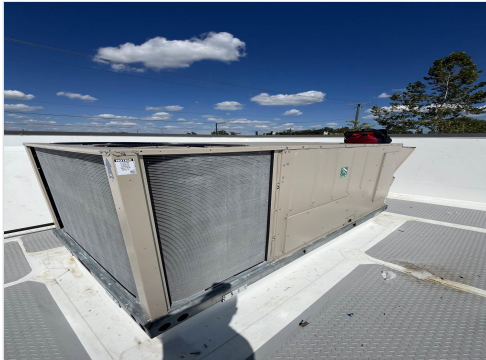
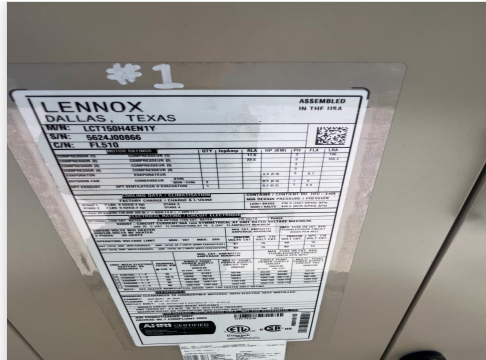
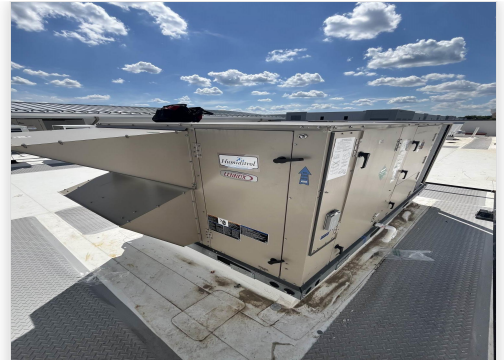
Asset: RTU1

Notes:
Unable to balance spiral duct diffusers due to deflector plates being installed instead of OBD integral dampers. Issue Created.

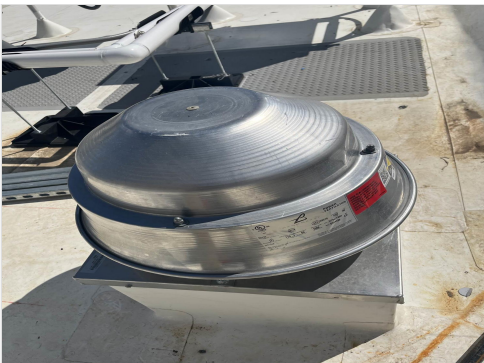
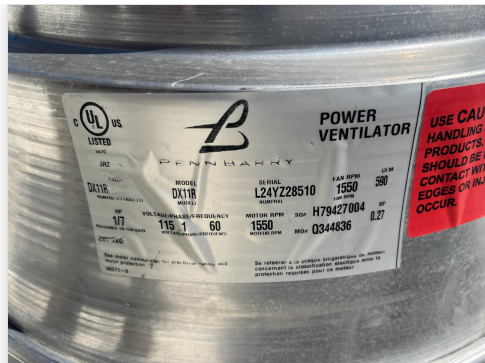
Asset: EF1

Notes:
 Unit is low on flow, at 312/375.
 Direct wired and missing speed controller.
 Unable to increase airflow to design.

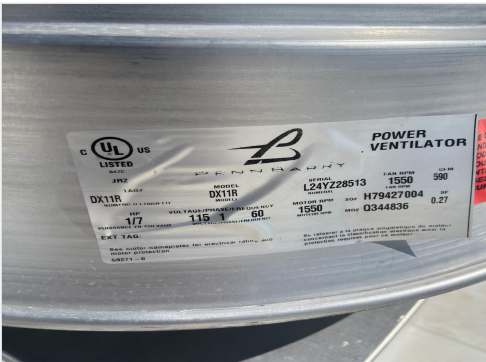
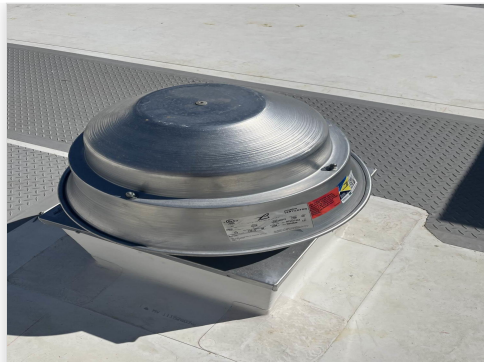
Asset: EF2

Fan is low on flow at 226/400.
Direct wired and missing speed controller.
Unable to increase airflow to design.
