**Report: Commissioning**

**Date: 3/16/2022**

## Shake Shack (Chesterfield) - Commissioning

***Shake Shack – Chesterfield, MO (FIV) In-Wall Inspection Summary (March 16<sup>th</sup>, 2022)***

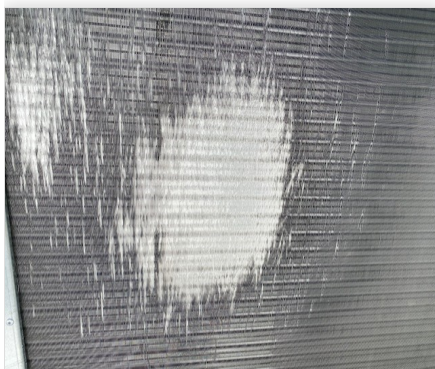
damaged\_DOAS\_outdoor\_coil.jpg

**1:** DOAS outdoor coil had incurred damage and was installed without a hail guard.

Crystal Heating and Cooling responded indicating the equipment is owner provided with no hail guard listed as a required accessory.

**Issue Name :** MC: Kitchen DOAS - Condenser Coil Damage, missing hail guard  
**Description :** Unit's condenser coil has damage to fins on face lower left end of coil. Unit was not provided with hail guard  
**Created By :** National TAB **Assigned To :** Crystal Heating & Cooling - Billy Gray  
**Status :** Open  
**Originated Date :** 03/06/2022 - Dan Hertenstein - National TAB

Status: Issue will remain open for owner review

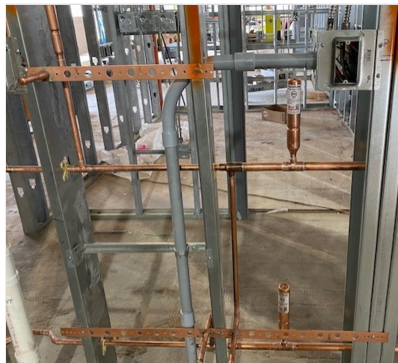
**Hard\_temper\_copper\_tubes\_soldered.PNG**

CW, FW, HW, HWR lines are type "L" hard temper copper tube with wrought copper fittings and soldered connections.	Yes
---	-----

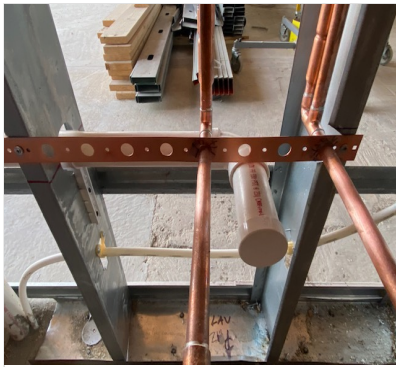
**Escutcheon\_bracing\_at\_termination\_point.jpg**

Escutcheon bracing is installed to support all piping at through wall locations	Yes
---	-----

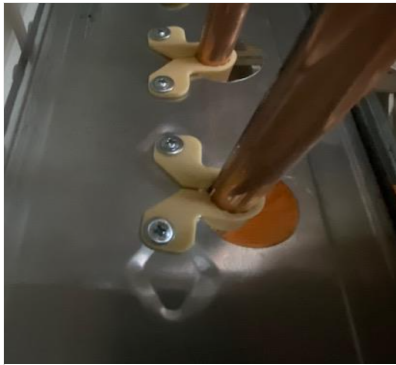
**HORIZONTAL\_PIPE\_BRACING\_TO\_STUD\_WALLS.PNG**

Horizontal bracing is provided through studs by utilizing stud fastening supports Yes

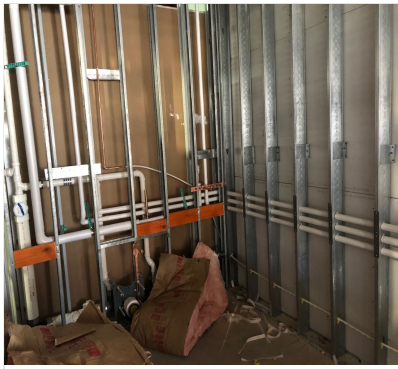
**in\_wall\_insulation\_2.jpg**

All lines in exterior walls are to be insulated with minimum 2" BATT insulation to prevent freezing Yes

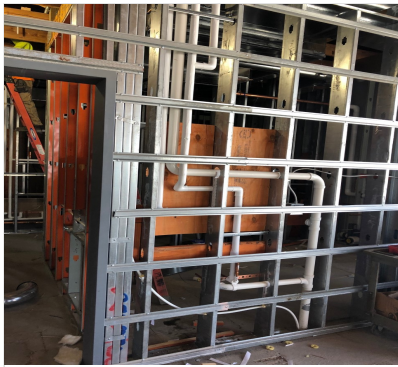
**in\_wall\_insulation\_1.jpg**

All copper lines within internal walls have been insulated per specification

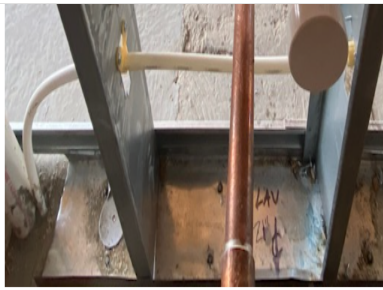
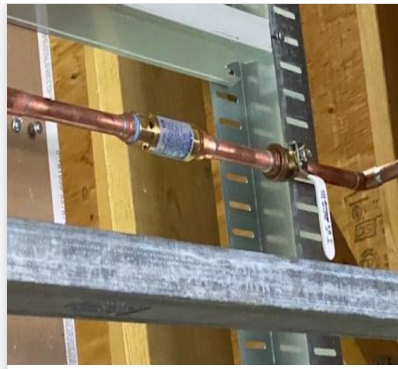
Gravity Trap Primer valve, shut-off valve, and water line has been installed and routed to each restroom floor drain. Access points will be available to ensure valves are accessible for future maintenance

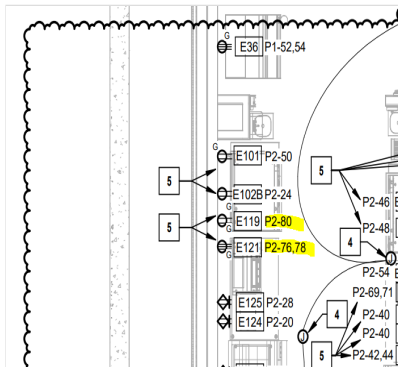
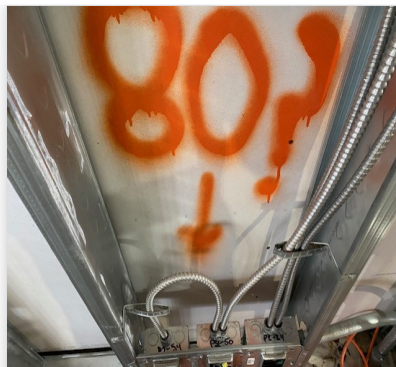
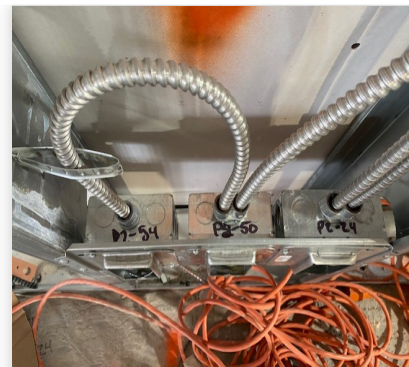
**3:** Electrical junction box panel breaker labels could not be identified per plan for a few junctions:

Electrical/GC response: All junctions are correctly installed, a few had been moved or relabeled but serve equipment as required

In-Wall Junction boxes are installed per electrical and food equipment plan to serve appliances, office equipment, Indoor signs and other necessary functions (no missing outlets)	All in-Wall outlets (excluding dining) validated and approved. See attached photo for circuit label correction for planned labeled circuits P2-80 (Item E119) and P2-76,78 (Item E121). GC spoke with electrician and indicated labeling of CB's will change but power and phase loading will remain as designed
--	--

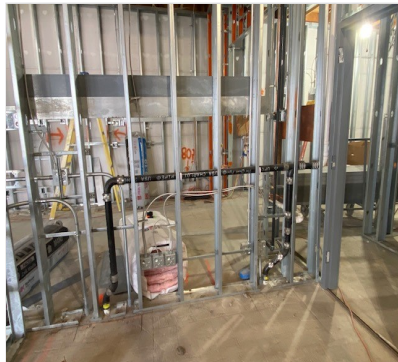
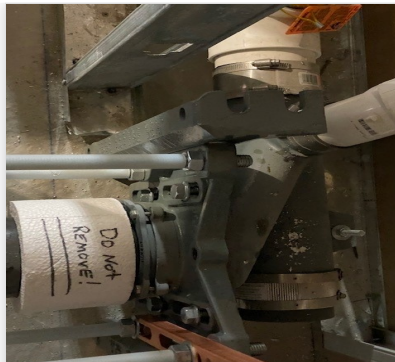
Interior waste dish machine and toilet lines above slab shall be hubless cast iron soil pipe and fittings	Yes
---	-----

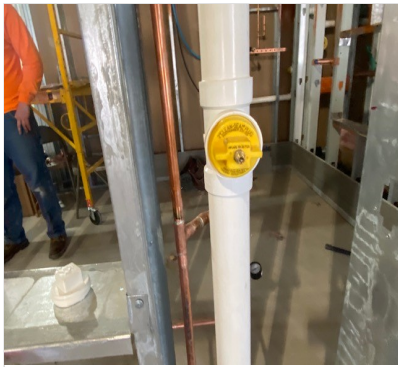
**vent\_line\_plug\_clean\_outs.jpg**

Interior plug clean-outs are installed in vents	Yes
---	-----

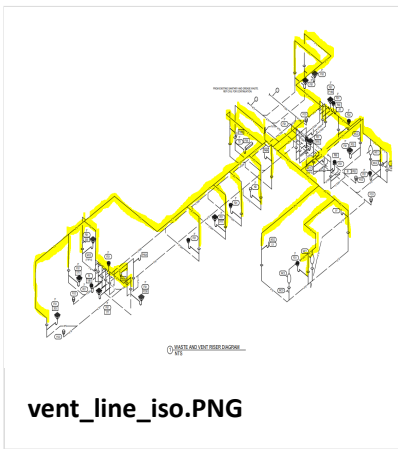
**vent\_line\_iso.PNG**

Vent lines are routed, sized per plan
