Report: Commissioning

Shake Shack (Chesterfield) - Commissioning

Shake Shack – Chesterfield, MO (FIV) In-Wall Inspection Summary (March 16th, 2022)

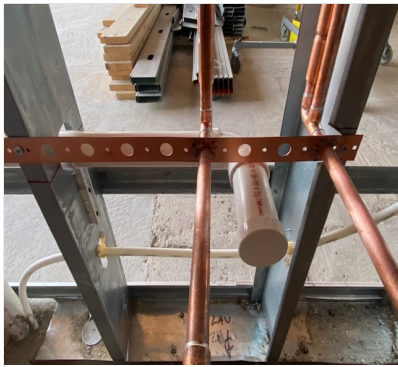
Escutcheon_bracing_at_termination_point.jpg

Escutcheon bracing is installed to support all piping at through wall locations	Yes
---	-----

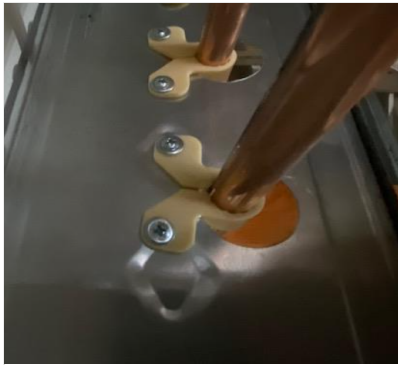
HORIZONTAL_PIPE_BRACING_TO_STUD_WALLS.PNG

Horizontal bracing is provided through studs by utilizing stud fastening supports

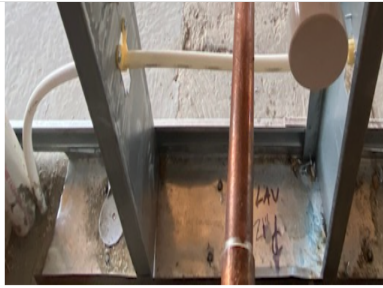
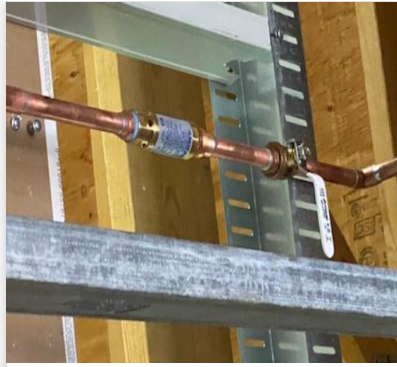
Gravity Trap Primer valve, shut-off valve, and water line has been installed and routed to each restroom floor drain. Access points will be available to ensure valves are accessible for future maintenance
