Report: Commissioning

Date: 4/1/2022

Shake Shack (Chesterfield) - Commissioning

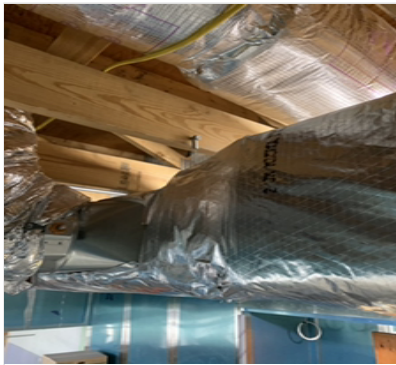
Ductsupport.jpeg

Duct is properly supported	Yes
----------------------------	-----

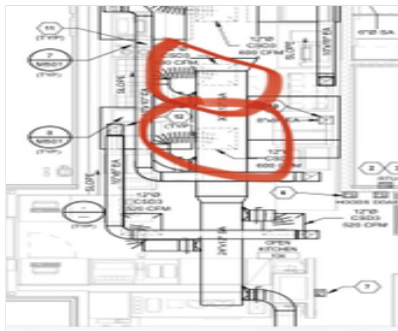
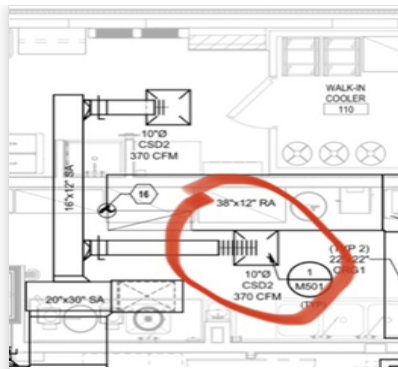
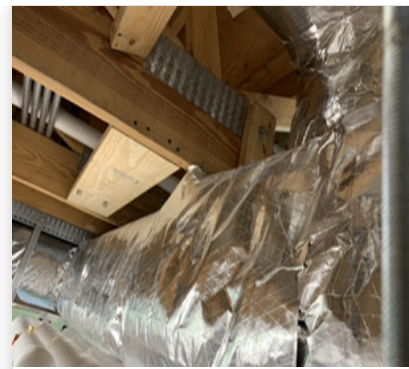
Diffuser takeoff moved to top and routed around obstructions. Best possible path due to obstructions. If TAB is not able to access damper during balance, MC will have to secure the take off damper to 100% open and mount a new damper at the diffuser neck. During inspection C-Agent was able to get to damper on 8ft ladder (prior to ceiling grid)

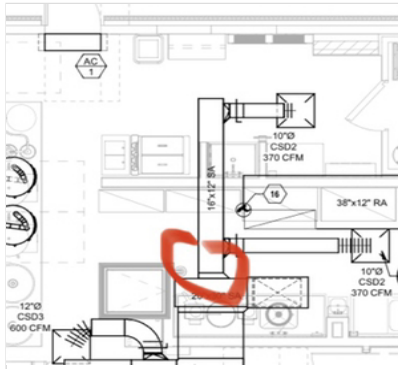
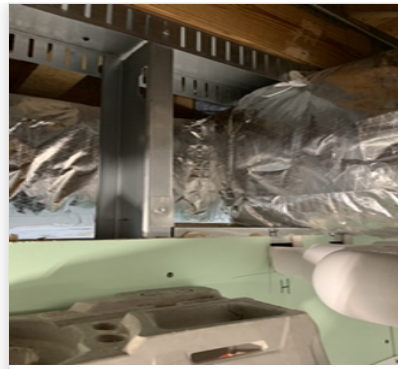
Most take-offs are high efficient, a few areas noted have straight round take-offs. If flow is not achieved during balance, MC should scoop or change the take-off. Due to the location C-agent does not believe this take-off will present an issue.

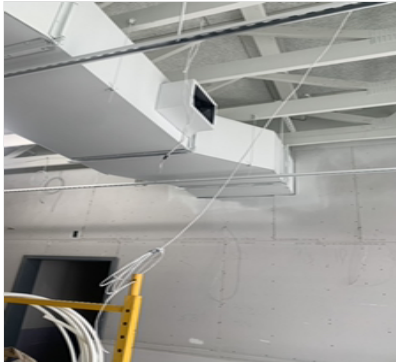
Offsetnotondrawing.jpeg

Through wall offset was installed due to arch/mech drawing location difference. Offset created to avoid conflicts with lighting

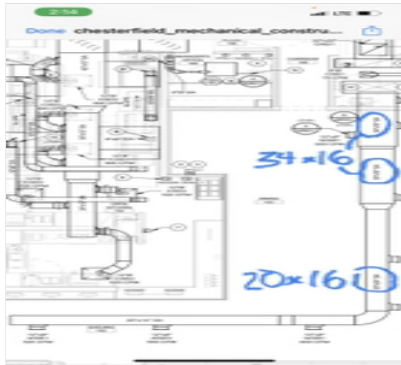
RTUDUCTDINING.jpeg

Through wall main duct is designed 34x18 actual size is 34x16 Section 24x20 is actually 24x16

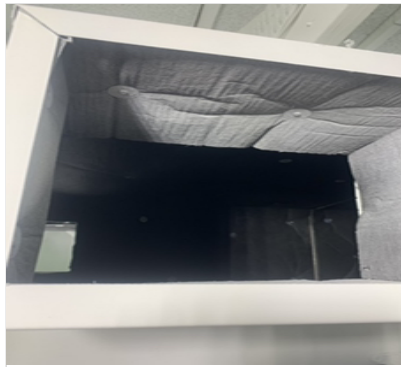
Internalinsulated.jpeg

Duct is internally insulated in open ceiling spaces per specification Yes

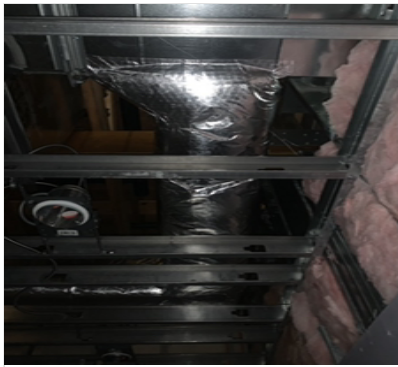
Externalwrapabdtaped.jpeg

Unexposed Duct is externally insulated and foil taped Yes

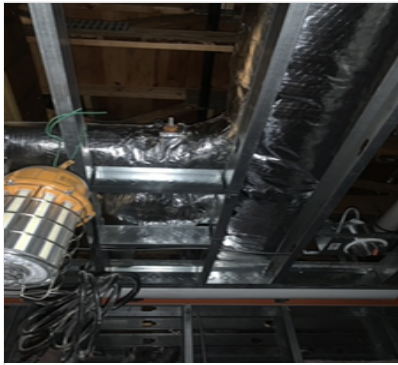
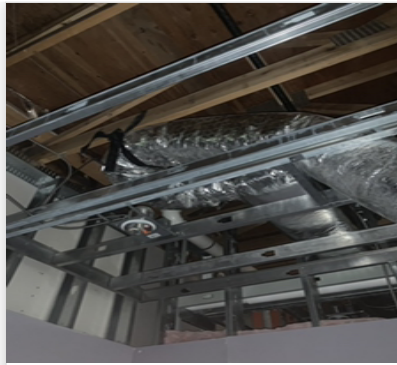
OBD'S not installed at time of inspection Restroom dampers are above hard-lid ceiling. Need to ensure access to damper once ceiling is installed Men's RR duct flex duct exceeds 5ft

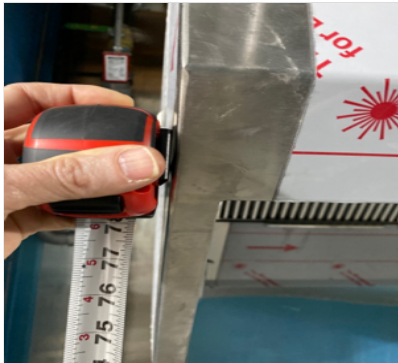
Hangheight.jpeg

Hood is hung at the correct elevation (height)	Design height is 71", hoods are hung at 78". CAS approved at 78" for airflow set to +5% over design and cooking equipment >31" tall
--	---

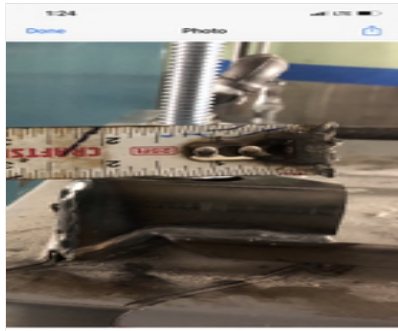
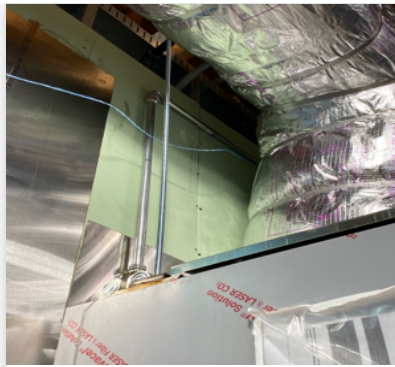
Hood is hung using 1/2" all-thread and supported from beam clamps or uni-strut off from the building structure	3/8" originally installed. MC replaced with 1/2" rod
--	--

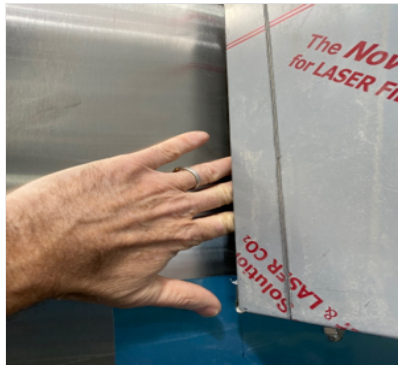
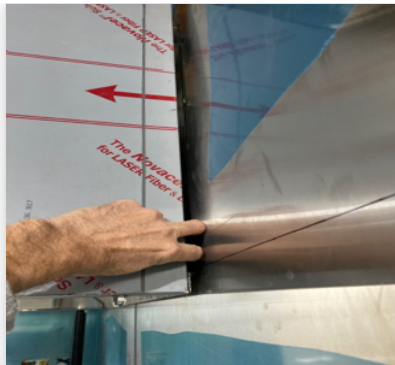
Hood is installed so the the bottom and sides of hoods are flush to the wall, with gaps less than 1/8".

No

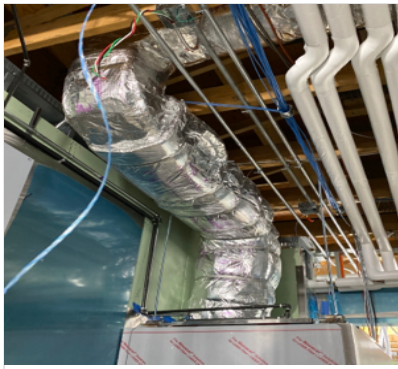
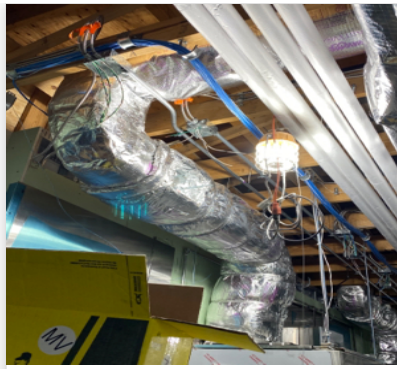
Yes. Extra back to back elbows on external wall fryer and griddle hoods.

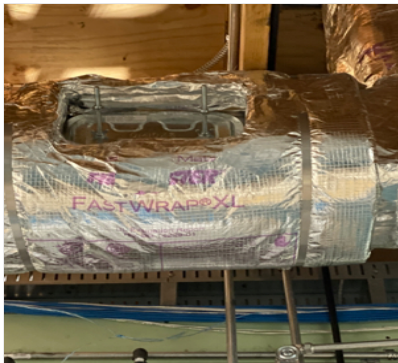
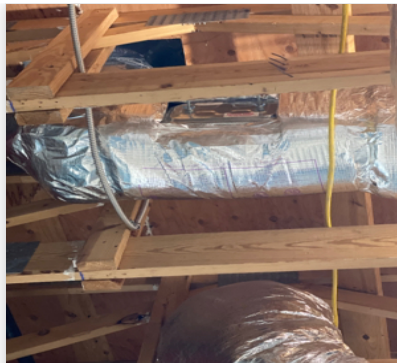
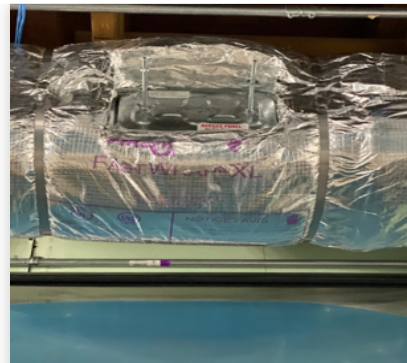
Grease duct pressure water test completed	Yes
Fire wrap layer 1 installed and inspected	Yes
Fire wrap 2nd layer installed and inspected	Installing during inspection
Proper cleanouts have been installed per code	Yes

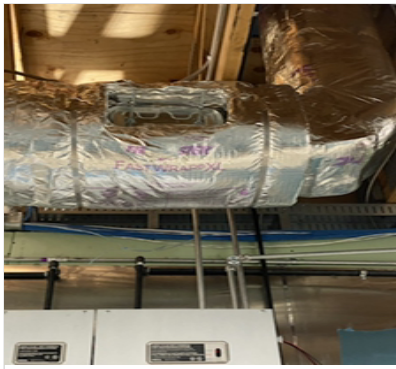
Cleanouts.jpeg

Cleanouts fire wrapped and marked for easy verification and access	Installed but cleanouts not insulated and marked at time of inspection,
--	---

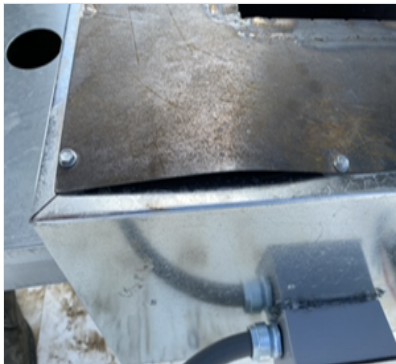
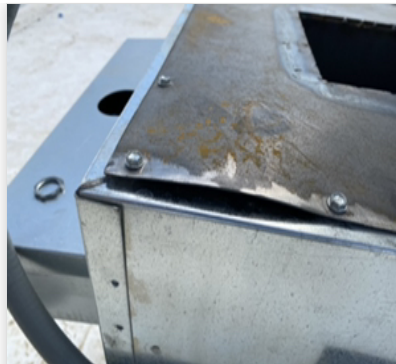
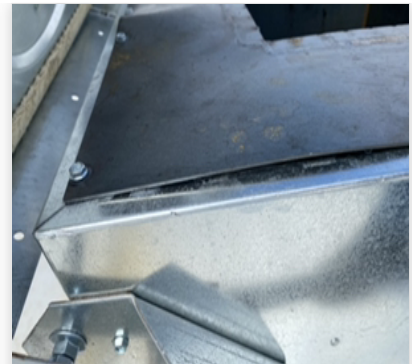
Curb is flashed but it is not flush, mechanical needs to unscrew the top plate and flatten the curb plate to obtain a good fan seal before securing to the curb

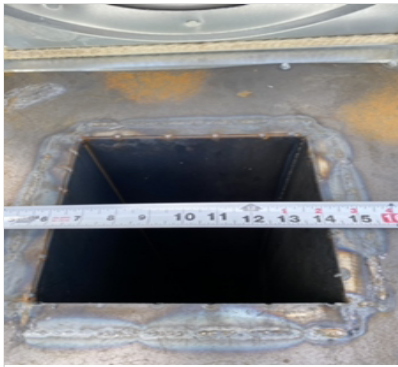
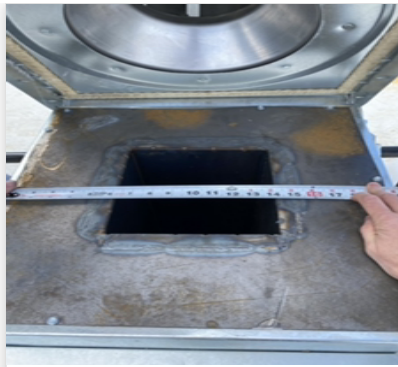
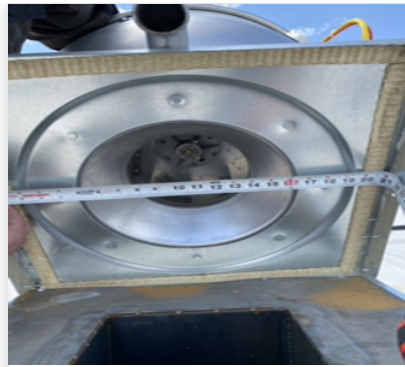
Grease duct is located in the center of the top plate, duct does not transition out to surround the fan inlet.

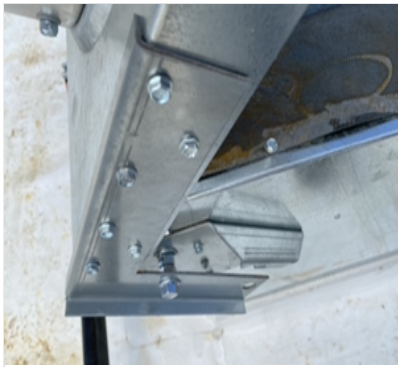
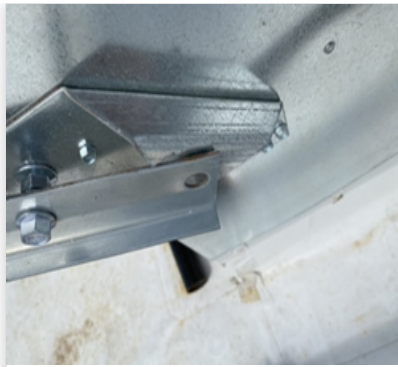
Unit Tag matches the design and submittal MFG and Model	Yes
There is no noticeable physical damage to the fan	No damage
Fans are installed in the correct location and orientation	Yes
All packing, material and debris has been removed from the blower/wheel housing and the motor compartment	Yes
Fan wheels turn easily by hand (turn power off prior to testing)	Yes
Exhaust fans have external disconnects and are are connected to allow full hinging of each exhaust fan	Yes
Fan is properly hinged and supported when hinged fully back for grease duct access	Fan is hinged but the lever arm is out side of the brace on some hinges. The bolts are tightened too tight, no allowing the fan to catch when opened on these braces. MC to bend lever arm so that it will catch on the brace and loosen the bolts to relieve some tension so that this functions as designed

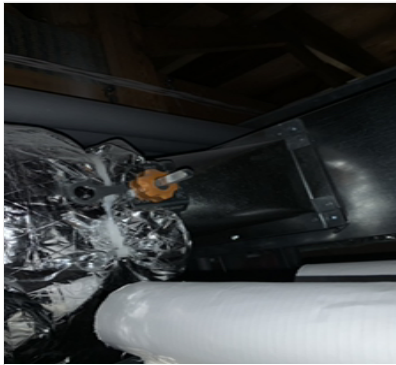
Takeoffabovehardlid.jpeg

Yes dampers will be above hard ceiling. Ensure access to dampers for TAB

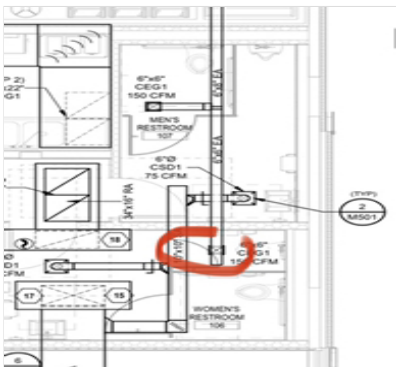
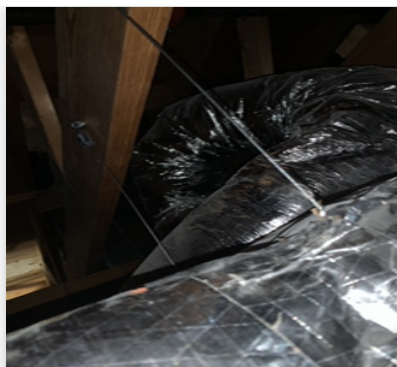
No, takeoff is located above ductwork. Runs 180deg flex (exceeds 90 degrees) and is greater than 5ft in length. This needs to be rerouted to ensure it meets the specification of less than 5ft of flexible duct with a limit of 1-90 degree bend.

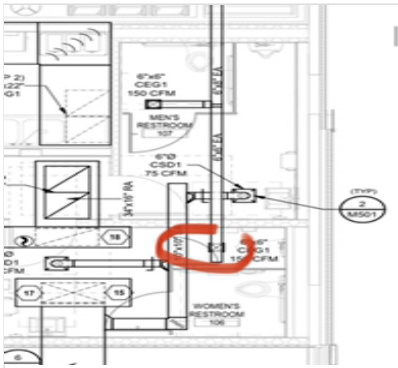
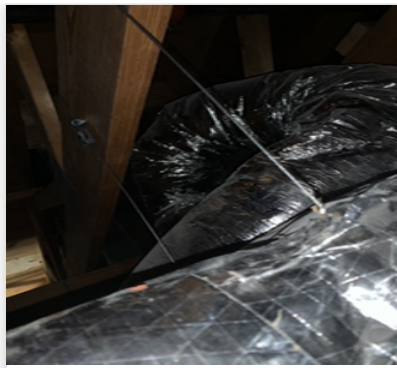
Flexible duct is supported and routed to prevent kinks

No

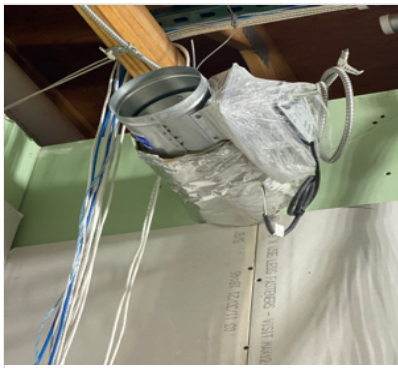
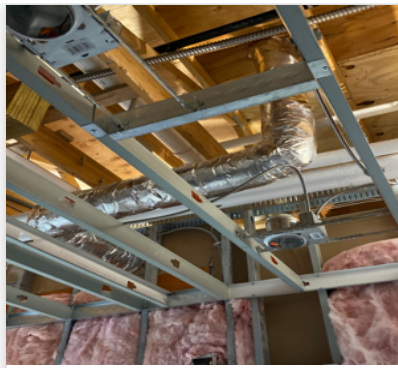
Yes, ducted into office with M-damper. Fully insulated
