**Report: Commissioning**

**Date: 3/11/2022**

## Shake Shack (Chesterfield) - Commissioning

17312 Chesterfield Airport Road

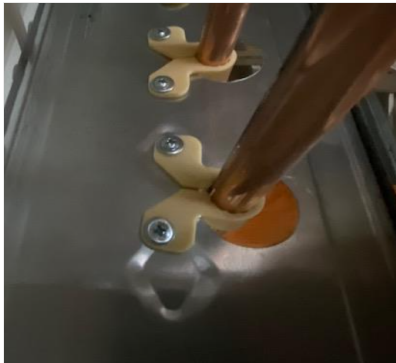
**HORIZONTAL\_PIPE\_BRACING\_TO\_STUD\_WALLS.PNG**

Horizontal bracing is provided through studs by utilizing stud fastening supports

Yes

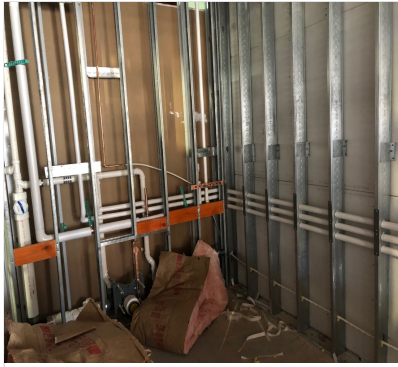
**in\_wall\_insulation\_2.jpg**

All lines in exterior walls are to be insulated with minimum 2" BATT insulation to prevent freezing

Yes

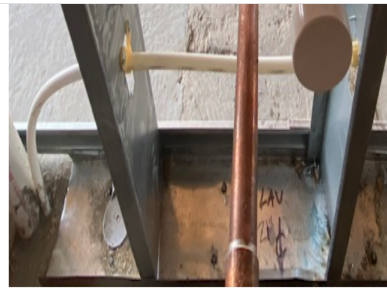
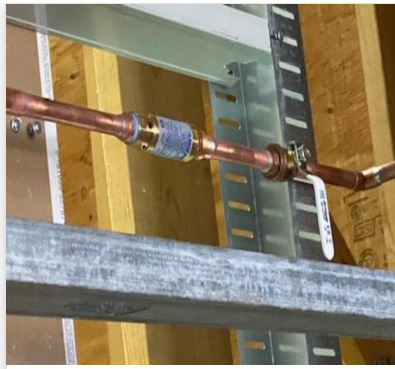
Gravity Trap Primer valve, shut-off valve, and water line has been installed and routed to each restroom floor drain. Access points will be available to ensure valves are accessible for future maintenance

Yes

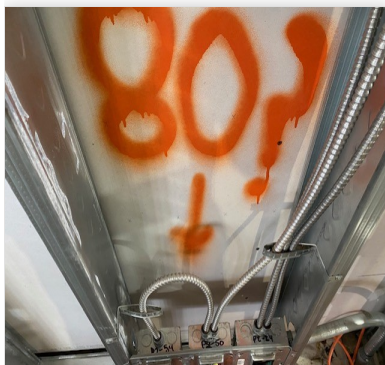
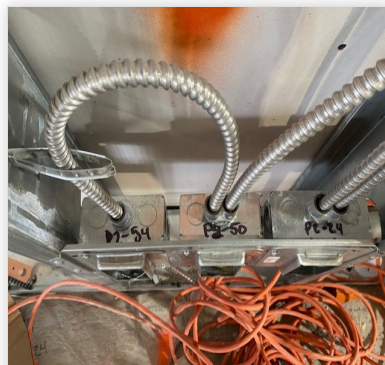
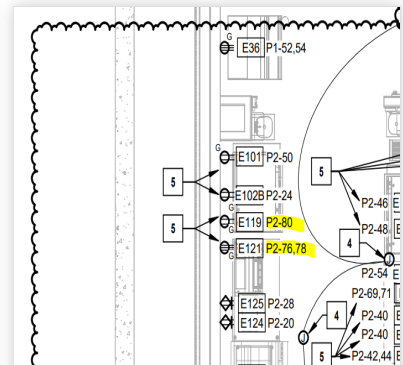
**Issue Name :** EC: Mislabeled Electrical outlets - Item 80  
**Description :** Review to determine if this circuit has been correctly labeled or not  
**Created By :** National TAB **Assigned To :** Spiegelglass Construction - Rob Benwell  
**Status :** Open  
**Originated Date :** 03/06/2022 - Dan Hertenstein - National TAB

- **03/09/2022 National TAB - Dan Hertenstein**
  - P2-80 circuit missing or incorrectly labeled (P2-50), Validate it is assigned to item E119; P2-76,78 circuit is missing or incorrectly labeled (P2-54), validate it is assigned to Item E121
