## Issue List

**01-22-24 KRISPY KREME METARAIRE, LA**

**Project Issue Information**

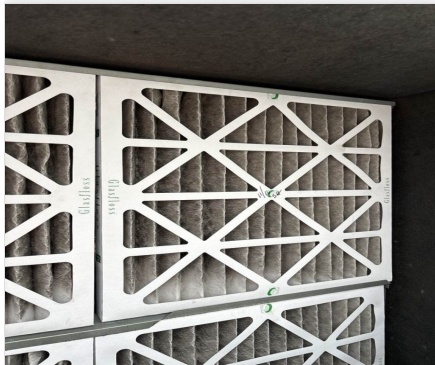
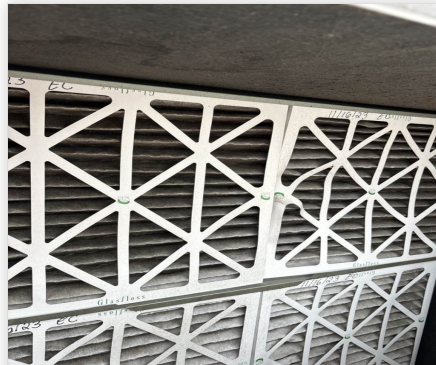
**Issue Name :** Dirty RTU Filters  
**Description :** Filters for all RTU's are dirty. Recommend to replace.  
**Created By :** National TAB                      **Assigned To :** National TAB - Antonio Flores-De La Cruz  
**Status :** Open  
**Priority :** **Urgent**                                      **Asset Tag :**  
**Originated Date :** 01/25/2024 - Antonio Flores-De La Cruz - National TAB

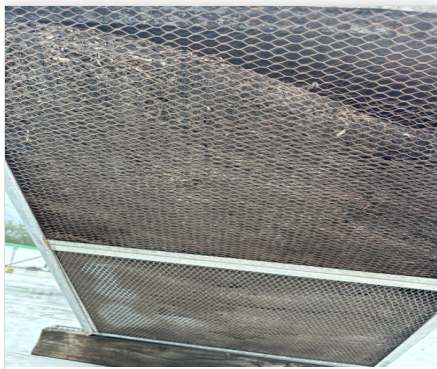
**MUA10Afilters  
01/25/2024**

**Issue Name :** MUA Dirty OA filters  
**Description :** Filters are dirty and damaged. Recommend to replace.  
**Created By :** National TAB                      **Assigned To :** National TAB - Antonio Flores-De La Cruz  
**Status :** Open  
**Priority :**    **Asset Tag :**  
**Originated Date :** 01/25/2024 - Antonio Flores-De La Cruz - National TAB

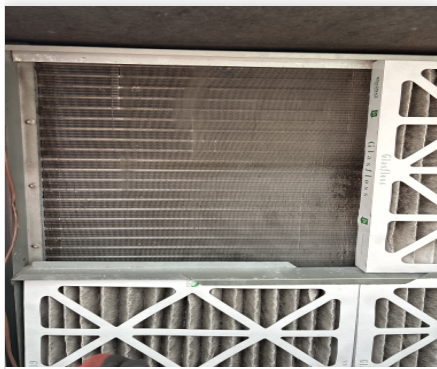
RTU1EvapCoil  
01/25/2024

**Issue Name :** RTU-1 Dirty Evaporator Coil  
**Description :** The Evaporator Coil is dirty. Recommend to clean to help improve airflow.  
**Created By :** National TAB                      **Assigned To :** National TAB - Antonio Flores-De La Cruz  
**Status :** Open  
**Priority :**    **Asset Tag :**  
**Originated Date :** 01/25/2024 - Antonio Flores-De La Cruz - National TAB

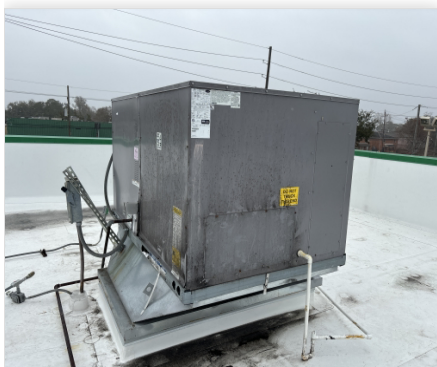
RTU-1(1)  
01/25/2024

**Issue Name :** RTU-1 Not operational  
**Description :** The unit was turned off at the disconnect to obtain data from inside the motor compartment. After gathering data, unit was turned back on again and the unit operated for a couple seconds before coming to a complete stop. It was observed that the unit was rotating Clockwise and Rotation should be Counterclockwise. Unit does not turn on anymore. Further investigation is required.

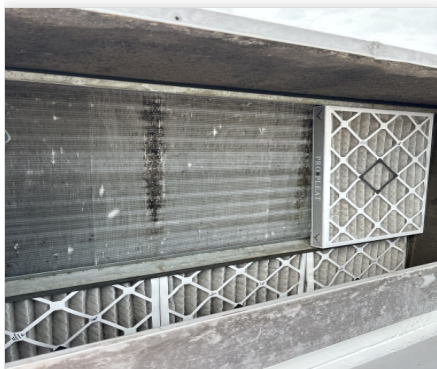
**RTU2EvapCoil**  
**01/25/2024**

**Issue Name :** RTU-2 Dirty Evaporator Coil  
**Description :** The evaporator coil is dirty. Recommend to clean.  
**Created By :** National TAB                      **Assigned To :** National TAB - Antonio Flores-De La Cruz  
**Status :** Open  
**Priority :**    **Asset Tag :**  
**Originated Date :** 01/25/2024 - Antonio Flores-De La Cruz - National TAB

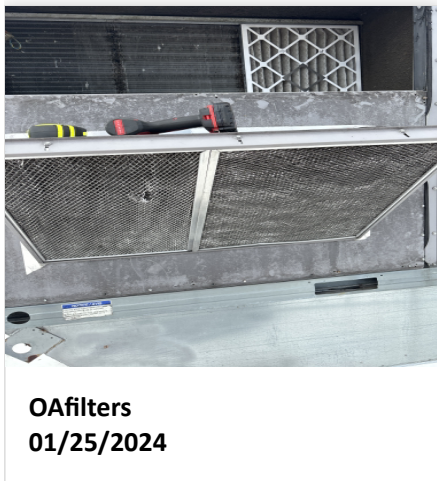
**Issue Name :** RTU-2 Dirty OA Filters  
**Description :** Filters are dirty and slightly damaged. Recommend to clean/replace.  
**Created By :** National TAB                      **Assigned To :** National TAB - Antonio Flores-De La Cruz  
**Status :** Open  
**Priority :**    **Asset Tag :**  
**Originated Date :** 01/25/2024 - Antonio Flores-De La Cruz - National TAB

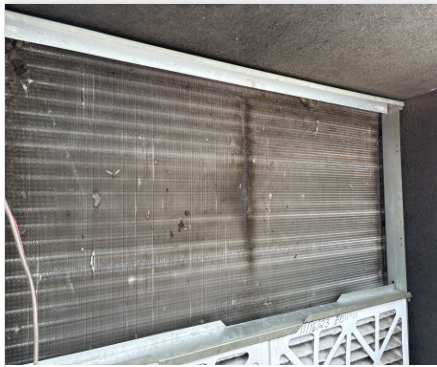
**RTU3EVAPCoil**  
**01/25/2024**

**Issue Name :** RTU-3 Dirty Evaporator Coil  
**Description :** Coil is dirty and has debris blocking. Recommend to clean.  
**Created By :** National TAB                      **Assigned To :** National TAB - Antonio Flores-De La Cruz  
**Status :** Open  
**Priority :**    **Asset Tag :**  
**Originated Date :** 01/25/2024 - Antonio Flores-De La Cruz - National TAB

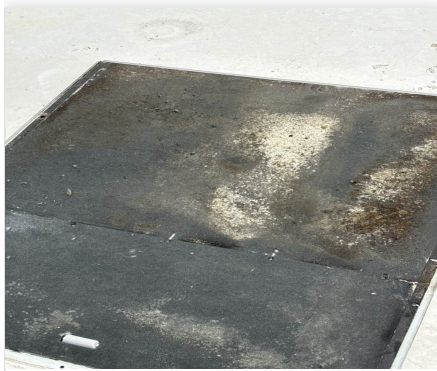
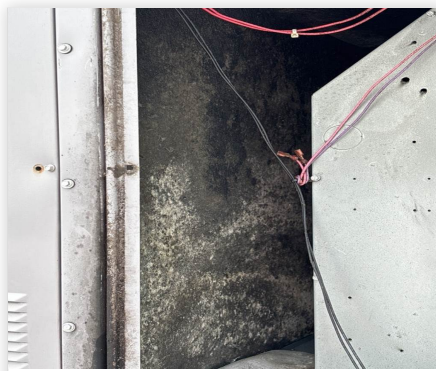
**Issue Name :** RTU-3 Mold inside Motor Compartment  
**Description :** Mold has been found on the walls and the panel of the motor compartment.  
**Created By :** National TAB                      **Assigned To :** National TAB - Antonio Flores-De La Cruz  
**Status :** Open  
**Priority :** Urgent                                      **Asset Tag :**  
**Originated Date :** 01/25/2024 - Antonio Flores-De La Cruz - National TAB
