Report: TAB REPORT
Function: Test, Adjust, & Balance
Date: 02/05/2024

01-22-24 KRISPY KREME METARRAIRE, LA

Krispy Kreme

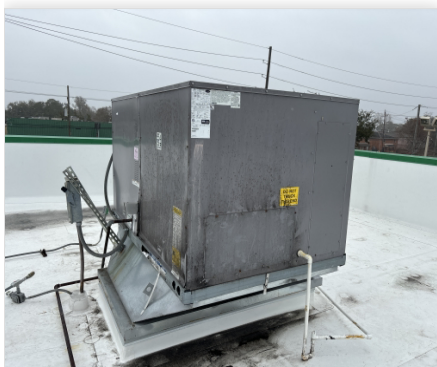
RTU-1(1)
01/25/2024

Issue Name : 01: RTU-1 Not operational
Description : The unit was turned off at the disconnect to obtain data from inside the motor compartment. After gathering data, unit was turned back on again and the unit operated for a couple seconds before coming to a complete stop. It was observed that the unit was rotating Clockwise and Rotation should be Counterclockwise. Unit does not turn on anymore. Further investigation is required.

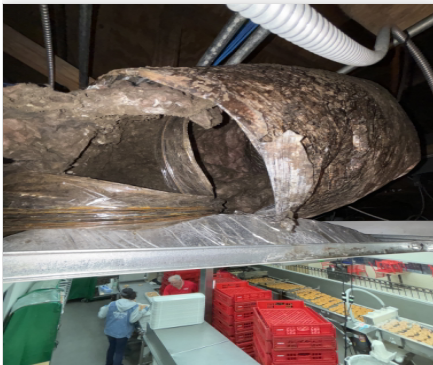
Flex
01/25/2024

Issue Name : 07: RTU-2 diffuser flex duct not installed
Description : Flex duct is not properly installed and sitting on top of the diffuser.
Created By : National TAB **Assigned To :** National TAB - Antonio Flores-De La Cruz
Status : Open
Priority : High **Asset Tag :**
Originated Date : 01/25/2024 - Antonio Flores-De La Cruz - National TAB

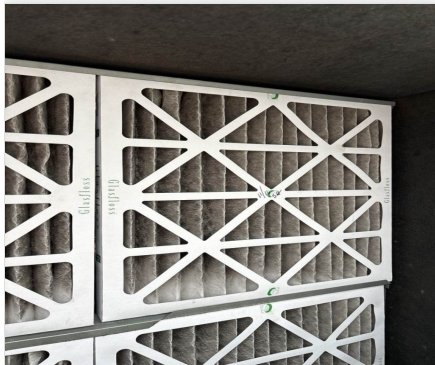
FILTERS1
01/25/2024

Issue Name : 09: Dirty RTU Filters
Description : Filters for all RTU's are dirty. Recommend replacing
Created By : National TAB **Assigned To :** National TAB - Antonio Flores-De La Cruz
Status : Open
Priority : Medium **Asset Tag :**
Originated Date : 01/25/2024 - Antonio Flores-De La Cruz - National TAB

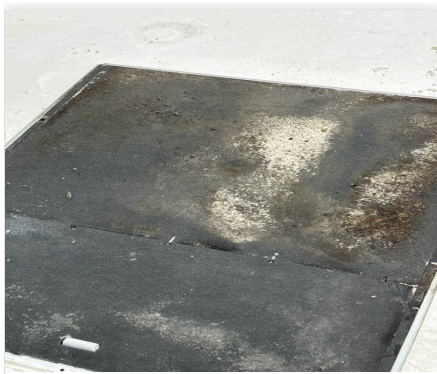
RTU3MOLD1
01/25/2024

Issue Name : 10: RTU-3 Growth inside Motor Compartment
Description : Microbial growth is on the walls and the panel of the motor compartment. Recommend cleaning
Created By : National TAB **Assigned To :** National TAB - Antonio Flores-De La Cruz
Status : Open
Priority : Medium **Asset Tag :**
Originated Date : 01/25/2024 - Antonio Flores-De La Cruz - National TAB

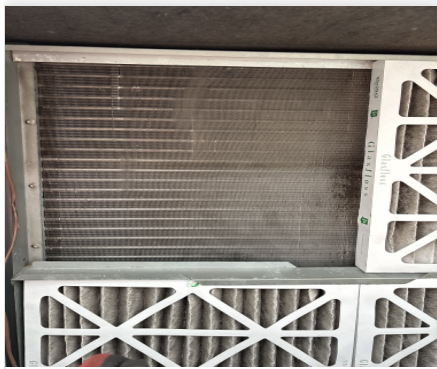
RTU1EvapCoil
01/25/2024

Issue Name : 11: RTU's evaporator coils
Description : Evaporator coils are dirty. Recommend cleaning and ensuring preventative maintenance company is completing during each visit.
Created By : National TAB **Assigned To :** National TAB - Antonio Flores-De La Cruz
Status : Open
Priority : Medium **Asset Tag :**
Originated Date : 01/25/2024 - Antonio Flores-De La Cruz - National TAB

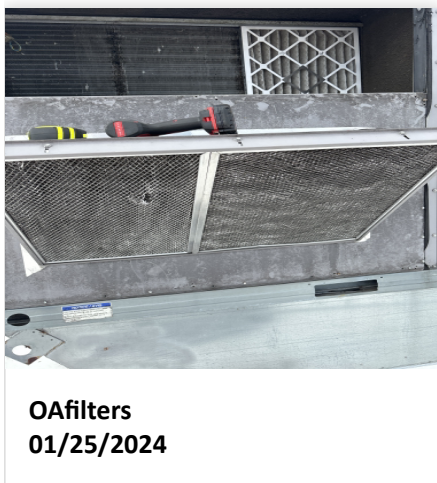
Issue Name : 12: RTU-2 Dirty OA Filters
Description : Filters are dirty and slightly damaged. Recommend to cleaning and may want to replace soon.
Created By : National TAB **Assigned To :** National TAB - Antonio Flores-De La Cruz
Status : Open
Priority : Low **Asset Tag :**
Originated Date : 01/25/2024 - Antonio Flores-De La Cruz - National TAB

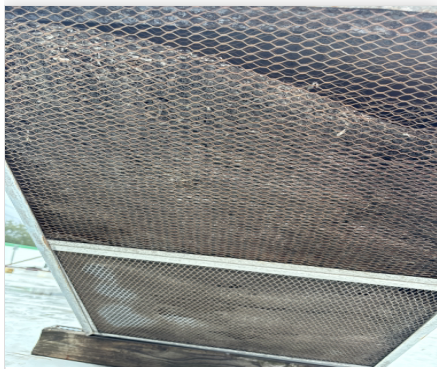
**MUA10Afilters
01/25/2024**

Issue Name : 13: MUA Dirty OA filters
Description : Filters are dirty and damaged. Recommend replacing.
Created By : National TAB **Assigned To :** National TAB - Antonio Flores-De La Cruz
Status : Open
Priority : Low **Asset Tag :**
Originated Date : 01/25/2024 - Antonio Flores-De La Cruz - National TAB
