Report: RENEW

Function: Test, Adjust, & Balance

Date: 11/17/2022

**11-14 FREDDY'S - BRIDGETON, MO - RENEW
3H (5)**

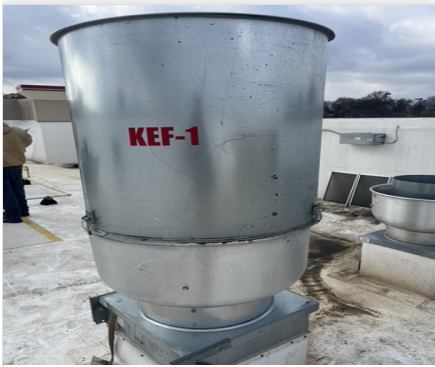
KEF-1.jpeg

Issue Name : KEF-1 Wind band extension.

Description : One strap will not secure. Extension is still firmly in place.

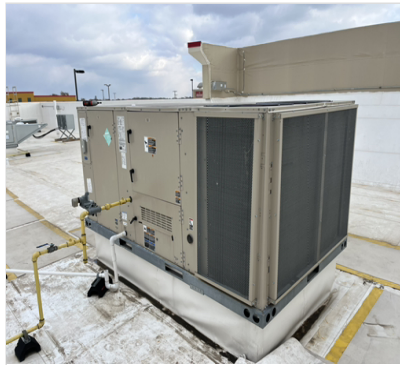
RTU1 (TAKE PICTURE OF UNIT)

LENNOX / LGH150H4BH2Y

892

30%

-0.59" MA 0.89" DISCHARGE

10.4/10.2/10.3

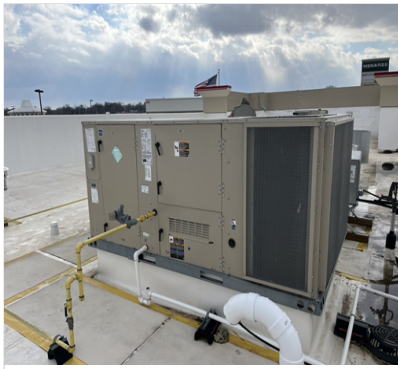
RTU2 (TAKE PICTURE OF UNIT)

LENNOX / LGH150H4BH2Y

OA CFM	882
OA DAMPER POSITION	27%
FAN SUCTION AND DISHCHARGE PRESSURE	-0.10" MA 0.58" DISCHARGE
BLOWER MOTOR RLA / FLA	10.4/10.4/10.4
RTU3 (TAKE PICTURE OF UNIT)	
MFG & MODEL NUMBER	NA
OA CFM	NA
OA DAMPER POSITION	NA
FAN SUCTION AND DISHCHARGE PRESSURE	NA
BLOWER MOTOR RLA / FLA	NA
KEF1 - HOOD 1 (TAKE PICTURE OF UNIT)	
MFG & MODEL NUMBER	CAPTIVE AIRE / DU85HFA
