**Report: RENEW**

**Function: Test, Adjust, & Balance**

**Date: 11/17/2022**

**11-14 FREDDY'S - BRIDGETON, MO - RENEW  
3H (5)**

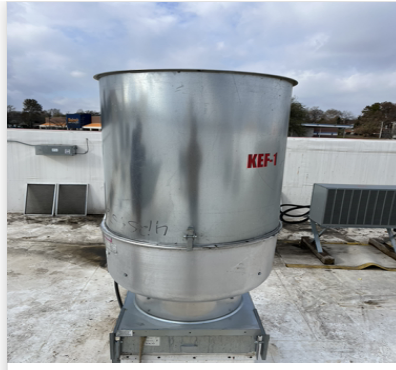
EXH-CFM

1458

MOTOR RLA / FLA

8.0

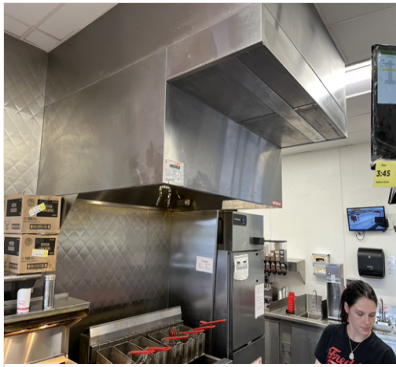
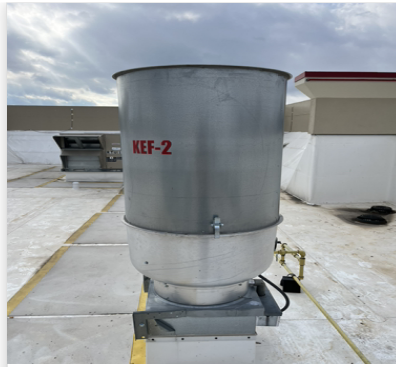
KEF2 - HOOD 2 (TAKE PICTURE OF UNIT)

MFG & MODEL NUMBER

CAPTIVE AIRE / DU50HFA

EXH-CFM

744

MOTOR RLA / FLA

2.5

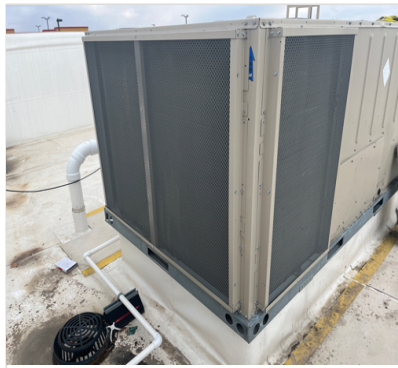
RTU 2 CONDENSOR COIL (BEFORE AND AFTER)

Did not clean due to freezing temperatures.

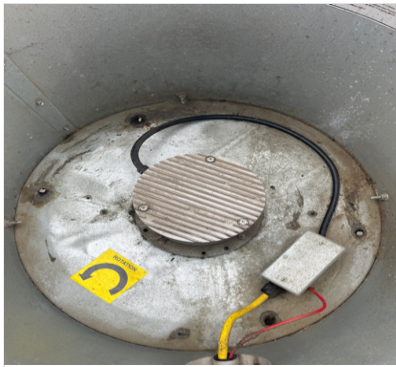
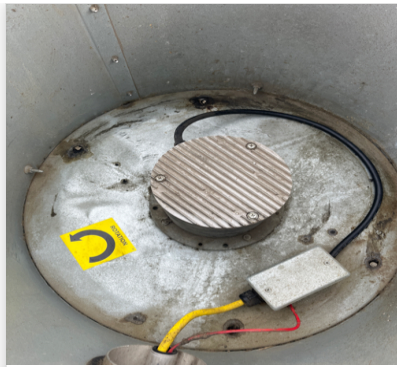
EXHAUST FAN KEF1 MOTOR HOUSING CLEANED

All exhaust fans were cleaned out on the roof. The vents to the motor were cleaned so they can vent properly.

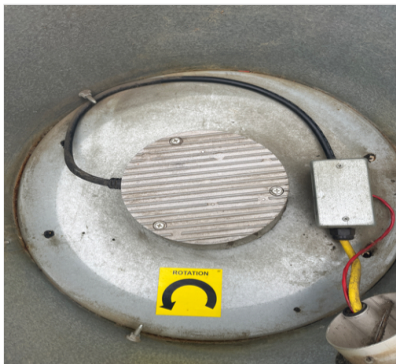
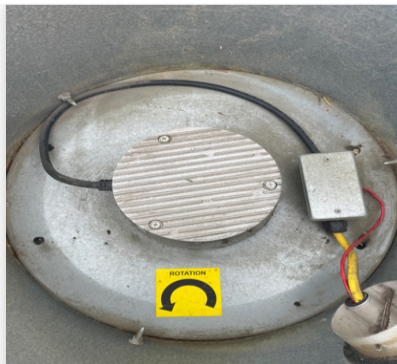
EXHAUST FAN KEF2 MOTOR HOUSING CLEANED

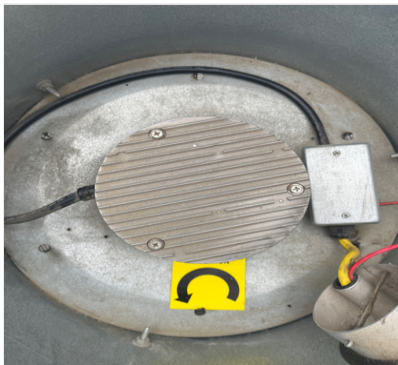
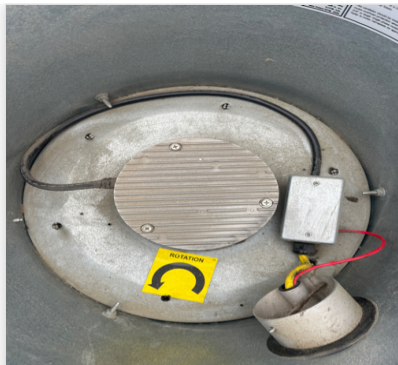
EXHAUST FAN KEF3 MOTOR HOUSING CLEANED
