**Report: RENEW**

**Function: Test, Adjust, & Balance**

**Date: 11/17/2022**

**11-14 FREDDY'S - BRIDGETON, MO - RENEW  
3H (5)**

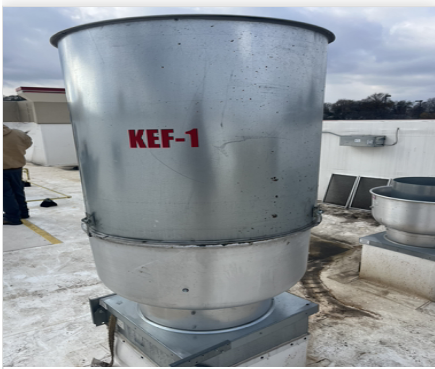
KEF-1.jpeg

**Issue Name :** KEF-1 Wind band extension.

**Description :** One strap will not secure. Extension is still firmly in place.

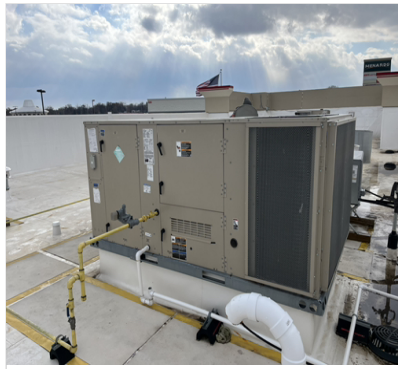
#### RTU2 (TAKE PICTURE OF UNIT)

MFG & MODEL NUMBER

LENNOX / LGH150H4BH2Y

| OA CFM | 882 |
| OA DAMPER POSITION | 27% |
| FAN SUCTION AND DISCHARGE PRESSURE | -0.10" MA 0.58" DISCHARGE |
| BLOWER MOTOR RLA / FLA | 10.4/10.4/10.4 |

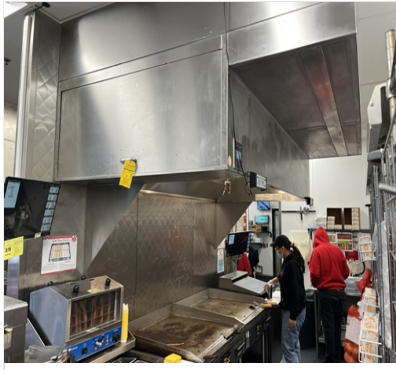
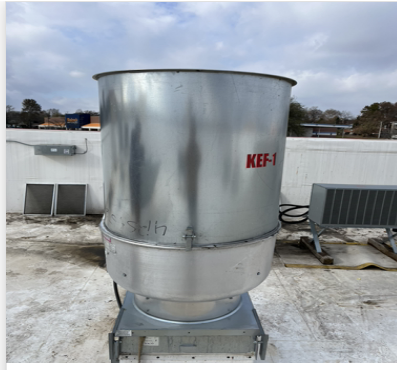
| <b>KEF1 - HOOD 1 (TAKE PICTURE OF UNIT)</b> | |

| MFG & MODEL NUMBER | CAPTIVE AIRE / DU85HFA |

EXH-CFM

1458

MOTOR RLA / FLA

8.0

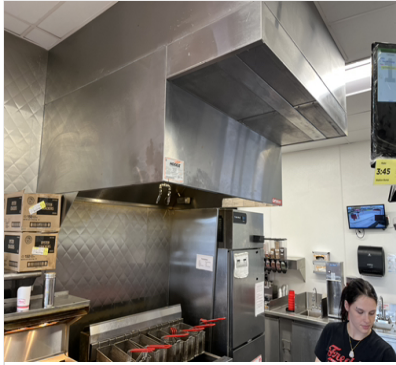
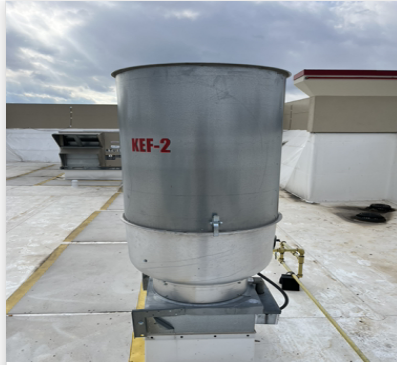
KEF2 - HOOD 2 (TAKE PICTURE OF UNIT)

MFG & MODEL NUMBER

CAPTIVE AIRE / DU50HFA

EXH-CFM

744

MOTOR RLA / FLA

2.5

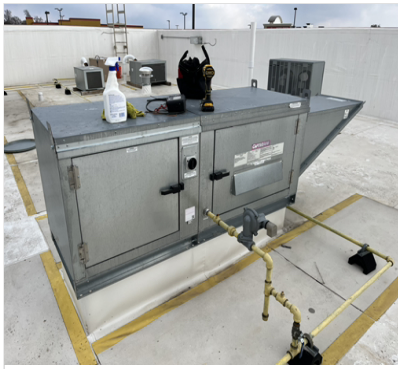
MUA - ALL HOODS (TAKE PICTURE OF UNIT)

MFG & MODEL NUMBER

CAPTIVE AIRE / A1-D.250-15D

MUA-CFM

1688

MOTOR RLA/FLA

2.5/2.4/2.4

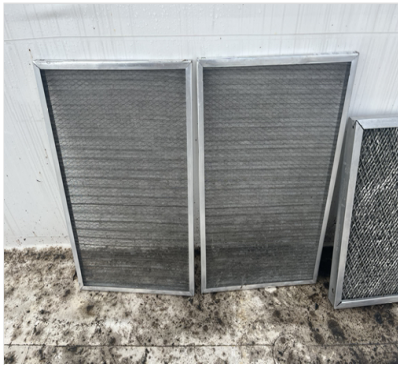
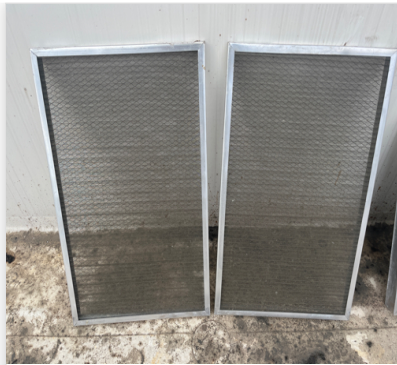
RTU 1 O.A. FILTER (BEFORE AND AFTER)

RTUs: There evaporator coil was rinsed off and cleaned. During warmer months a self-cleaning chemical is sprayed on the evaporator. The outside air filters were rinsed off to remove any dirt, so the unit stays at the designated outside air set point. Based on static pressures, amps, and fan rpm it shows that the total supply has not changed since the last test and balance.

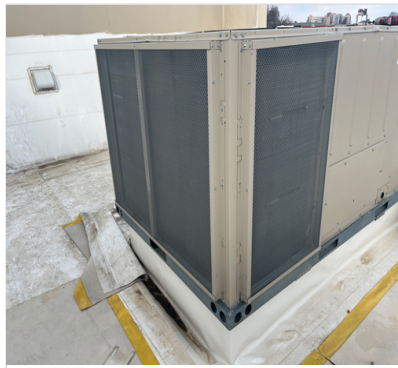
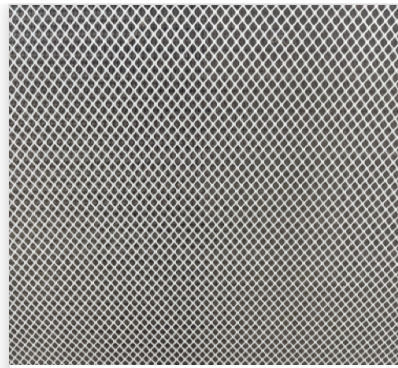
**RTU 1 CONDENSOR COIL (BEFORE AND AFTER)**

Did not clean due to freezing temperatures.

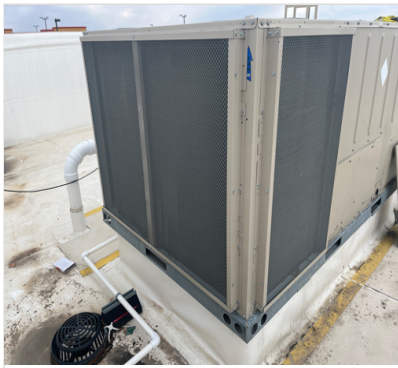
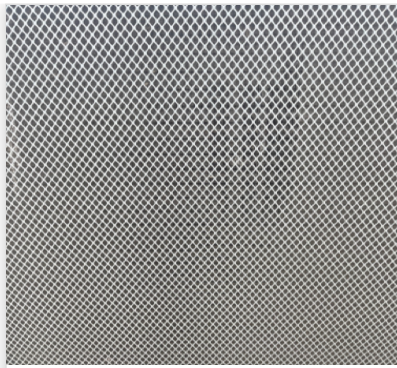
RTU 2 CONDENSOR COIL (BEFORE AND AFTER)

Did not clean due to freezing temperatures.

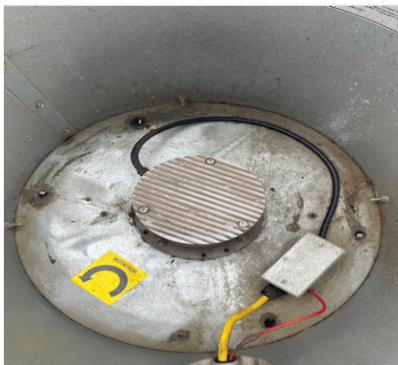
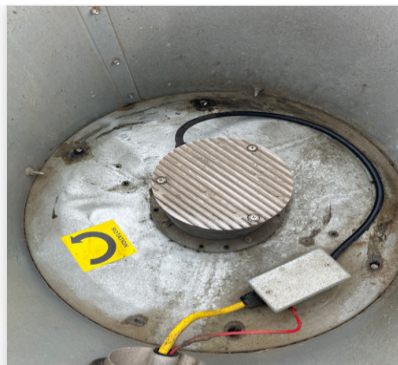
All exhaust fans were cleaned out on the roof. The vents to the motor were cleaned so they can vent properly.

**EXHAUST FAN KEF1 MOTOR HOUSING CLEANED**

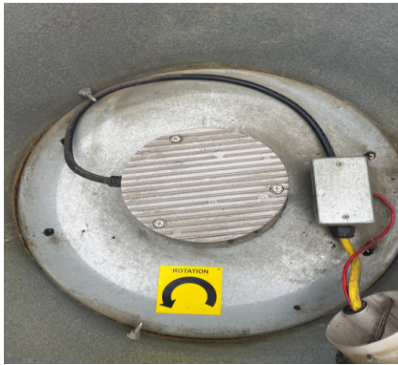
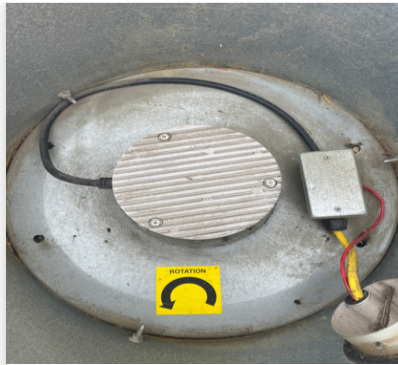
EXHAUST FAN KEF2 MOTOR HOUSING CLEANED

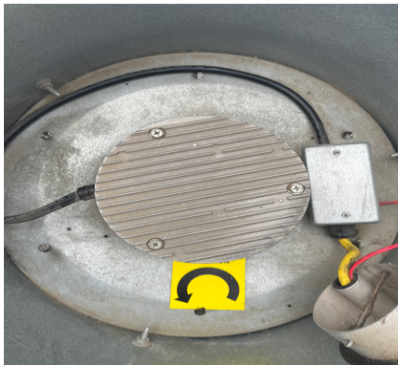
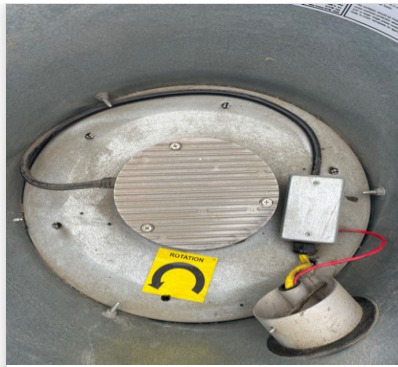
EXHAUST FAN KEF3 MOTOR HOUSING CLEANED
