**Report: TAB Report**  
**Function: Test, Adjust, & Balance**  
**Date: 11/07/2025**  
**Completed By: National TAB**

**PROJECT**  
**11-03-25 QT #1435 GLENDALE, AZ**

Project: 11-03-25 QT #1435 GLENDALE, AZ

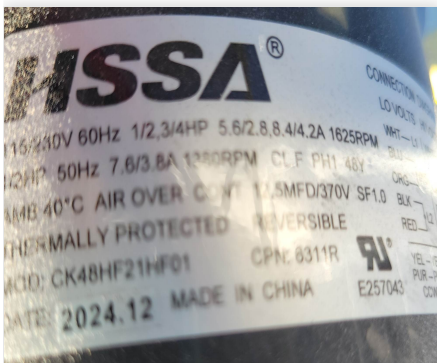
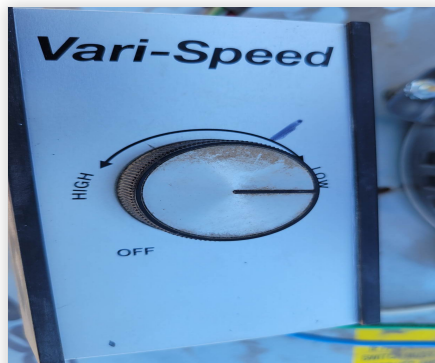
**Issue Name :** EF-1: EXHAUST MOTOR TOO HIGH, SPEED CONTROLLER BAD  
**Description :** Exhaust fan should be 0.5HP and within 5.6A. Appears to be 0.75HP since fan current = 5.9A to 6.0A. Speed controller is not functioning correctly, barely adjusts fan speed, and doesn't turn unit off when clicked into 'off' position. Speed controller is set to lowest position and flow is twice design (1562/750cfm). Recommend service.  
**Created By :** National TAB                      **Assigned To :** National TAB - Dan Hertenstein  
**Status :** Open  
**Priority :** High                                      **Asset Tag :** EF1  
**Originated Date :** 11/06/2025 - Christine Weale - National TAB

Notes:  
UNABLE TO REDUCE FAN SPEED. SPEED CONTROLLER APPEARS BAD, NEEDS SERVICE.

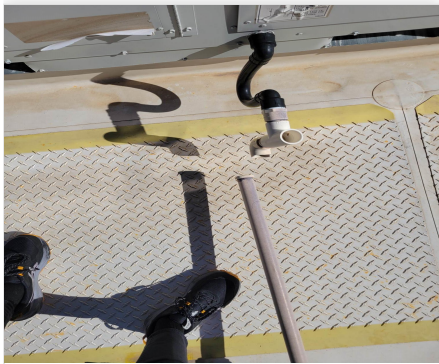
**Issue Name :** RTU-1: CONDENSATE PIPE BROKEN  
**Description :** Condensate pipe is broken and will pool in front of unit.  
**Created By :** National TAB                      **Assigned To :** National TAB - Dan Hertenstein  
**Status :** Open  
**Priority :** InfoOnly                                      **Asset Tag :** RT-1  
**Originated Date :** 11/06/2025 - Christine Weale - National TAB

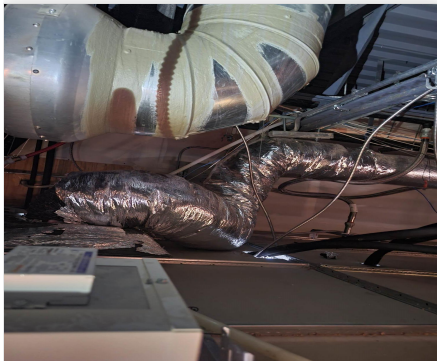
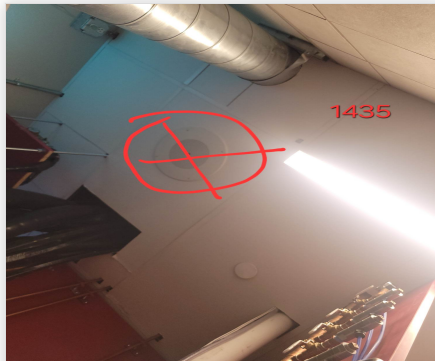
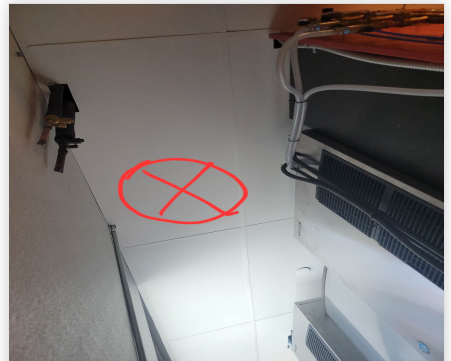
**Issue Name :** RTU-2: BACK AREA NOT CONDITIONED  
**Description :** Diffuser 2-5 and duct are laying on top of the ceiling, pictures show where diffuser should be installed and another place it could be rerouted. Damper is closed, but back area is not being conditioned and may cause issues.  
**Created By :** National TAB                      **Assigned To :** National TAB - Dan Hertenstein  
**Status :** Open  
**Priority :** Medium                                      **Asset Tag :** SGRD5  
**Originated Date :** 11/06/2025 - Christine Weale - National TAB

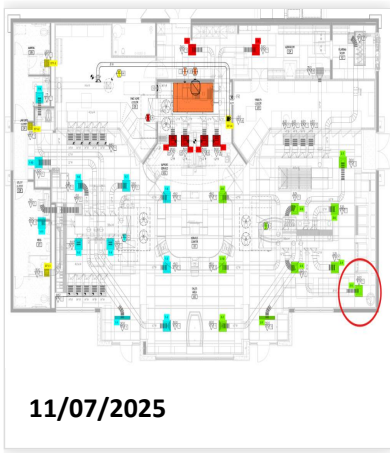
- **11/07/2025 National TAB - Michael McDonnell**
  - Location of Diffuser 2-5 and unconditioned space.

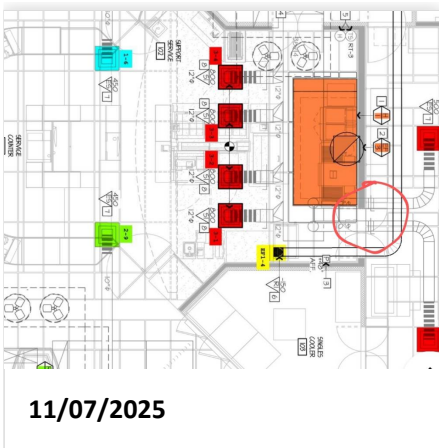
**Issue Name :** RTU-3: DAMPERS INACCESSIBLE  
**Description :** Dampers for Diffusers 3-5 and 3-6, which serve the BOH, are inaccessible. 3-5 is above design and 3-6 is below design as a result. Total airflow for BOH area is within design. Recommend moving to a more accessible location in future stores so diffusers can be properly balanced.  
**Created By :** National TAB                      **Assigned To :** National TAB - Dan Hertenstein  
**Status :** Open  
**Priority :** Low                                      **Asset Tag :** SGRD6  
**Originated Date :** 11/06/2025 - Christine Weale - National TAB

<b>Asset</b>	<b>Notes</b>	<b>Date</b>	<b>Written By</b>
SGRD6	Damper inaccessible.	11/06/2025	Christine Weale
