PlanGrid Task Report - Oct 18, 2024

#244 [EXHA 499] [NEW] CRITICAL (MISC) – [FAN LOW OF DESIGN CFM]

00766 New Bern FSU // New Bern, NC // 2024

#243 [REFG 999] [NEW] (MISC) [CONDENSER ROOFTOP ORIENTATION]

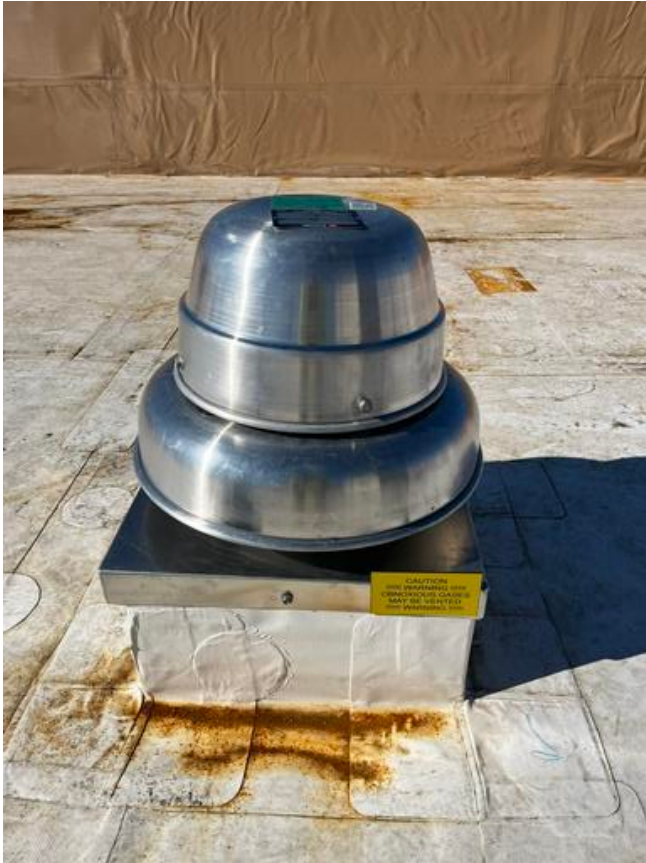
IMG_5904

EF3 is low of design CFM due to EGRD3 (employee RR) being low of design flow. Egrd3's inline damper & face damper are 100% open. Fans backdraft damper opens and closes freely, EF3 is running at max speed. Ductwork is installed per prints. Recommend a larger fan be installed to increase air flow and achieve design CFM.

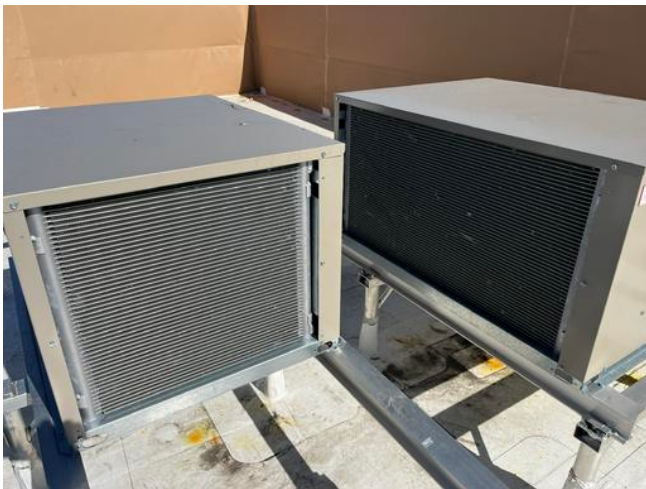
IMG_5909

WIF & WIC condenser rooftop orientation is different than shown on prints.
