Report: Punchlist
Function: Test, Adjust, & Balance
Date: 03/03/2025
Completed By: National TAB

PROJECT
03-03-25 FIREBIRDS LIBERTY TOWNSHIP,
OH

Project: 03-03-25 FIREBIRDS LIBERTY TOWNSHIP, OH

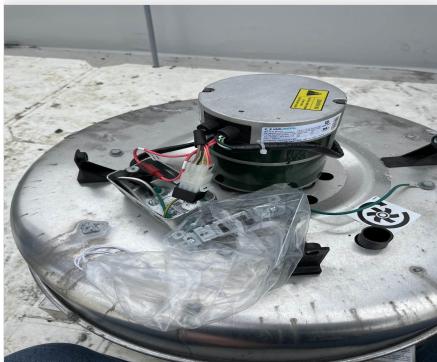
Issue Name : FET-1 power not wired.
Description : FET-1 power not wired.
Created By : National TAB **Assigned To :** National TAB - Will Turnbough
Status : Open
Priority : Urgent **Asset Tag :**
Originated Date : 03/03/2025 - Cody Collett - National TAB

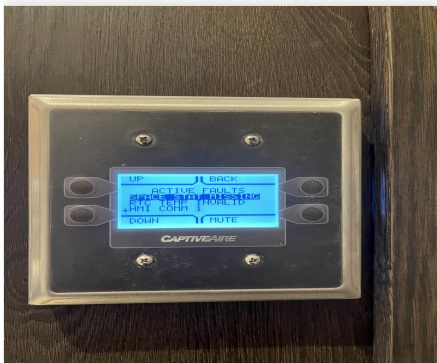
Issue Name : RTU-1 incorrect HMI wiring/programing
Description : RTU-1 (is actually a DOAS unit) has incorrect HMI wiring and or programing. HMI's are unable to receive any input and thus the unit is unable to be controlled. HMI's are displaying fault codes (picture attached).
