Report: TAB REPORT
Function: Test, Adjust, & Balance
Date: 06/27/2024

PROJECT
06-24-24 DOMINICKS SCOTTSDALE, AZ

Project: 06-24-24 DOMINICKS SCOTTSDALE, AZ

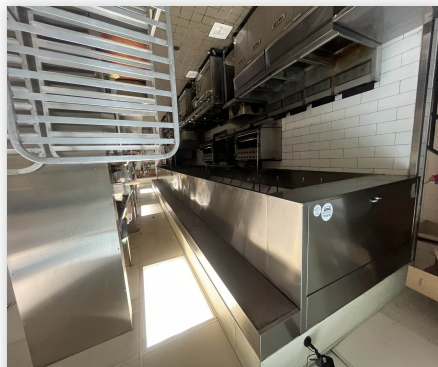
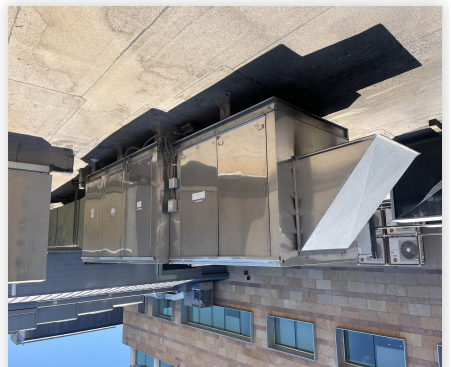
Issue Name : KEF-1: Controls - Always Operational
Description : Hood controls in kitchen space do not control KEF-1. Kitchen exhaust hoods appear to run 24/7. This is unnecessarily exhausting treated air from space when cooling is not occurring. Only roof disconnect powers off fan. Recommend controls are inspected/corrected.
Created By : National TAB **Assigned To :** National TAB - Michael McDonnell
Status : Open
Priority : Medium **Asset Tag :**
Originated Date : 07/25/2024 - Michael McDonnell - National TAB

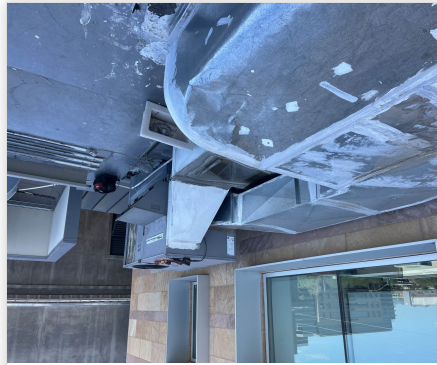
Issue Name : RTU-2 & 3: Economizer Not Functional
Description : Economizers do not appear functional on RTUs serving pool dining (2&3).
Created By : National TAB **Assigned To :** National TAB - Brianna Biggs
Status : Open
Priority : Medium **Asset Tag :**
Originated Date : 07/26/2024 - Michael McDonnell - National TAB

Economizers installed on carrier units, do not appear operational. WSHP1 and WSHP2 on roof have manual damper OA inlet cut into horizontal rooftop return duct. WSHP 4 and 9 are not ducted for outside air. All other WSHPs are ducted for OA from common duct with manual dampers installed. Most of these dampers are not easily accessible.

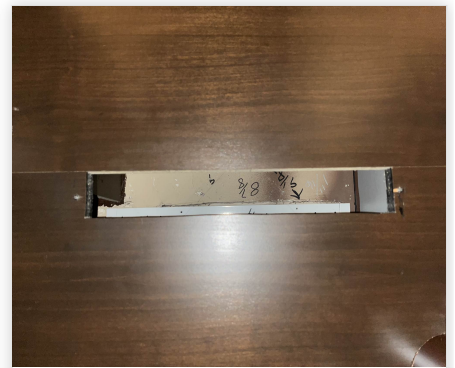
Issue Name : WSHP-1: Dining Diffusers Supply Wall Plenum
Description : Dining room supply grilles mounted on wall in upper dining room supply the wall plenum, which then has grille sized cutouts to allow airflow. Inefficient delivery of supply airflow.
Created By : National TAB **Assigned To :** National TAB - Michael McDonnell
Status : Open
Priority : Medium **Asset Tag :**
Originated Date : 07/26/2024 - Michael McDonnell - National TAB
