Report: TAB REPORT
Function: Test, Adjust, & Balance
Date: 06/27/2024

PROJECT
06-24-24 DOMINICKS SCOTTSDALE, AZ

Prime Steak Concepts

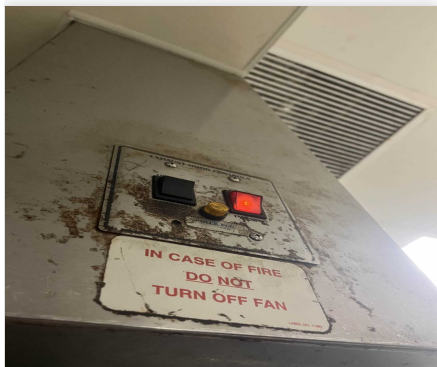
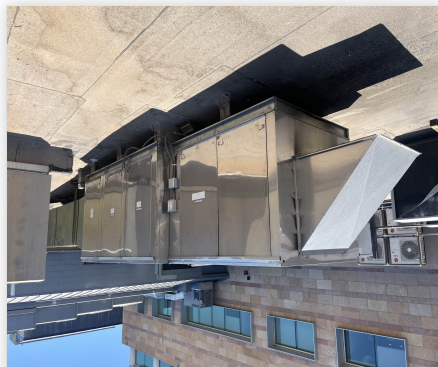
Issue Name : KEF-1: Controls - Always Operational
Description : Hood controls in kitchen space do not control KEF-1. Kitchen exhaust hoods appear to run 24/7. This is unnecessarily exhausting treated air from space when cooling is not occurring. Only roof disconnect powers off fan. Recommend controls are inspected/corrected.
Created By : National TAB **Assigned To :** National TAB - Michael McDonnell
Status : Open
Priority : High **Asset Tag :**
Originated Date : 07/25/2024 - Michael McDonnell - National TAB

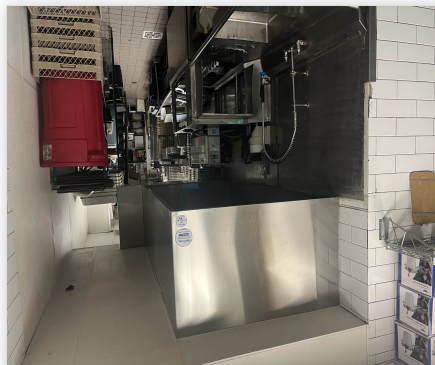
Issue Name : KEF-2 Dish Exhaust: Controls - Not Operational
Description : HD-3, Dishwasher hood, is served by KEF-2. Fan is functional but is not operating. Hood Switch does not control fan. Left off at roof, recommend controls installed.

Notes:
[1] FUNCTIONAL, BUT NOT OPERATIONAL. NO CONTROL OF EXHAUST FAN IN SPACE.

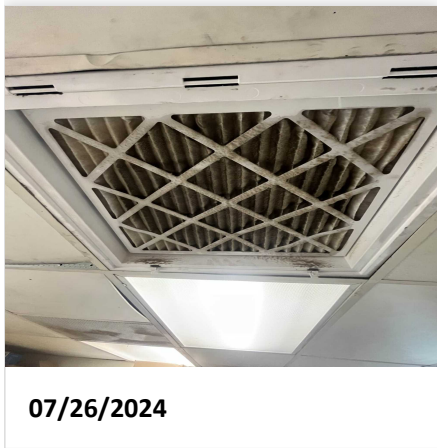
Issue Name : WSHP-4: Kitchen- Return Filter found Clogged
Description : Return filter installed in WSHP-4 was found extremely dirty and clogged. When filter was replaced, airflow increased from 1100cfm to 1823. Recommend filter on this system is changed more frequently due to location (kitchen) to maintain consistent cfm from WSHP.
Created By : National TAB **Assigned To :** National TAB - Michael McDonnell
Status : Open
Priority : InfoOnly **Asset Tag :**
Originated Date : 07/26/2024 - Michael McDonnell - National TAB

- [1] SERVES FRONT KITCHEN AREA-4 DIFFUSERS IN COOKING AREA AND HAS 2 GRILLES DUCTED FROM UNIT TO 2ND FLOOR OFFICE. OFFICE GRILLES TOTAL 401 CFM. THERE IS NO RETURN IN OFFICE.
- [2] FILTER INSTALLED ON RETURN INITIALLY FOUND CLOGGED, REPLACED FILTER. AIRFLOW INCREASED FROM 1100 CFM TO 1823 CFM.
- [3] NOT DUCTED FOR OA.
