**Report: TAB REPORT**  
**Function: Test, Adjust, & Balance**  
**Date: 06/27/2024**

**PROJECT**  
**06-24-24 DOMINICKS SCOTTSDALE, AZ**

15169 N Scottsdale Rd

Prime Steak Concepts

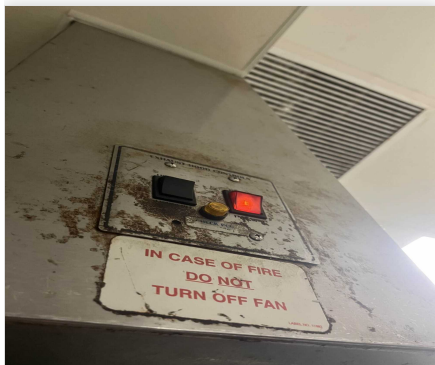
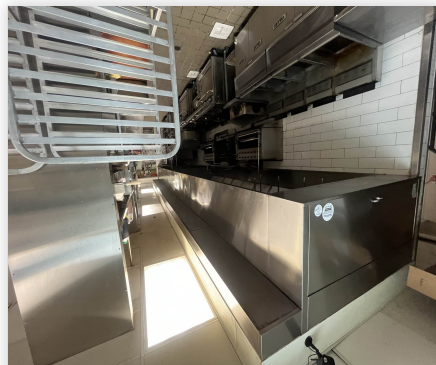
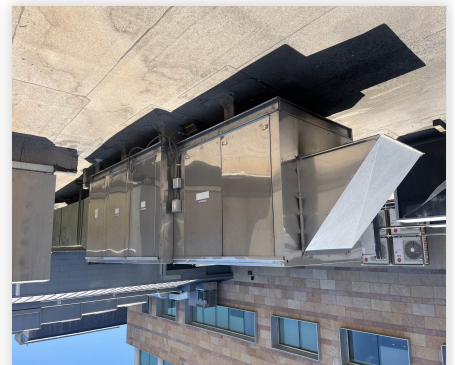
**Issue Name :** KEF-1: Controls - Always Operational  
**Description :** Hood controls in kitchen space do not control KEF-1. Kitchen exhaust hoods appear to run 24/7. This is unnecessarily exhausting treated air from space when cooling is not occurring. Only roof disconnect powers off fan. Recommend controls are inspected/corrected.  
**Created By :** National TAB                      **Assigned To :** National TAB - Michael McDonnell  
**Status :** Open  
**Priority :** Medium                                      **Asset Tag :**  
**Originated Date :** 07/25/2024 - Michael McDonnell - National TAB

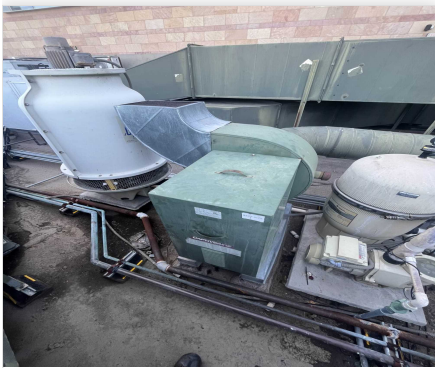
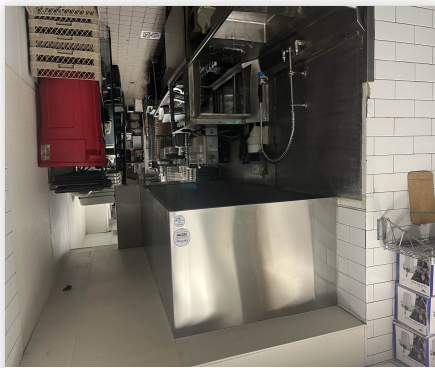
**Issue Name :** KEF-2 Dish Exhaust: Controls - Not Operational  
**Description :** HD-3, Dishwasher hood, is served by KEF-2. Fan is functional but is not operating. Hood Switch does not control fan. Left off at roof, recommend controls installed.

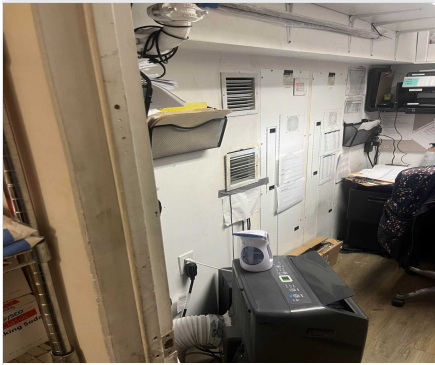
**Issue Name :** Office Comfort: Portable AC Unit  
**Description :** Managers office running portable AC unit due to hot conditions in the office. Portable AC unit is exhausting hot air into kitchen space below.  
**Created By :** National TAB                      **Assigned To :** National TAB - Michael McDonnell  
**Status :** Open  
**Priority :** InfoOnly                              **Asset Tag :**  
**Originated Date :** 07/26/2024 - Michael McDonnell - National TAB

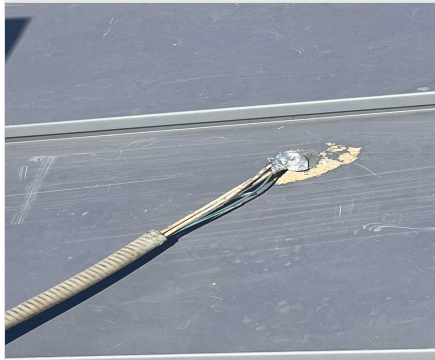
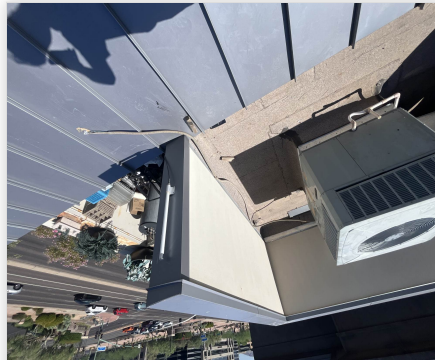
**Issue Name :** RTU-1: Power Conduit Damaged  
**Description :** Power conduit running from the roof to RTU-1 is damaged and wiring is exposed to the elements. Recommend conduit is repaired.  
**Created By :** National TAB                      **Assigned To :** National TAB - Michael McDonnell  
**Status :** Open  
**Priority :** Medium                                      **Asset Tag :**  
**Originated Date :** 07/25/2024 - Michael McDonnell - National TAB

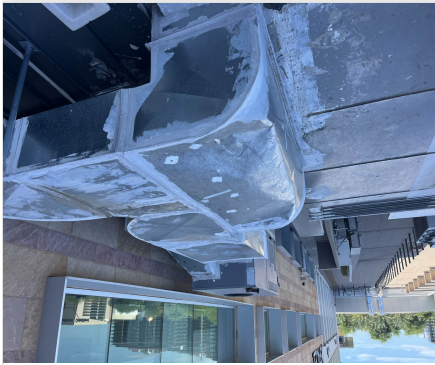
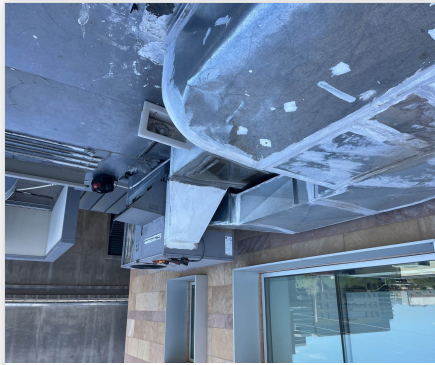
**Issue Name :** RTU-2 & 3: Economizer Not Functional  
**Description :** Economizers do not appear functional on RTUs serving pool dining (2&3).  
**Created By :** National TAB                      **Assigned To :** National TAB - Brianna Biggs  
**Status :** Open  
**Priority :** Medium                                      **Asset Tag :**  
**Originated Date :** 07/26/2024 - Michael McDonnell - National TAB

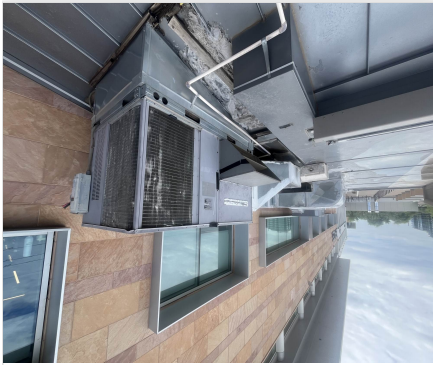
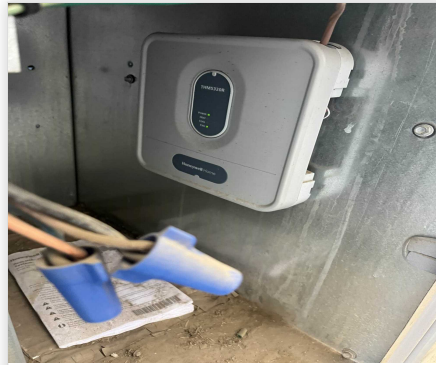
**Issue Name :** RTU-2: Cooling Not Operational  
**Description :** Cooling not Operational at time of visit. Service call was made and technician on site at conclusion of visit.  
**Created By :** National TAB                      **Assigned To :** National TAB - Michael McDonnell  
**Status :** Open  
**Priority :** High                                      **Asset Tag :**  
**Originated Date :** 07/26/2024 - Michael McDonnell - National TAB

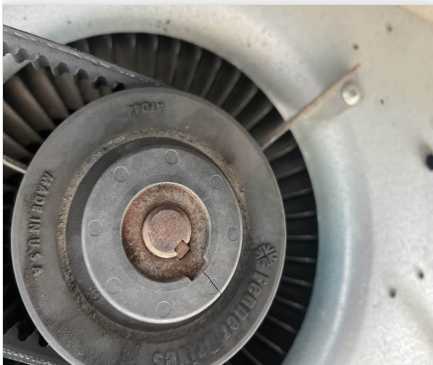
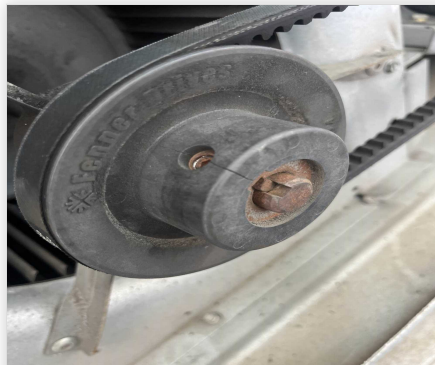
**Issue Name :** RTU-3: Pool RTU Fan Pulley Cracked  
**Description :** Plastic fan pulleys installed on Pool RTUs appear damaged. RTU-3 pulley has significant crack developing. Recommend replacement.  
**Created By :** National TAB                      **Assigned To :** National TAB - Michael McDonnell  
**Status :** Open  
**Priority :** High                                      **Asset Tag :**  
**Originated Date :** 07/26/2024 - Michael McDonnell - National TAB

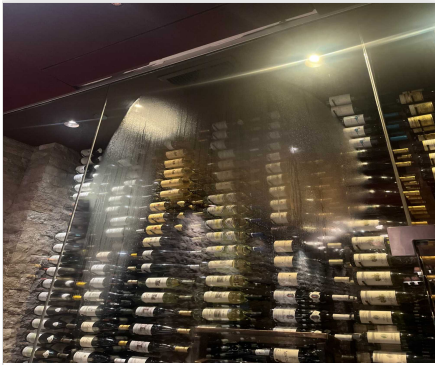
**Issue Name :** Wine Chiller: Condensate on Glass Chiller room Wall.  
**Description :** Condensate forming on wine chiller wall. Recommend unit setpoint is verified and unit is serviced. Not accessible by NTAB tech.  
**Created By :** National TAB                      **Assigned To :** National TAB - Michael McDonnell  
**Status :** Open  
**Priority :** Medium                                      **Asset Tag :**  
**Originated Date :** 07/26/2024 - Michael McDonnell - National TAB

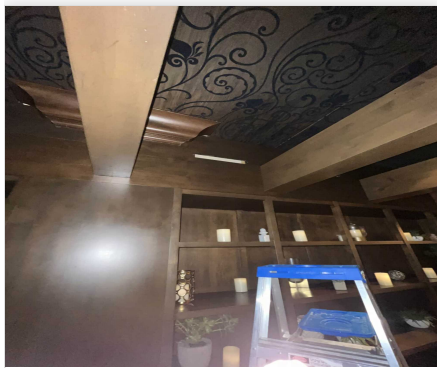
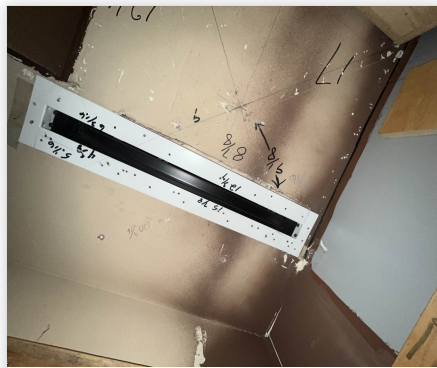
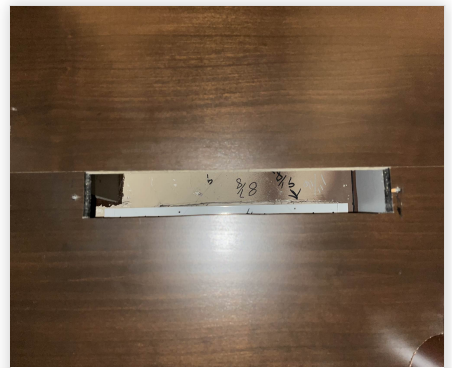
**Issue Name :** WSHP-1: Dining Diffusers Supply Wall Plenum  
**Description :** Dining room supply grilles mounted on wall in upper dining room supply the wall plenum, which then has grille sized cutouts to allow airflow. Inefficient delivery of supply airflow.  
**Created By :** National TAB                      **Assigned To :** National TAB - Michael McDonnell  
**Status :** Open  
**Priority :** Medium                                      **Asset Tag :**  
**Originated Date :** 07/26/2024 - Michael McDonnell - National TAB

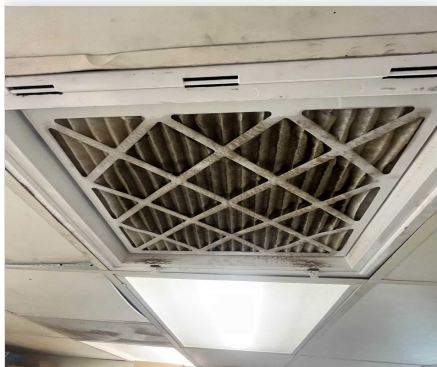
**Issue Name :** WSHP-4: Kitchen- Return Filter found Clogged  
**Description :** Return filter installed in WSHP-4 was found extremely dirty and clogged. When filter was replaced, airflow increased from 1100cfm to 1823. Recommend filter on this system is changed more frequently due to location (kitchen) to maintain consistent cfm from WSHP.  
**Created By :** National TAB                      **Assigned To :** National TAB - Michael McDonnell  
**Status :** Open  
**Priority :** InfoOnly                              **Asset Tag :**  
**Originated Date :** 07/26/2024 - Michael McDonnell - National TAB

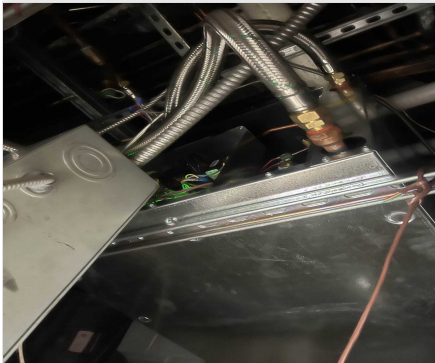
**Issue Name :** WSHP-9: Electrical Compartment Cover Missing  
**Description :** Unit cover for the electrical/control compartment is missing. Could not be located, recommend it's installed.  
**Created By :** National TAB                      **Assigned To :** National TAB - Michael McDonnell  
**Status :** Open  
**Priority :** Low                                      **Asset Tag :**  
**Originated Date :** 07/26/2024 - Michael McDonnell - National TAB
