**Report: TAB REPORT**  
**Function: Test, Adjust, & Balance**  
**Date: 06/27/2024**

**PROJECT**  
**06-24-24 DOMINICKS SCOTTSDALE, AZ**

Project: 06-24-24 DOMINICKS SCOTTSDALE, AZ

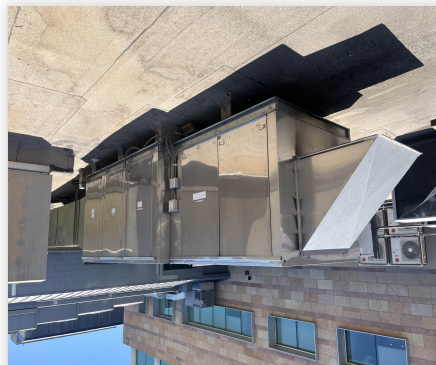
3. Kitchen Exhaust Hoods (HD-1 and HD-2) are not controlled by Hood Switch. Respective fans (KEF-1 and MAU) appear to run 24/7, only controlled by roof disconnect.

**Issue Name :** KEF-1: Controls - Always Operational  
**Description :** Hood controls in kitchen space do not control KEF-1. Kitchen exhaust hoods appear to run 24/7. This is unnecessarily exhausting treated air from space when cooling is not occurring. Only roof disconnect powers off fan. Recommend controls are inspected/corrected.  
**Created By :** National TAB                      **Assigned To :** National TAB - Michael McDonnell  
**Status :** Open  
**Priority :** High                                      **Asset Tag :**  
**Originated Date :** 07/25/2024 - Michael McDonnell - National TAB

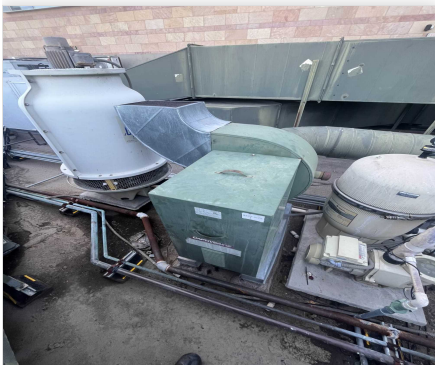
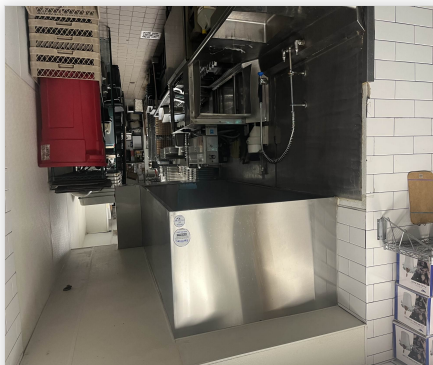
4. Dishwasher exhaust (HD-3) and its respective fan is not operating. The fan is functional but has no controls in the space below and can only be operated by roof disconnect.

**Issue Name :** KEF-2 Dish Exhaust: Controls - Not Operational  
**Description :** HD-3, Dishwasher hood, is served by KEF-2. Fan is functional but is not operating. Hood Switch does not control fan. Left off at roof, recommend controls installed.

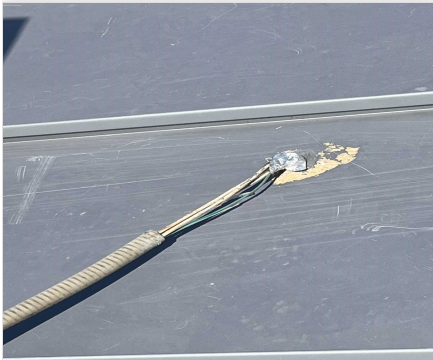
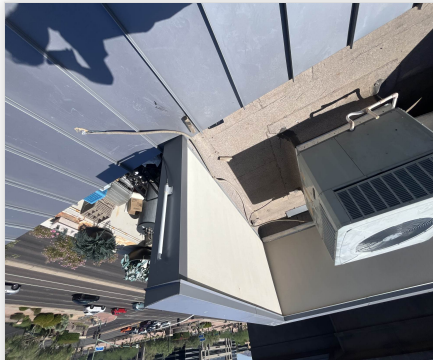
**Issue Name :** RTU-1: Power Conduit Damaged  
**Description :** Power conduit running from the roof to RTU-1 is damaged and wiring is exposed to the elements. Recommend conduit is repaired.  
**Created By :** National TAB                      **Assigned To :** National TAB - Michael McDonnell  
**Status :** Open  
**Priority :** Medium                                      **Asset Tag :**  
**Originated Date :** 07/25/2024 - Michael McDonnell - National TAB

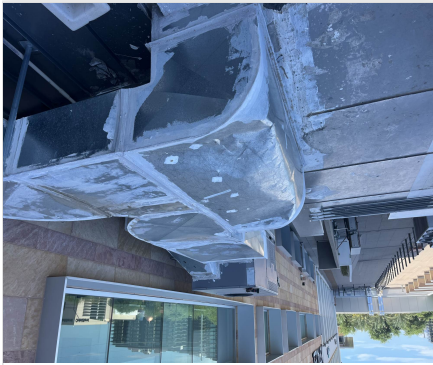
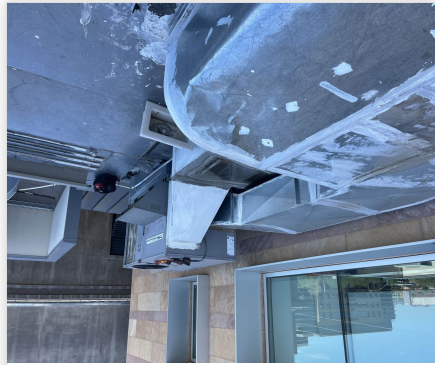
**Issue Name :** RTU-2 & 3: Economizer Not Functional  
**Description :** Economizers do not appear functional on RTUs serving pool dining (2&3).  
**Created By :** National TAB                      **Assigned To :** National TAB - Brianna Biggs  
**Status :** Open  
**Priority :** Medium                                      **Asset Tag :**  
**Originated Date :** 07/26/2024 - Michael McDonnell - National TAB

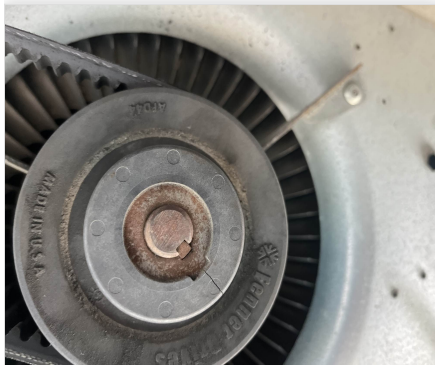
**Issue Name :** RTU-3: Pool RTU Fan Pulley Cracked  
**Description :** Plastic fan pulleys installed on Pool RTUs appear damaged. RTU-3 pulley has significant crack developing. Recommend replacement.  
**Created By :** National TAB                      **Assigned To :** National TAB - Michael McDonnell  
**Status :** Open  
**Priority :** High                                      **Asset Tag :**  
**Originated Date :** 07/26/2024 - Michael McDonnell - National TAB

[1] FAN PULEY DAMAGED / CRACKED

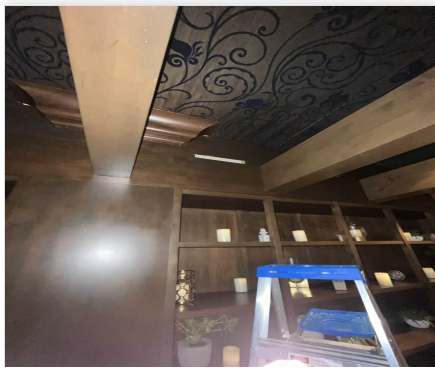
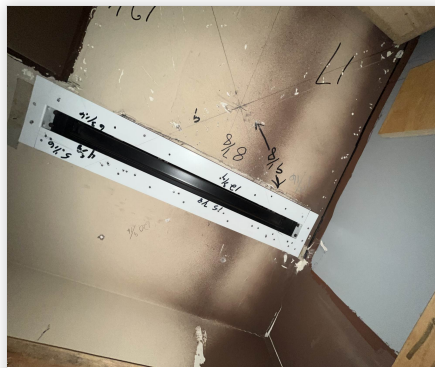
**Issue Name :** WSHP-1: Dining Diffusers Supply Wall Plenum  
**Description :** Dining room supply grilles mounted on wall in upper dining room supply the wall plenum, which then has grille sized cutouts to allow airflow. Inefficient delivery of supply airflow.  
**Created By :** National TAB                      **Assigned To :** National TAB - Michael McDonnell  
**Status :** Open  
**Priority :** Medium                                      **Asset Tag :**  
**Originated Date :** 07/26/2024 - Michael McDonnell - National TAB

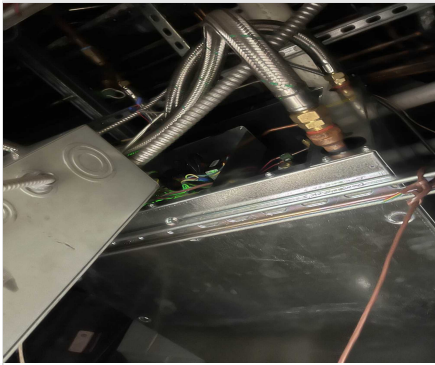
**Issue Name :** WSHP-9: Electrical Compartment Cover Missing  
**Description :** Unit cover for the electrical/control compartment is missing. Could not be located, recommend it's installed.  
**Created By :** National TAB                      **Assigned To :** National TAB - Michael McDonnell  
**Status :** Open  
**Priority :** Low                                      **Asset Tag :**  
**Originated Date :** 07/26/2024 - Michael McDonnell - National TAB

- Notes:
- [1] ELECTRICAL COMPARTMENT COVER MISSING. COULD NOT FIND IN THE CEILING.
  - [2] NOT DUCTED FOR OA.
