Report: TAB Report
Function: Test, Adjust, & Balance
Date: 12/31/2025
Completed By: National TAB

PROJECT
12-29-25 QT #0450 CHANDLER, AZ

175 N MCQUEEN RD

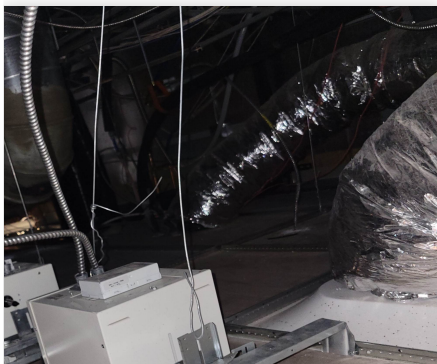
Issue Name : BACK AREA NOT BEING CONDITIONED
Description : RTU2-SGRD5 duct laying atop ceiling. Humid, normally warm, area behind soda & ice machines not being conditioned. Damper was open upon arrival, recommend making sure duct is closed before decommissioning them.
Created By : National TAB **Assigned To :** National TAB - Dan Hertenstein
Status : Open
Priority : **Medium** **Asset Tag :** SGRD5
Originated Date : 12/31/2025 - Christine Weale - National TAB

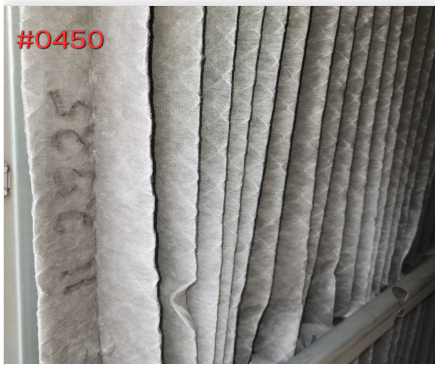
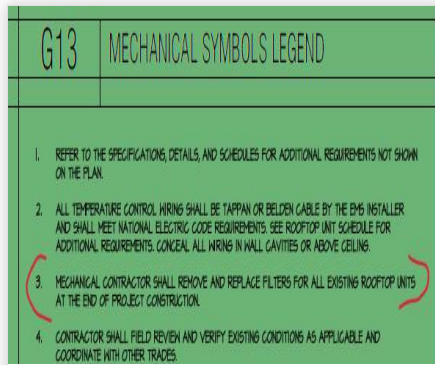
Issue Name : FINAL FILTERS NOT REPLACED
Description : ALL UNITS: FINAL FILTERS NOT REPLACED AS INSTRUCTED IN MSET. FILTERS ARE VERY DIRTY.
Created By : National TAB **Assigned To :** National TAB - Dan Hertenstein
Status : Open
Priority : Low **Asset Tag :**
Originated Date : 03/22/2026 - Christine Weale - National TAB

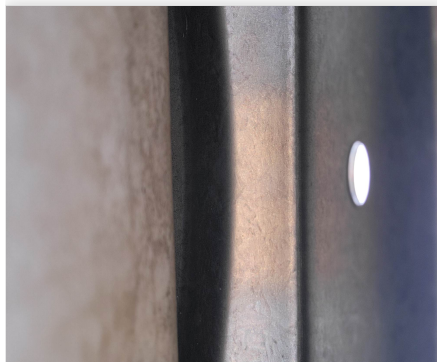
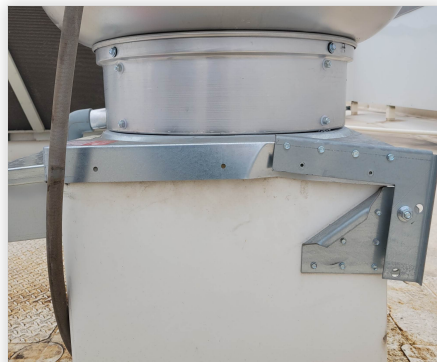
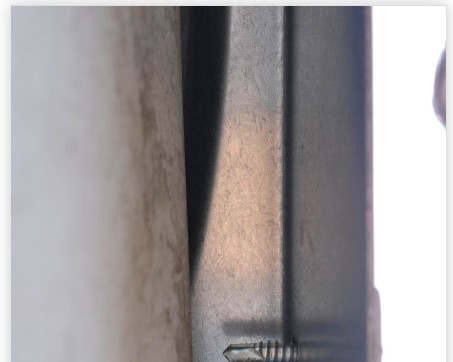
Issue Name : HOOD EXHAUST INEFFICIENT, GAP AT CURB
Description : There is a substantial space between curb top and fan base, SP= ~.33" w.c. Air is coming out of curb top instead of through duct. Air flow at filters is very low. Smoke test failed at 57.8Hz (100fpm/filter). Also appears curb may be too small, and fan base is bent. Needs correction so hood/fan can be balanced. Fan left at normal design parameters.
Created By : National TAB **Assigned To :** National TAB - Dan Hertenstein
Status : Open
Priority : Urgent **Asset Tag :** EF3
Originated Date : 12/31/2025 - Christine Weale - National TAB

No major leakage around the fan base	Fail
--------------------------------------	------

EF3 FUNCTIONAL BUT COULDN'T BE BALANCED DUE TO POOR INSTALLATION. SEE 'REMARKS'.

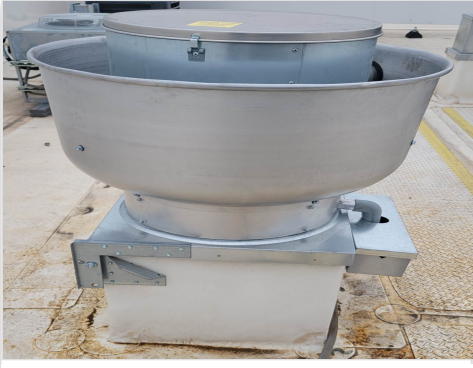
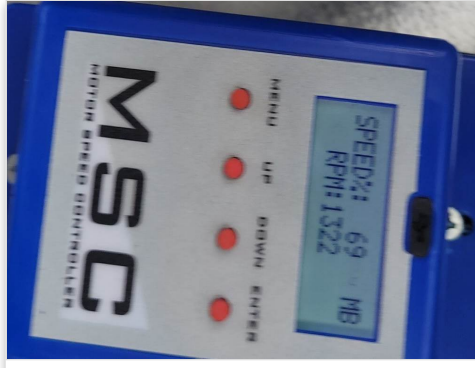
LARGE AIR LEAKAGE AT CURB, SEE 'REMARKS'. COULD NOT BALANCE, SMOKE TEST FAILED. NO 'FINAL MEASUREMENTS' TO TAKE.
