**Report: Deficiency Report**  
**Function: Test, Adjust, & Balance**  
**Date: 05/06/2025**  
**Completed By: National TAB**

**05-05-25 WHATABURGER #1365 DAPHNE, AL**

## Issue List

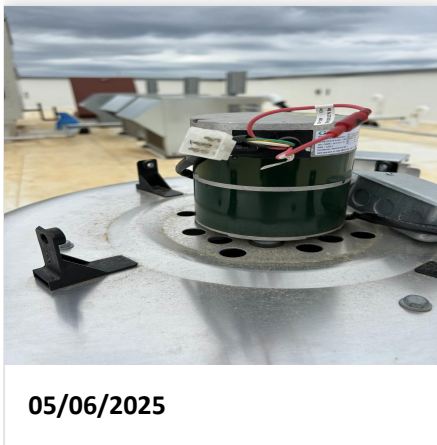
**Issue Name :** EF-1 - Not Powered  
**Description :** EF-1 (restrooms) is currently not powered. Speed control potentiometer is missing. Recommend installing.  
**Created By :** National TAB                      **Assigned To :** National TAB - Dan Hertenstein  
**Status :** Open  
**Priority :** **Urgent**                                      **Asset Tag :** EF1  
**Originated Date :** 05/06/2025 - Mark Johnson - National TAB
