Report: TAB Report
Function: Test, Adjust, & Balance
Date: 05/08/2025
Completed By: National TAB

05-05-25 WHATABURGER #1365 DAPHNE, AL

Whataburger Restaurants
300 Concord Plaza Dr
San Antonio, TX 78216

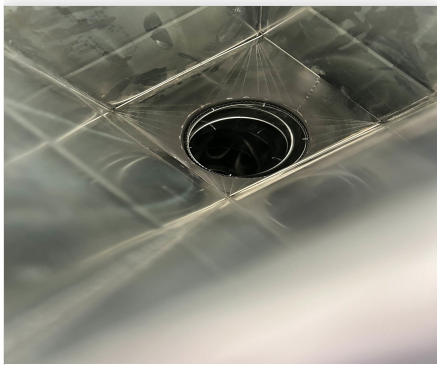
Issue Name : EF 1 - Backdraft Damper
Description : EF-1 is missing a backdraft damper. Recommend installing per mechanical plans.
Created By : National TAB **Assigned To :** National TAB - Dan Hertenstein
Status : Open
Priority : Low **Asset Tag :** EF1
Originated Date : 05/09/2025 - Mark Johnson - National TAB

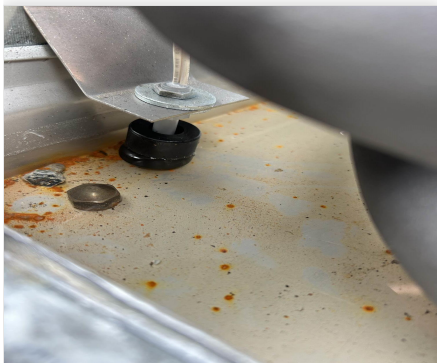
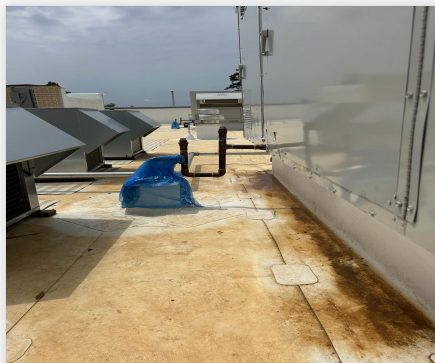
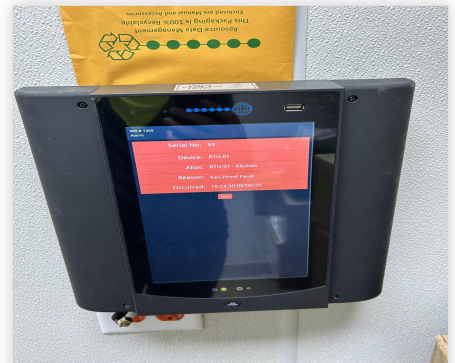
Issue Name : RTU 1 - Float Switch
Description : RTU 1 (kitchen) periodically locks out due to float switch activation. Excessive condensate is present inside unit, and drains slowly. Recommend inspection.
Created By : National TAB **Assigned To :** National TAB - Dan Hertenstein
Status : Open
Priority : Medium **Asset Tag :** RTU1
Originated Date : 05/06/2025 - Mark Johnson - National TAB

- **05/09/2025 National TAB - Mark Johnson**
 - Issue still occurring periodically at the end of TAB. Recommend observing for changes and a mechanical inspection if issue persists.

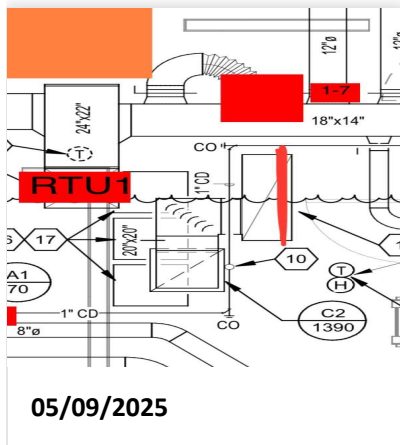
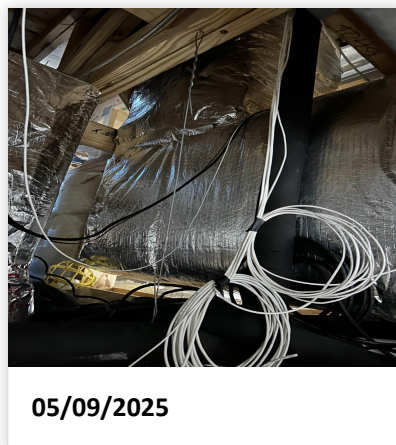
Screenshot of the GRD marked up with supply and return traverse locations for RTU-1 (Add picture here)

SUPPLY NOT ACCESSIBLE FOR TRAVERSE (SEE PICTURE)

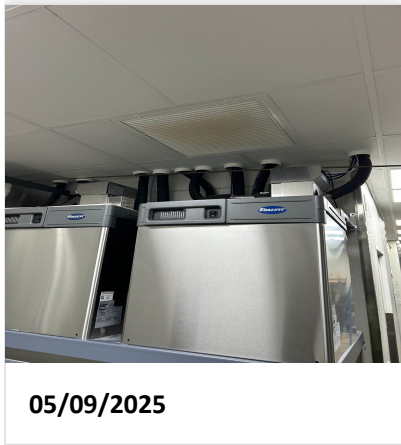
RTU 2 RETURN GRILLE NOT ACCESSIBLE FOR FLOW HOOD READING. TRAVERSE READING IS WITHIN DESIGN.

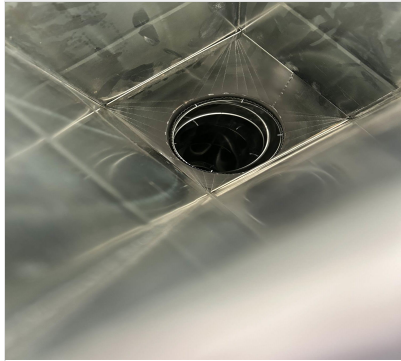
For restroom fan(s) is the back draft damper installed and can it fully open?

Fail

NOT INSTALLED
