Report: TAB Report
Function: Test, Adjust, & Balance
Date: 05/08/2025
Completed By: National TAB

05-05-25 WHATABURGER #1365 DAPHNE, AL

Whataburger Restaurants
300 Concord Plaza Dr
San Antonio, TX 78216

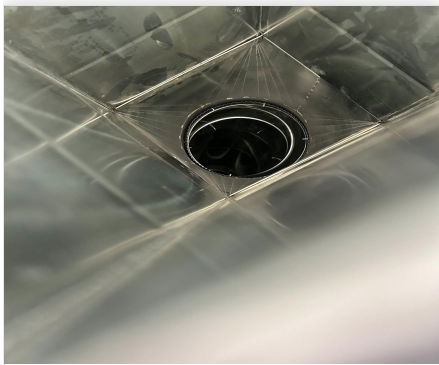
Issue Name : EF 1 - Backdraft Damper
Description : EF-1 is missing a backdraft damper. Recommend installing per mechanical plans.
Created By : National TAB **Assigned To :** National TAB - Dan Hertenstein
Status : Open
Priority : Low **Asset Tag :** EF1
Originated Date : 05/09/2025 - Mark Johnson - National TAB
