Report: Deficiency Report
Function: Test, Adjust, & Balance
Date: 05/06/2025
Completed By: National TAB

05-05-25 WHATABURGER #1365 DAPHNE, AL

US HIGHWAY 98 & LAVENDER LANE

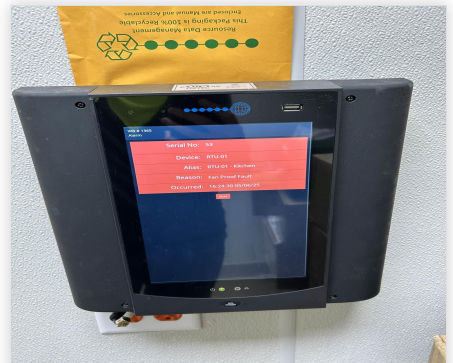
Issue Name : RTU 1 - Float Switch
Description : RTU 1 (kitchen) periodically locks out due to float switch activation. Excessive condensate is present inside unit, and drains slowly. Recommend inspection.
Created By : National TAB **Assigned To :** National TAB - Dan Hertenstein
Status : Open
Priority : Medium **Asset Tag :** RTU1
Originated Date : 05/06/2025 - Mark Johnson - National TAB

- **05/09/2025 National TAB - Mark Johnson**
 - Issue still occurring periodically at the end of TAB. Recommend observing for changes and a mechanical inspection if issue persists.
