**Report: Deficiency Report**  
**Function: Test, Adjust, & Balance**  
**Date: 03/18/2025**  
**Completed By: National TAB**

**PROJECT**  
**03-17-25 CARMAX #7107 ORLANDO, FL**

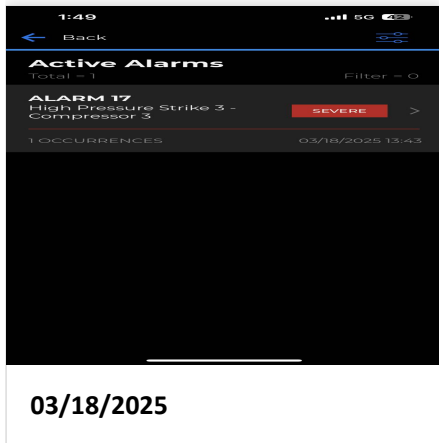
**Issue Name :** RTU 2 Alarm  
**Description :** RTU 2 alarm 17 - High Pressure Strike 3 Compressor 3  
**Created By :** National TAB                      **Assigned To :** National TAB - Will Turnbough  
**Status :** Open  
**Priority :** High                                      **Asset Tag :**  
**Originated Date :** 03/18/2025 - Stephen Tassinaro - National TAB

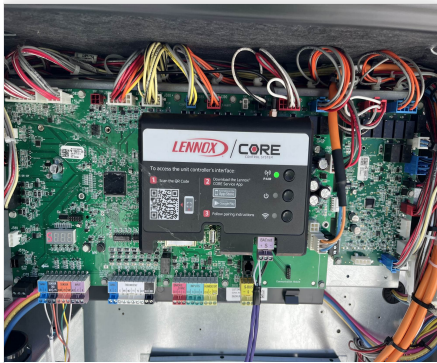
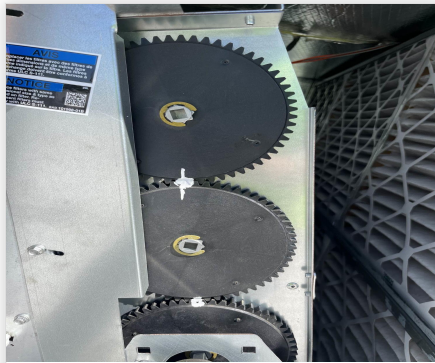
**Issue Name :** RTU 2 CORE Board Issues  
**Description :** The CORE board on RTU 2 will connect to the bluetooth app, but the unit is not reflecting the changes made. For example adjusting the outside air or attempting to run the damper calibration function. Outside air damper was balanced manually and position marked.  
**Created By :** National TAB                      **Assigned To :** National TAB - Will Turnbough  
**Status :** Open  
**Priority :** Medium                                      **Asset Tag :**  
**Originated Date :** 03/18/2025 - Stephen Tassinaro - National TAB

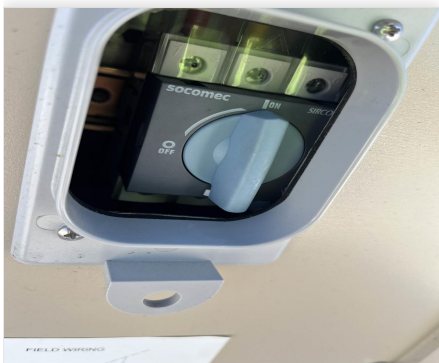
**Issue Name :** RTU 4 Disconnect  
**Description :** The disconnect switch cannot be turned due to the body of the switch coming into contact with the panel. Motor and drive data not retrieved for safety concerns.  
**Created By :** National TAB                      **Assigned To :** National TAB - Will Turnbough  
**Status :** Open  
**Priority :** High                                      **Asset Tag :**  
**Originated Date :** 03/18/2025 - Stephen Tassinaro - National TAB

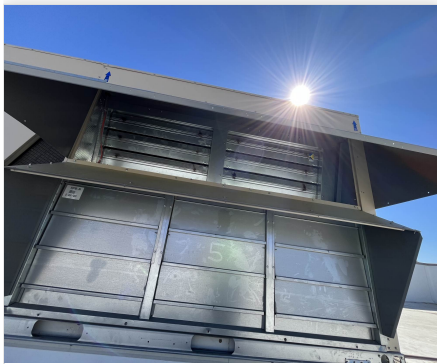
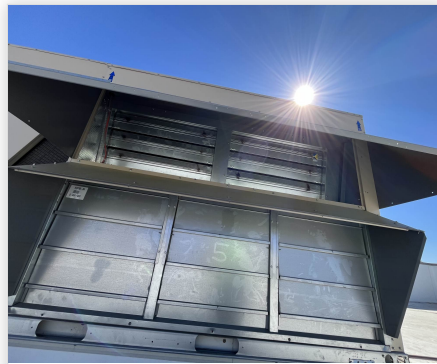
**Issue Name :** RTU 5 Missing OA Filters  
**Description :** The outside air filters are not installed on RTU 5.  
**Created By :** National TAB                      **Assigned To :** National TAB - Will Turnbough  
**Status :** Open  
**Priority :** Medium                                      **Asset Tag :**  
**Originated Date :** 03/18/2025 - Stephen Tassinaro - National TAB
