Report: Deficiency Report
Function: Test, Adjust, & Balance
Date: 03/18/2025
Completed By: National TAB

PROJECT
03-17-25 CARMAX #7107 ORLANDO, FL

Issue List

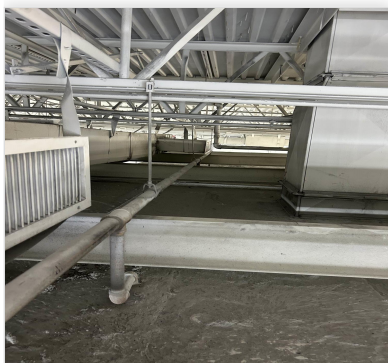
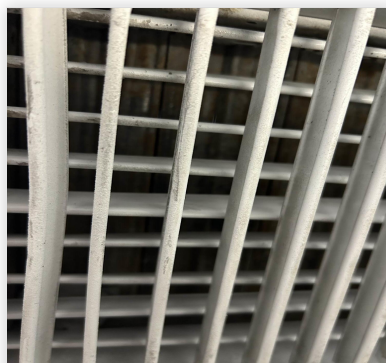
Issue Name : 1. RTU 12 - Low Flow (80%)
Description : RTU 12 is below design airflow. Current airflow is 3863CFM out of 4800CFM design (80.4%). The discharge static pressure is higher than typical at 1.34". This indicates that the restriction is in the supply ductwork. Due to work being done in the body shop bays, this duct drop could not be fully inspected during TAB. Further investigation recommend.

- During the inspection of ductwork, it was found that the dampers for the supply diffusers were mostly closed on one side. Damper mechanisms are broken and could not be opened fully. Additionally, two out of four supply registers could not be reached via lift as they are located too far above the service bays. Two dampers were slightly pried open by hand, and as a result the total airflow increased to 86% design. Recommend repairing all dampers and ensuring they are fully open.

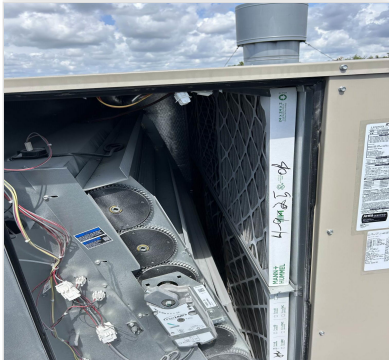
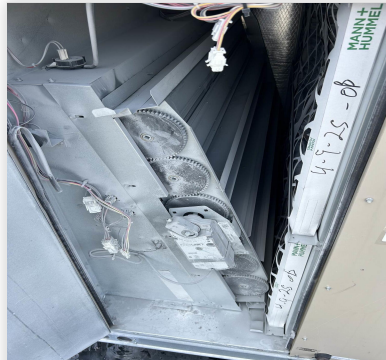
Issue Name : 4. RTU 12 & 14 - Dirty
Description : RTUs 12 & 14 are quickly building up debris from the body shop below. A layer of sanding dust has already coated the mixed air compartments and there is a light dusting present on the evaporator coils. The final filters had to be temporarily removed for balancing as they were loaded with dust.
Created By : National TAB **Assigned To :** National TAB - Will Turnbough
Status : Open
Priority : InfoOnly **Asset Tag :**
Originated Date : 03/26/2025 - Stephen Tassinaro - National TAB

- **06/10/2025 National TAB - Mark Johnson**
 - Compartments and filters remain dirty.
