PlanGrid Task Report - Dec 16, 2024

L05381_RELO Monroe (NC) FSU

2579 West Roosevelt Boulevard, Monroe, North Carolina

L2220005381

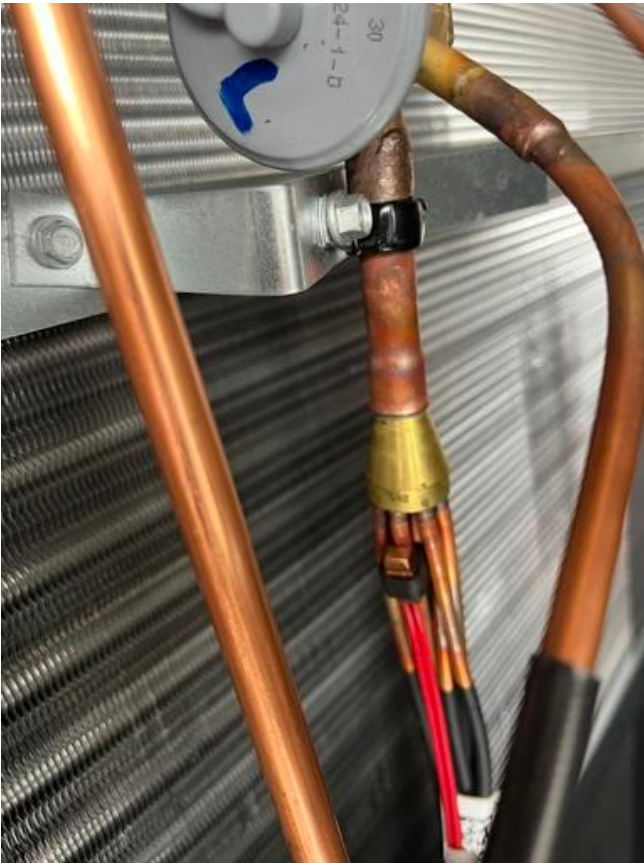
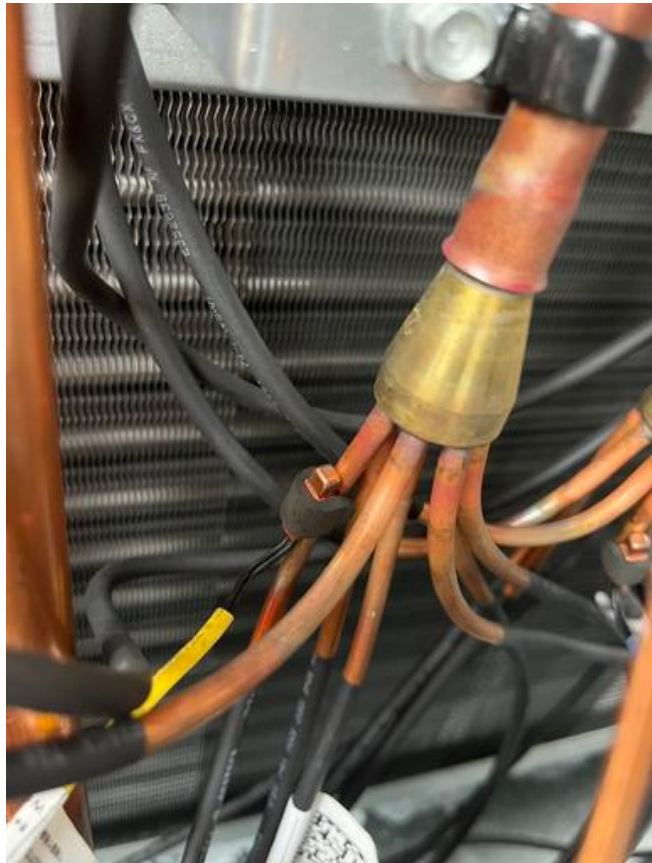
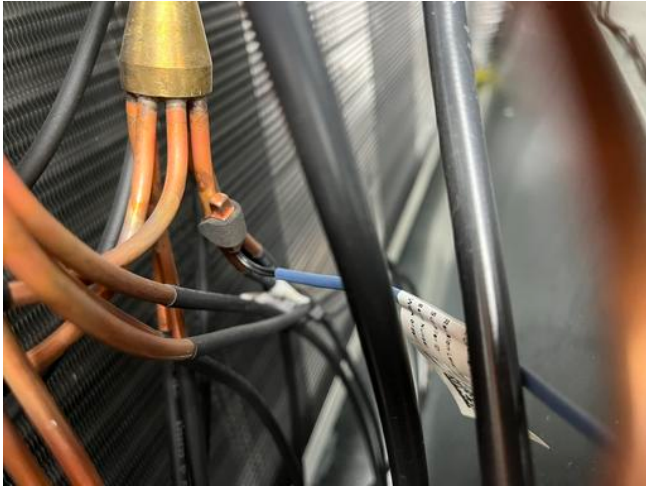
#12 [UNIT 999] [NEW] (MISC) [[RETAINING TIES ON WIRES]

AC1, AC2, AC3 wires are missing factory retaining ties. This is a Lennox factory issue.

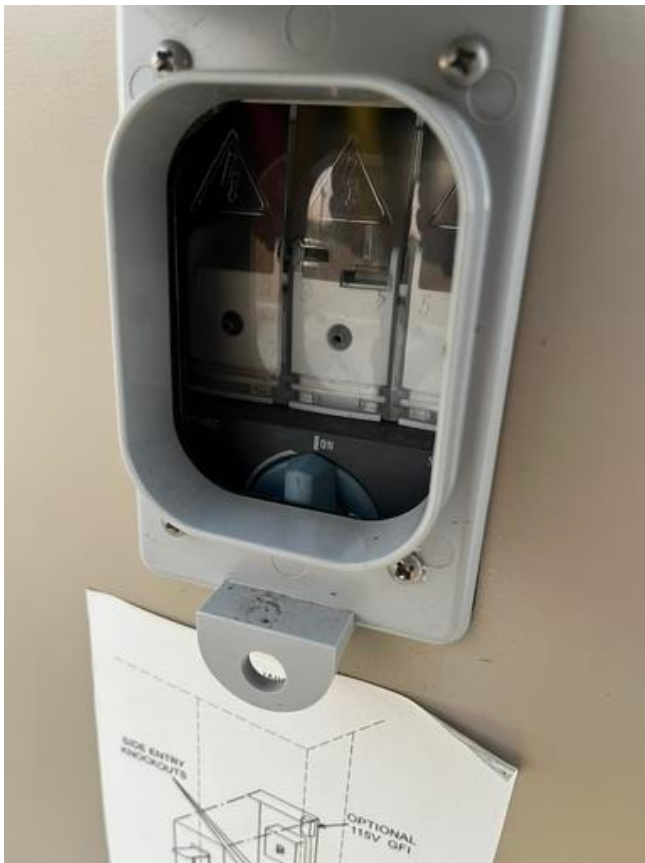
#11 [UNIT 999] [NEW] (MISC) [UNIT DISCONNECT]

AC2 unit disconnect panel is incorrect. The correct style disconnect / access panel has been shipped from Lennox per mechanical.
