Report: TAB REPORT
Function: Test, Adjust, & Balance
Date: 10/31/2023

PROJECT
MISSION HILLS COUNTRY CLUB

10/31/2023 - Summary

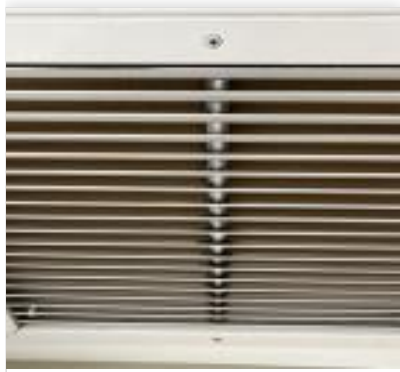
Exhaust
11/01/2023

Exhaust has card board 100% blocking airflow, creating noise.

6. A small return in the workout room is blanked off with cardboard. The larger return is full open. Recommend opening up this blanked off return.

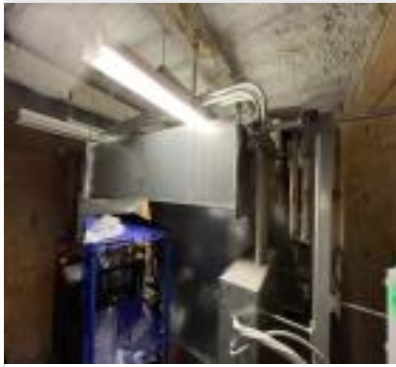
OArea
11/01/2023

Increased the frequency to 60Hz and airflow was balanced to 5282 CFM with the outside air damper set to 10% open at the front end. From 25% to 10% there was little change in the outside air flow. At 10% the outside air was measured as 1213 CFM which is 12% above design of 1000 CFM.

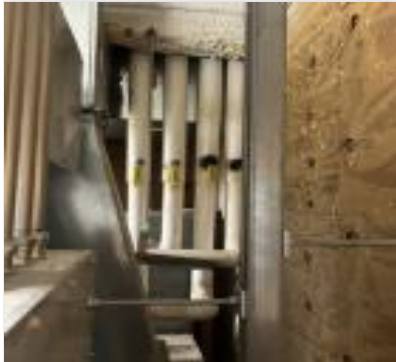
Manualvalves
11/01/2023

1. Flow at the balance valve was measured as 0 GPM. Appears that the valve is installed in correct orientation. Visible shut off valves are full open. Possibly there is an issue with the balance valve.

2. Recommend verifying that the strainers have been cleaned recently. If not recommend cleaning all strainers in the system. Also ensure that the water quality is good.

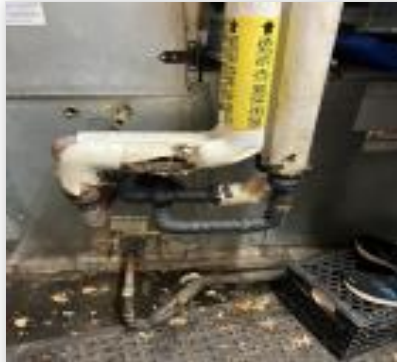
Coil(1)
11/01/2023

The chilled water was turned off and only hot water was tested. The flow measured at the balance valve was 0 GPM with the valve fully open. Closing the valve did change pressures but did not change flow. However, the discharge air temperature and change in temperature between the entering and leaving water indicated a flow of approximately 10.9 GPM.
