Report: PUNCH LIST
Function: Test, Adjust, & Balance
Date: 02/04/2026
Completed By: National TAB

PROJECT
02-02-26 CULVERS - CHARLOTTE, NC

Project: 02-02-26 CULVERS - CHARLOTTE, NC

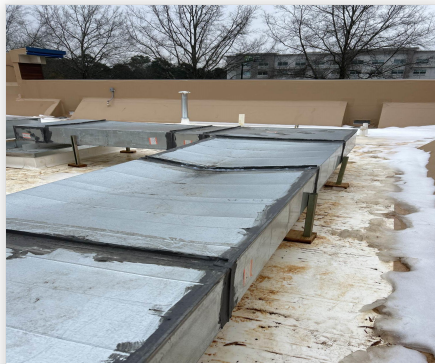
Issue Name : RTU-2 return ductwork damaged
Description : On RTU-2 return duct damaged
Created By : National TAB **Assigned To :** National TAB - Dan Hertenstein
Status : Open
Priority : High **Asset Tag :** RTU2
Originated Date : 02/04/2026 - Jearod Ferrette - National TAB
