**Report: TAB REPORT**  
**Function: Test, Adjust, & Balance**  
**Date: 02/06/2026**  
**Completed By: National TAB**

**PROJECT**  
**02-02-26 CULVERS - CHARLOTTE, NC**

Project: 02-02-26 CULVERS - CHARLOTTE, NC

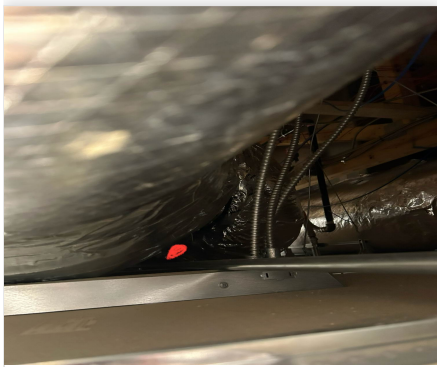
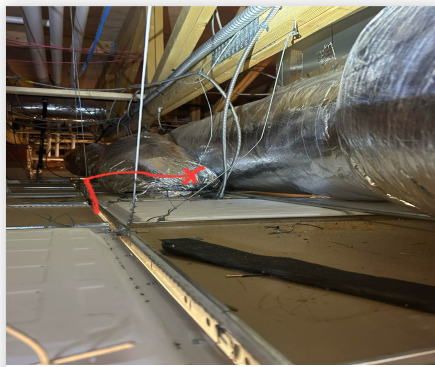
**Issue Name :** Damper inaccessible  
**Description :** Damper inaccessible, supply drop is laying on ceiling pad, unable moved. diffuser is taking to the air from neighboring diffusers.  
**Created By :** National TAB                      **Assigned To :** National TAB - Dan Hertenstein  
**Status :** Open  
**Priority :** Medium                                      **Asset Tag :** SGRD10  
**Originated Date :** 02/05/2026 - Jearod Ferrette - National TAB

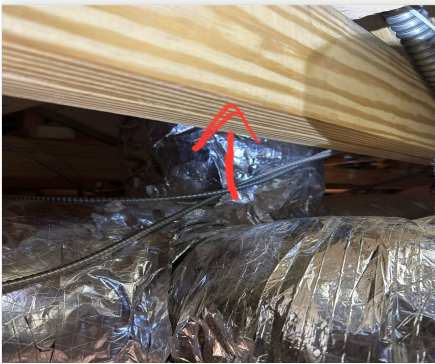
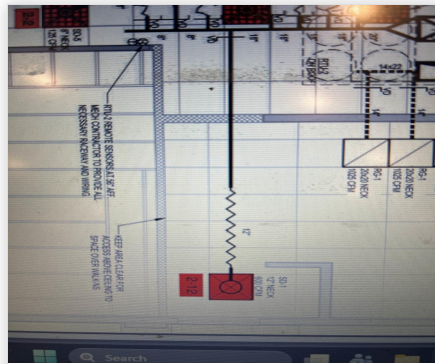
**Issue Name :** Damper not installed SRGD12  
**Description :** SGRD 2-12 damper not installed.  
**Created By :** National TAB                      **Assigned To :** National TAB - Dan Hertenstein  
**Status :** Open  
**Priority :** Medium                                      **Asset Tag :** SGRD12  
**Originated Date :** 02/05/2026 - Jearod Ferrette - National TAB

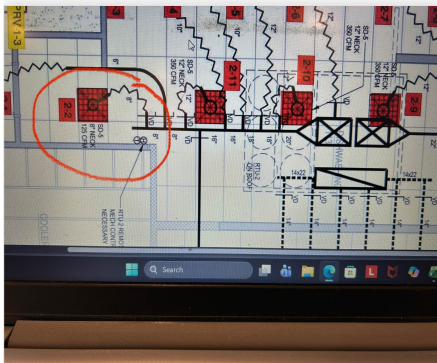
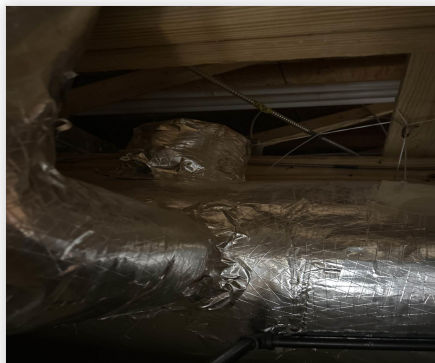
**Issue Name :** Diffuser not installed SGRD 2  
**Description :** On RTU 2 diffuser 2-2 wasn't installed due to spacing issue. Duct was capped, and the air will be equally balanced to the back 3 diffuser of the cook line.  
**Created By :** National TAB                      **Assigned To :** National TAB - Dan Hertenstein  
**Status :** Open  
**Priority :** Medium                                      **Asset Tag :** SGRD2  
**Originated Date :** 02/04/2026 - Jearod Ferrette - National TAB

RTU 2- SGRD 2-2 NOT INSTALLED

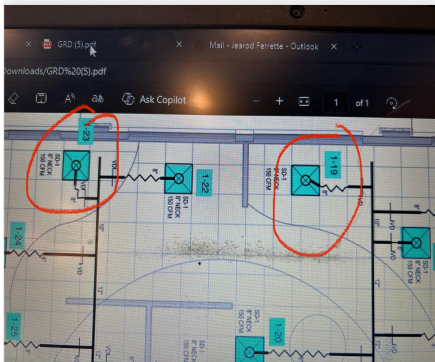
**Issue Name :** Missing dampers on RTU 1  
**Description :** Missing dampers on SGRD 19/23.  
**Created By :** National TAB                      **Assigned To :** National TAB - Dan Hertenstein  
**Status :** Open  
**Priority :** Medium                                      **Asset Tag :** RTU1  
**Originated Date :** 02/05/2026 - Jearod Ferrette - National TAB

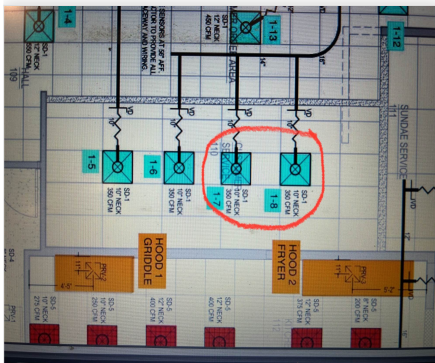
**Issue Name :** RTU 1 balance note  
**Description :** Inaccessible/ missing dampers are stealing air from the front registers. The ceilings are at least 14 feet so the air flow change will not be noticeable.  
**Created By :** National TAB  
**Assigned To :** National TAB - Dan Hertenstein  
**Status :** Open  
**Priority :** InfoOnly  
**Asset Tag :** RTU1  
**Originated Date :** 02/05/2026 - Jearod Ferrette - National TAB

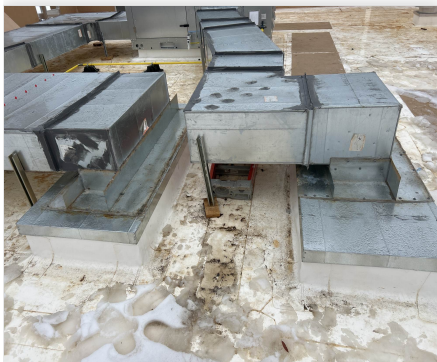
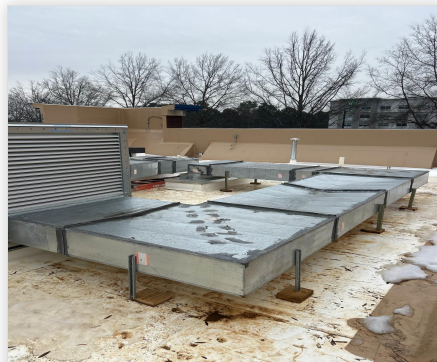
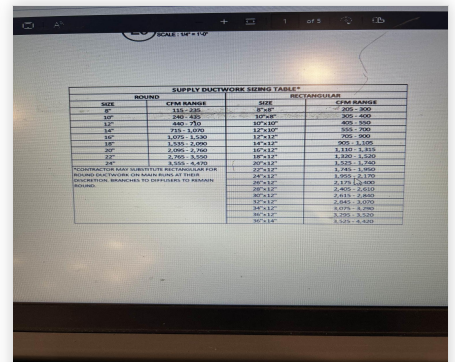
**Description :** RTU 2 is currently at 88% of design total flow. The ductwork from the unit was installed horizontally, this restricts the unit. On the MSET rooftop drawings refers to a note (M101) about proper ductwork size. Currently the supply ductwork 25x14 and also insulated inside. Supply pressure is at 1.50", the unit was at max amps 26.9a @61.5hz.

**Priority :** Urgent                                      **Asset Tag :** RTU2

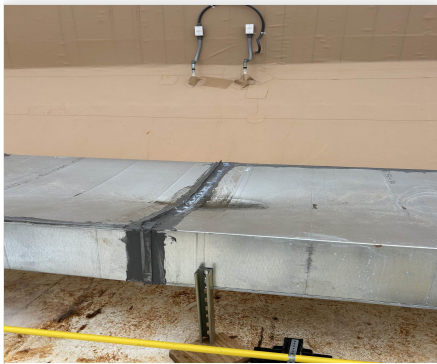
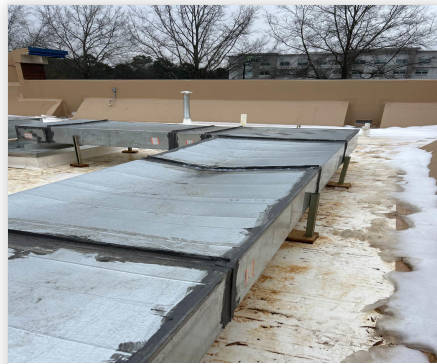
**Issue Name :** RTU-2 return ductwork damaged  
**Description :** On RTU-2 return duct damaged  
**Created By :** National TAB                      **Assigned To :** National TAB - Dan Hertenstein  
**Status :** Open  
**Priority :** High                                      **Asset Tag :** RTU2  
**Originated Date :** 02/04/2026 - Jearod Ferrette - National TAB

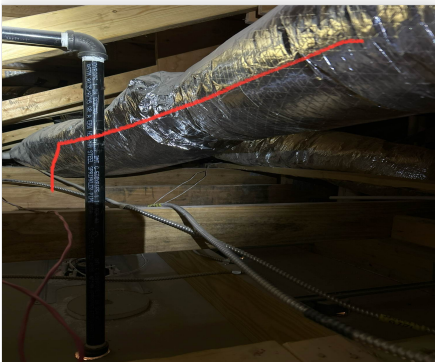
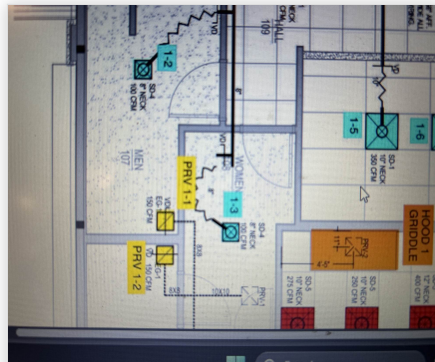
**Issue Name :** Women's RR damper inaccessible  
**Description :** Women's restroom, damper inaccessible above hard ceiling.  
**Created By :** National TAB                      **Assigned To :** National TAB - Dan Hertenstein  
**Status :** Open  
**Priority :** Medium                                      **Asset Tag :** SGRD3  
**Originated Date :** 02/05/2026 - Jearod Ferrette - National TAB
