Report: PUNCH LIST
Function: Test, Adjust, & Balance
Date: 02/04/2026
Completed By: National TAB

PROJECT
02-02-26 CULVERS - CHARLOTTE, NC

Project: 02-02-26 CULVERS - CHARLOTTE, NC

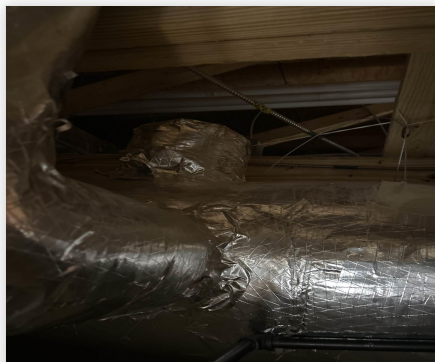
Issue Name : Diffuser not installed.
Description : On RTU 2 diffuser 2-2 wasn't installed due to spacing issue. Dust was capped, and the air will be equally balanced to the back 3 diffuser of the cook line.
Created By : National TAB **Assigned To :** National TAB - Dan Hertenstein
Status : Open
Priority : Low **Asset Tag :** SGRD2
Originated Date : 02/04/2026 - Jearod Ferrette - National TAB
