Report: PUNCH LIST
Function: Test, Adjust, & Balance
Date: 02/04/2026
Completed By: National TAB

PROJECT
02-02-26 CULVERS - CHARLOTTE, NC

Project: 02-02-26 CULVERS - CHARLOTTE, NC

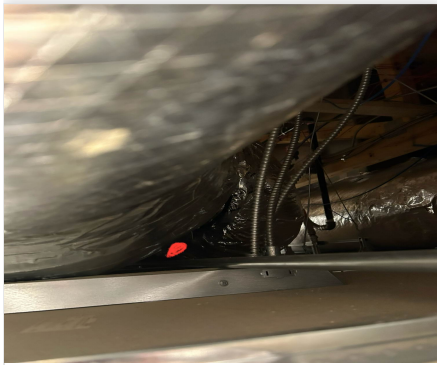
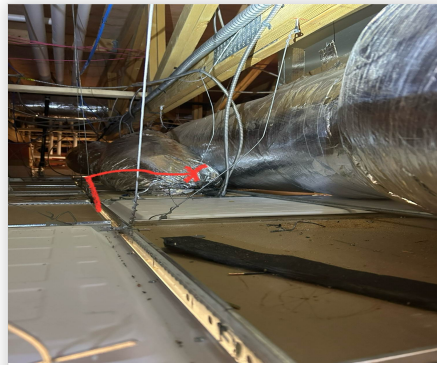
Issue Name : Damper inaccessible
Description : Damper inaccessible, supply drop is laying on ceiling pad, unable moved. diffuser is taking to the air from neighboring diffusers.
Created By : National TAB **Assigned To :** National TAB - Dan Hertenstein
Status : Open
Priority : Medium **Asset Tag :** SGRD10
Originated Date : 02/05/2026 - Jearod Ferrette - National TAB

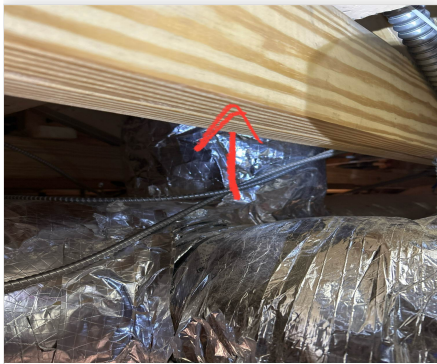
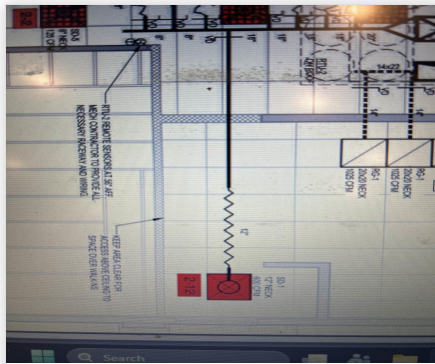
Issue Name : Damper not installed SRGD12
Description : SGRD 2-12 damper not installed.
Created By : National TAB **Assigned To :** National TAB - Dan Hertenstein
Status : Open
Priority : Medium **Asset Tag :** SGRD12
Originated Date : 02/05/2026 - Jearod Ferrette - National TAB

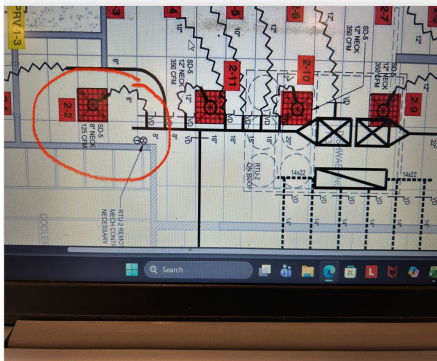
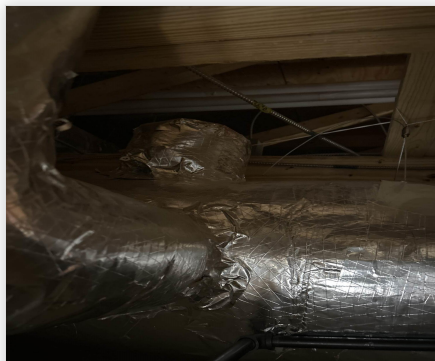
Issue Name : Diffuser not installed SGRD 2
Description : On RTU 2 diffuser 2-2 wasn't installed due to spacing issue. Duct was capped, and the air will be equally balanced to the back 3 diffuser of the cook line.
Created By : National TAB **Assigned To :** National TAB - Dan Hertenstein
Status : Open
Priority : Medium **Asset Tag :** SGRD2
Originated Date : 02/04/2026 - Jearod Ferrette - National TAB

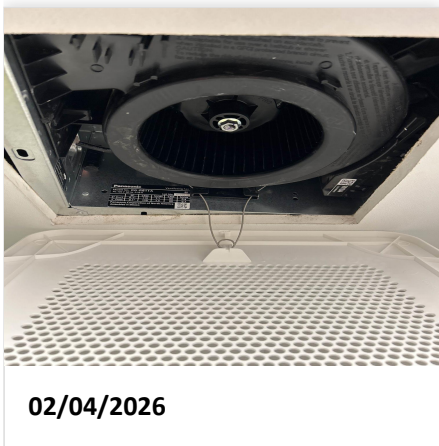
Issue Name : EF-1 Mop room fan
Description : EF-1 doesn't have power ran to the unit.
Created By : National TAB **Assigned To :** National TAB - Dan Hertenstein
Status : Closed
Priority : Urgent **Asset Tag :** EF1
Originated Date : 02/04/2026 - Jearod Ferrette - National TAB

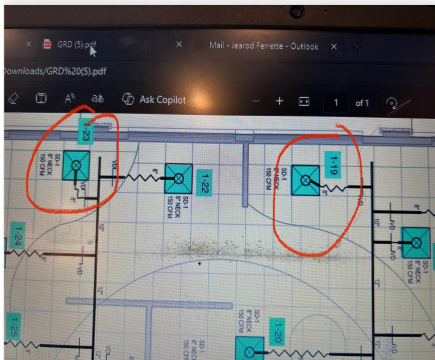
Issue Name : Missing dampers on RTU 1
Description : Missing dampers on SGRD 19/23.
Created By : National TAB **Assigned To :** National TAB - Dan Hertenstein
Status : Open
Priority : Medium **Asset Tag :** RTU1
Originated Date : 02/05/2026 - Jearod Ferrette - National TAB

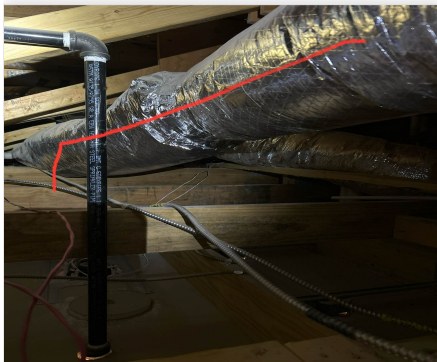
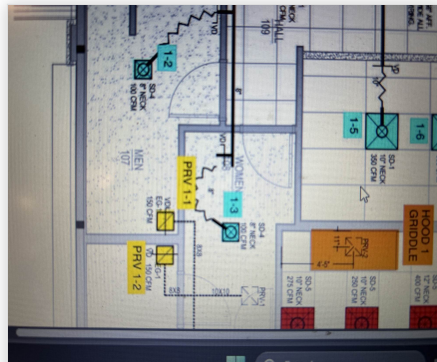
Issue Name : Women's RR damper inaccessible
Description : Women's restroom, damper inaccessible above hard ceiling.
Created By : National TAB **Assigned To :** National TAB - Dan Hertenstein
Status : Open
Priority : Medium **Asset Tag :** SGRD3
Originated Date : 02/05/2026 - Jearod Ferrette - National TAB
