Report: PUNCH LIST
Function: Test, Adjust, & Balance
Date: 02/04/2026
Completed By: National TAB

PROJECT
02-02-26 CULVERS - CHARLOTTE, NC

Project: 02-02-26 CULVERS - CHARLOTTE, NC

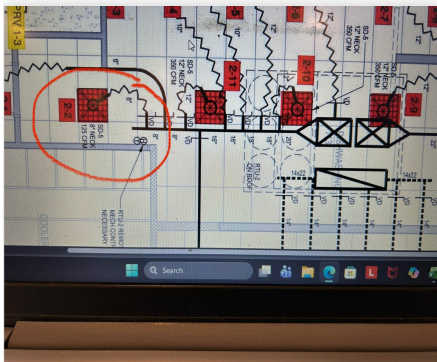
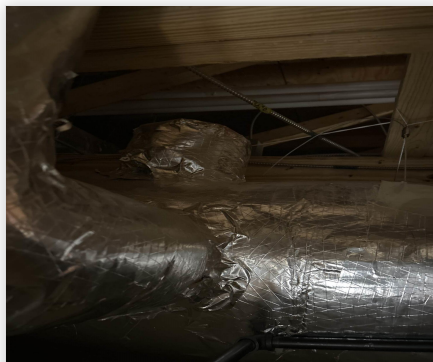
Issue Name : Diffuser not installed.
Description : On RTU 2 diffuser 2-2 wasn't installed due to spacing issue. Dust was capped, and the air will be equally balanced to the back 3 diffuser of the cook line.
Created By : National TAB **Assigned To :** National TAB - Dan Hertenstein
Status : Open
Priority : Low **Asset Tag :** SGRD2
Originated Date : 02/04/2026 - Jearod Ferrette - National TAB

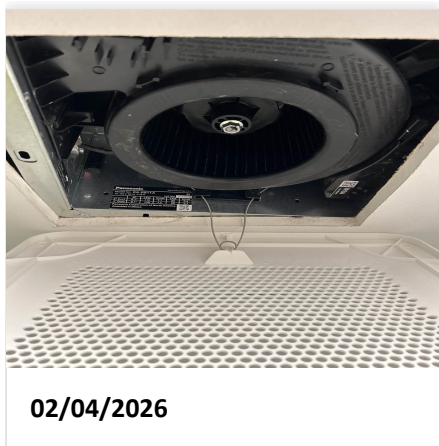
Issue Name : EF-1 Mop room fan
Description : EF-1 doesn't have power ran to the unit.
Created By : National TAB **Assigned To :** National TAB - Dan Hertenstein
Status : Open
Priority : Urgent **Asset Tag :** EF1
Originated Date : 02/04/2026 - Jearod Ferrette - National TAB

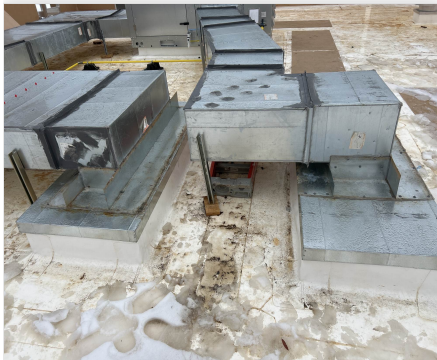
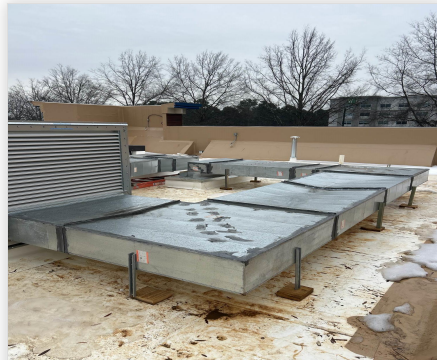
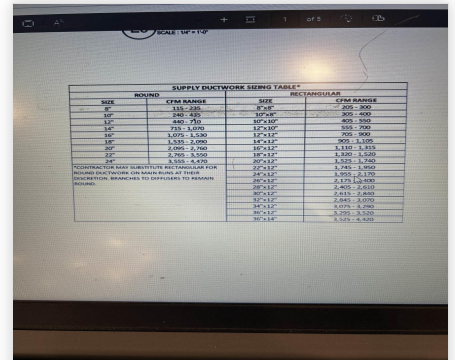
Issue Name : RTU-2 ductwork undersized
Description : RTU 2 is currently at 88% of design total flow. The ductwork from the unit was installed horizontally, this restricts the unit. On the MSET rooftop drawings refers to a note (M101) about proper ductwork size. Currently the supply ductwork 25x14 and also insulated inside. Supply pressure is at 1.50", the unit was at max amps 26.9a @61.5hz.

- **02/04/2026 National TAB - Jearod Ferrette**
 - I slowed the unit down by 2hz, to bring down the amps. Per the mechanical there is an email chain from Captive Air. The engineers wanted the unit to be ducted horizontally. This unit will be proportionally balance.
