PlanGrid Task Report - Oct 9, 2024

L05222_Broadview FSU (IL)

3300 Broadview Village Square, Riverside, Illinois

L1020005222

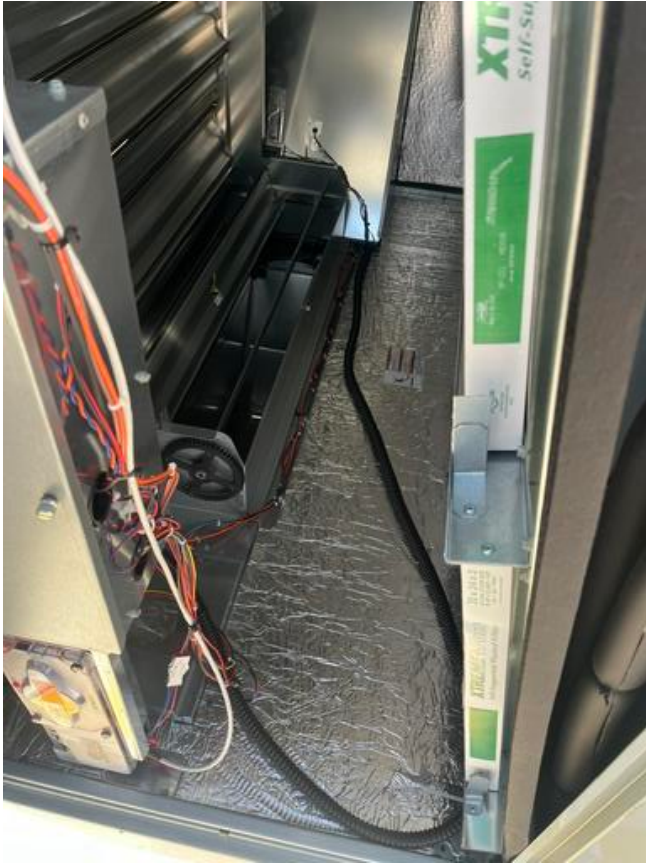
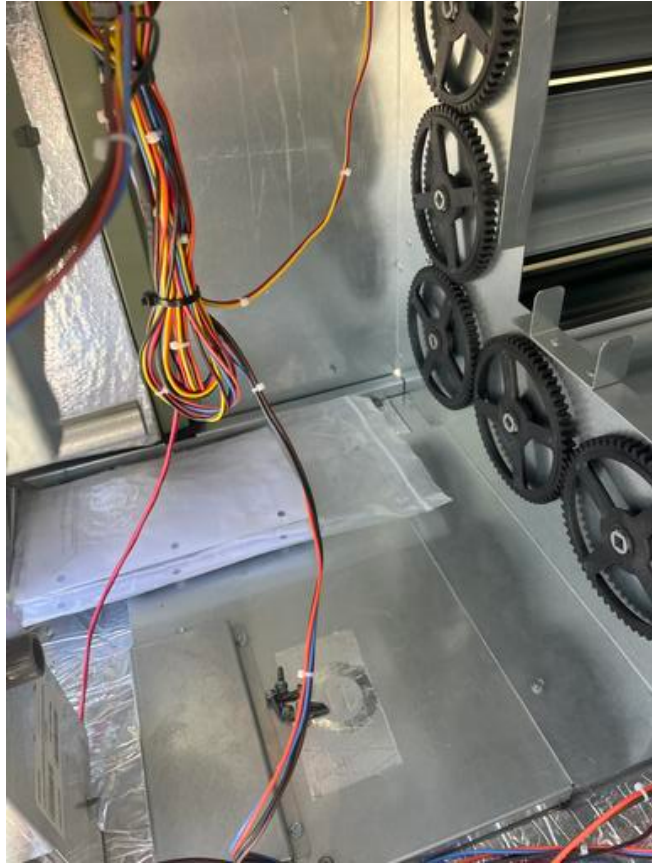
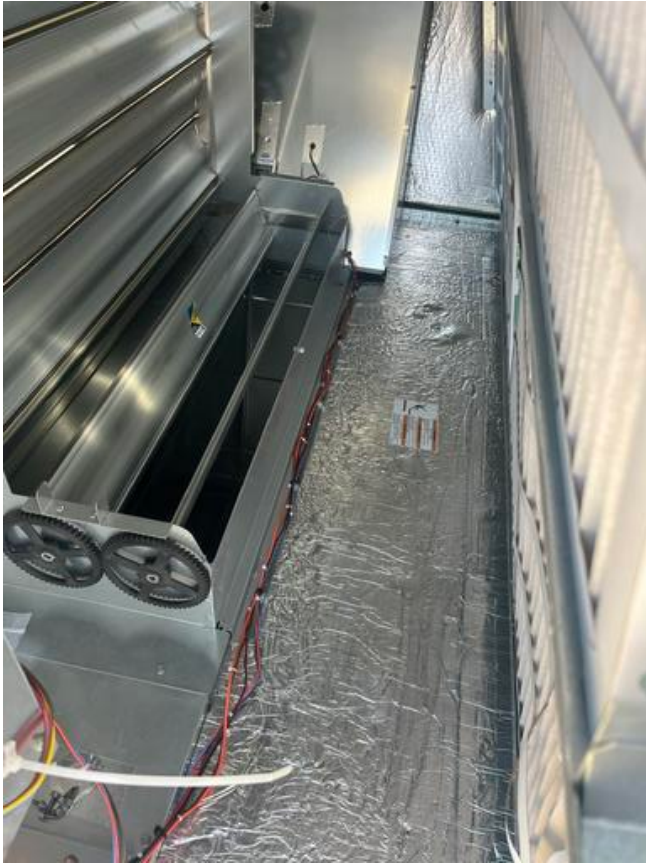
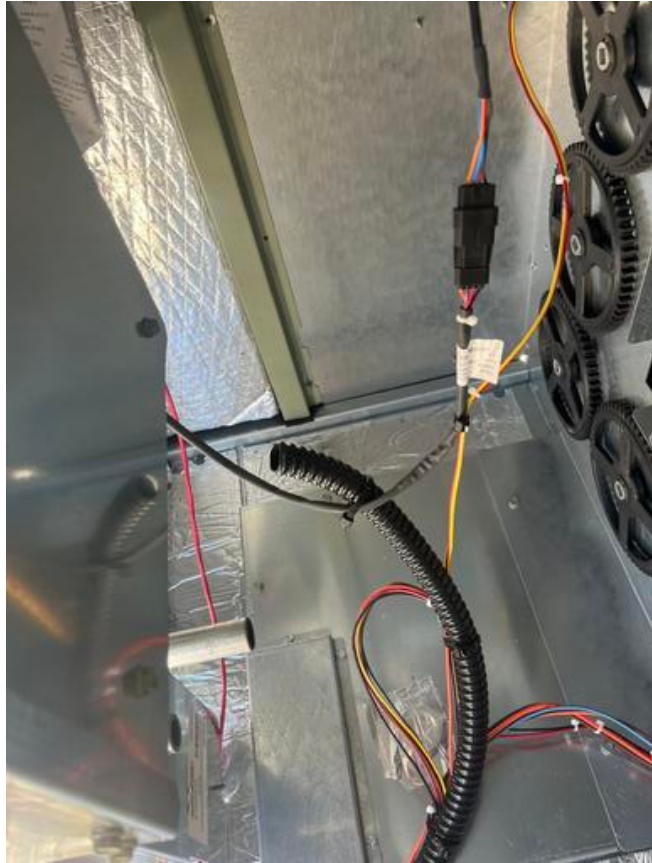
#590 [UNIT 509][NEW] Factory Smoke detectors

Request confirmation of proper smoke detector sampling tube configuration/installation. AC-1 does not have tube installed. AC-2 has tube installed to detector and routed to return. AC-3 has tube in mixed air compartment but it is not connected to sampling tube.

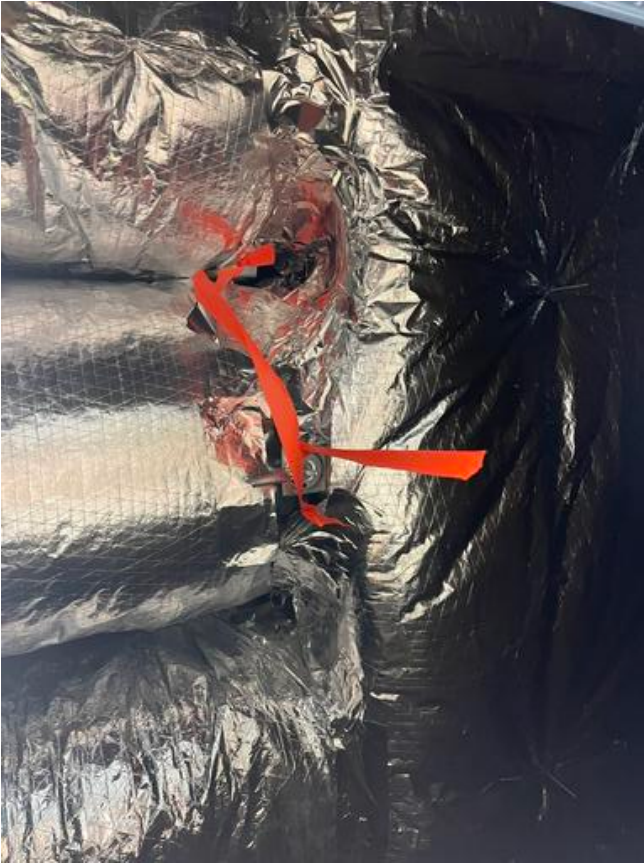
#583 [DUCT 008][NEW] CRITICAL- AC-1 Supply Start Collar damper orientation.

Dampers installed at 6 o'clock on 2 supply dampers on AC-1. This is incorrect orientation as dampers are perpendicular to airflow. However, TAB is accepting as installed. Unit is performing at design, all diffusers at design airflow. Ductwork Design does not provide enough room for dampers to be installed in correct orientation, and be accessible. Recommend EOR review plans and provide more spacing for proper damper installation in future.
