# PlanGrid Task Report - Oct 9, 2024

Oct 9, 2024

**L05222\_Broadview FSU (IL)**

3300 Broadview Village Square, Riverside, Illinois

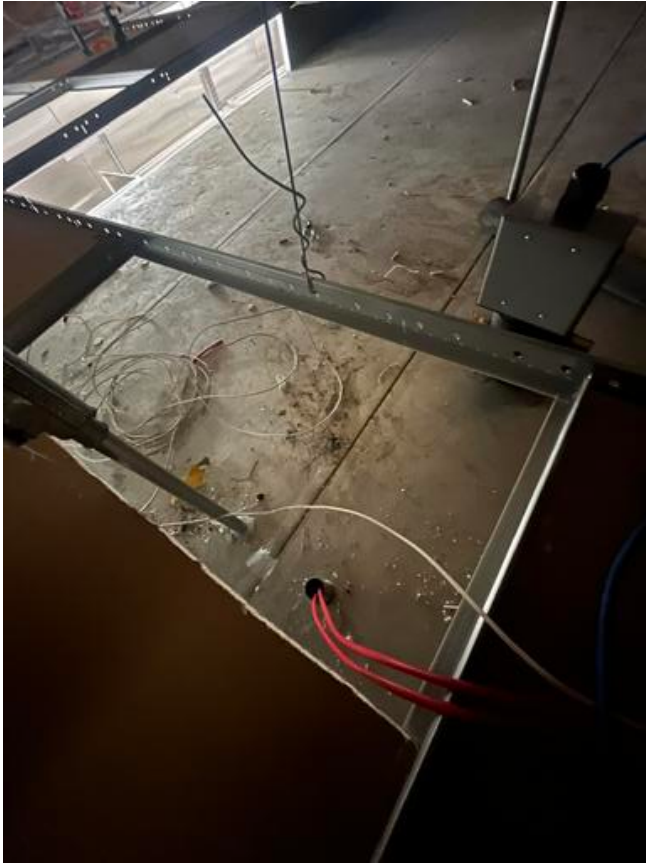
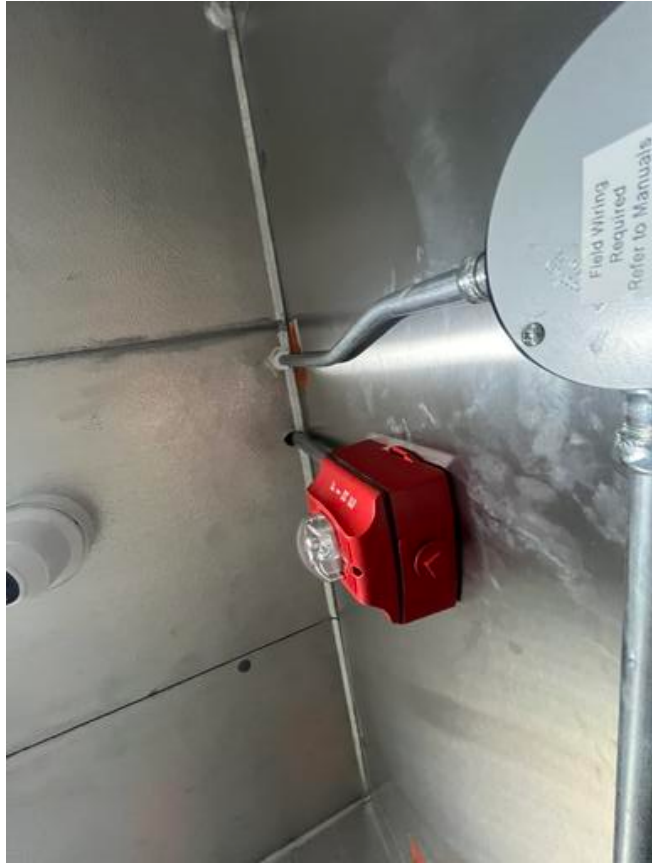
**#589 [REFG 508][NEW] WIC/WIF Panel Penetrations**

WIF-WIC penetrations are not sealed inside with silicone or above at time of inspection.

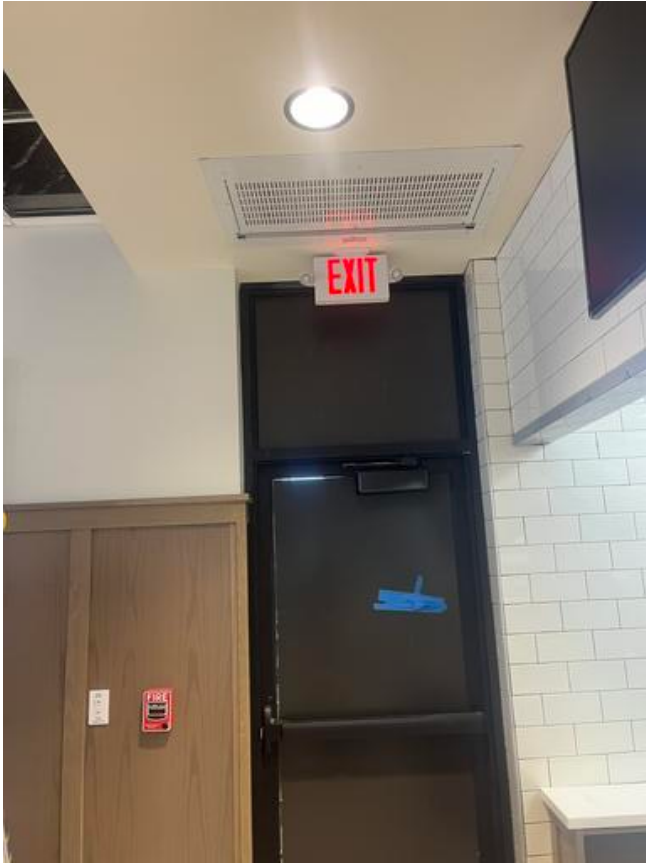
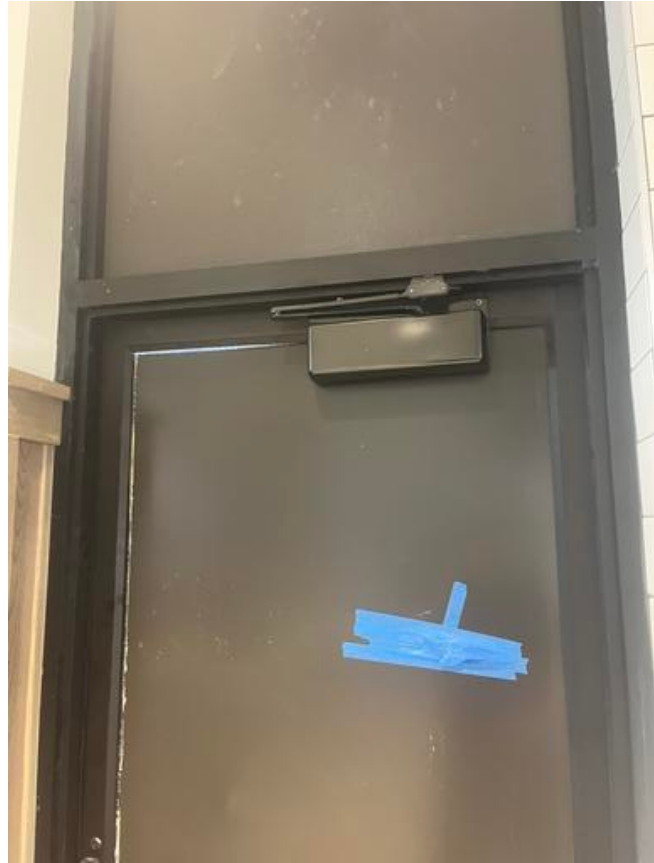
**#587 [CURT 503][NEW] Air Curtain Door Switched**

AD#2 not operational at time of TAB. Door Sensors are not yet installed as door is scheduled to be replaced.

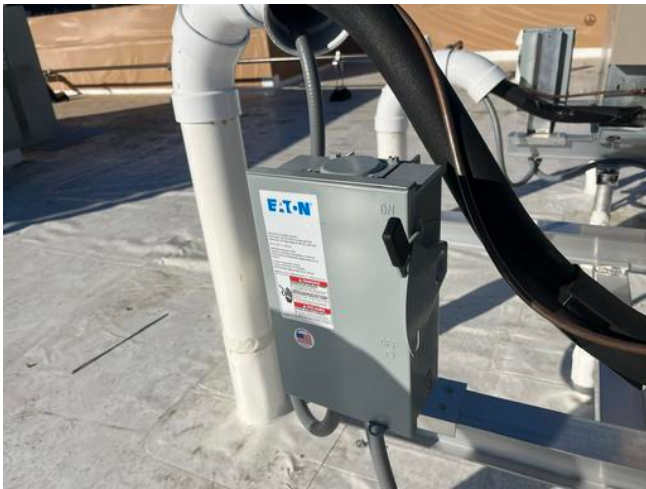
**#585 [REFG 516][NEW] Condenser Electrical Disconnects**

Electrical disconnects not labeled.

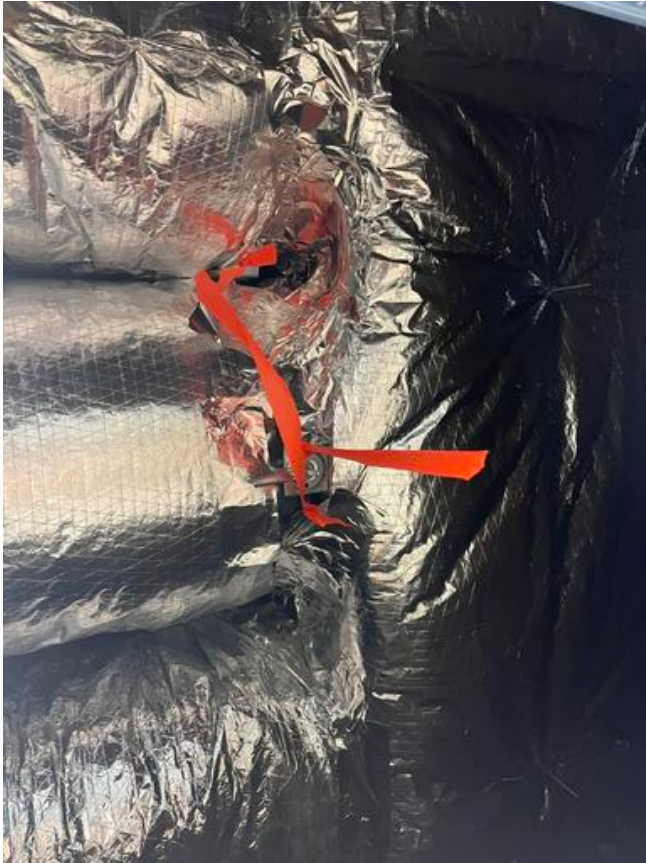
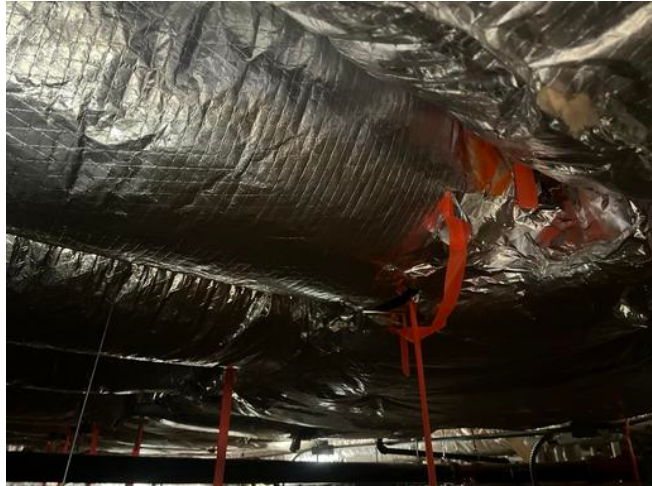
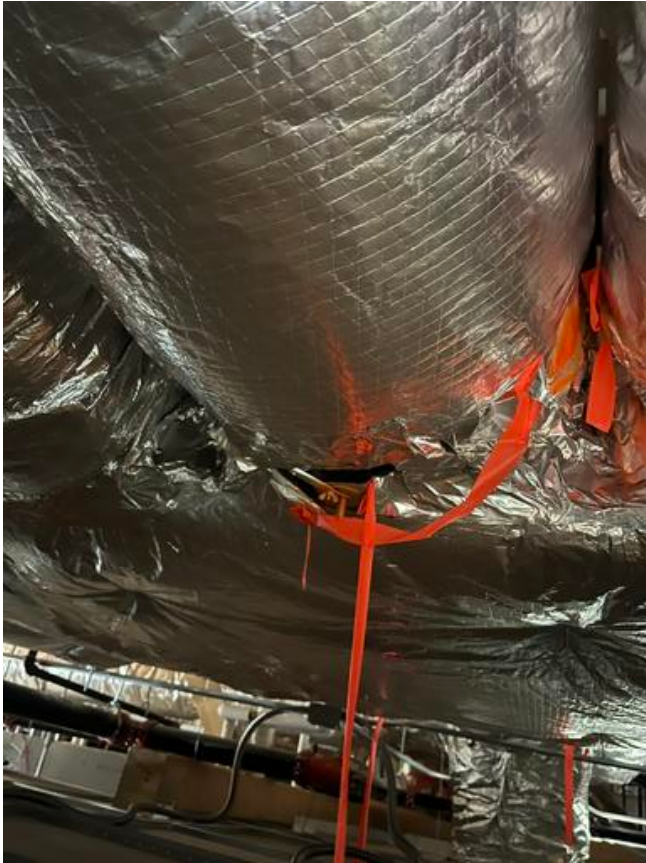
## #583 [DUCT 008][NEW] CRITICAL- AC-1 Supply Start Collar damper orientation.

Dampers installed at 6 o'clock on 2 supply dampers on AC-1. This is incorrect orientation as dampers are perpendicular to airflow. However, TAB is accepting as installed. Unit is performing at design, all diffusers at design airflow. Ductwork Design does not provide enough room for dampers to be installed in correct orientation, and be accessible. Recommend EOR review plans and provide more spacing for proper damper installation in future.

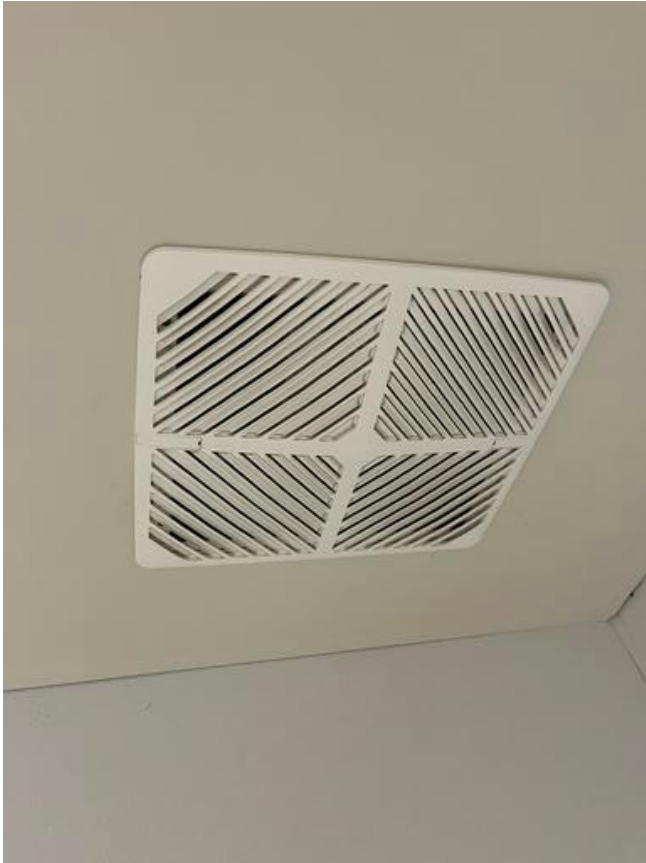
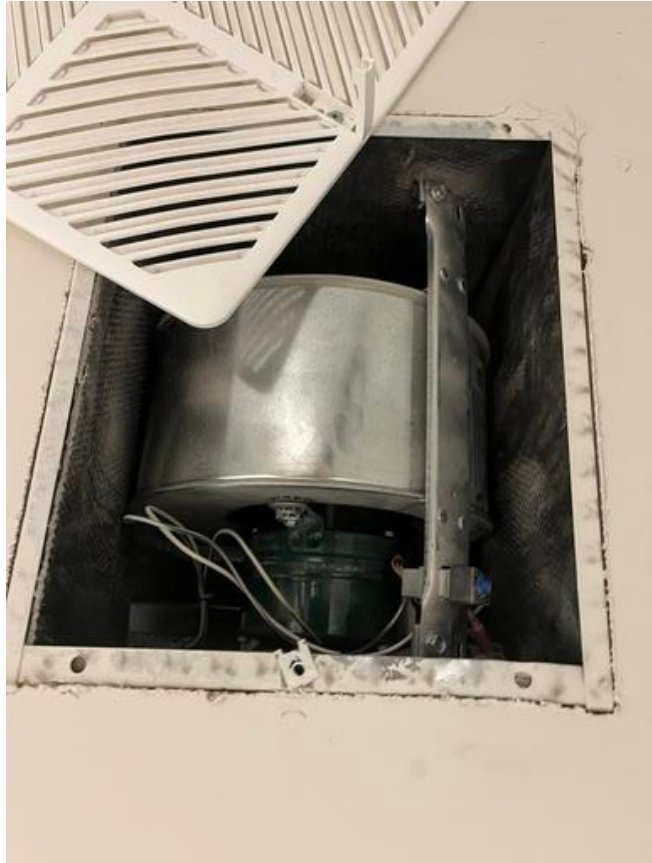
**#582 [EXHA 008][NEW] EF-4 is Wrong Model Fan**

Plans call for SP-A90, SP-A390 model is installed. Fan was able to be slowed into design. Wrong fan model has been sent to multiple locations. Recommend Halton Review.

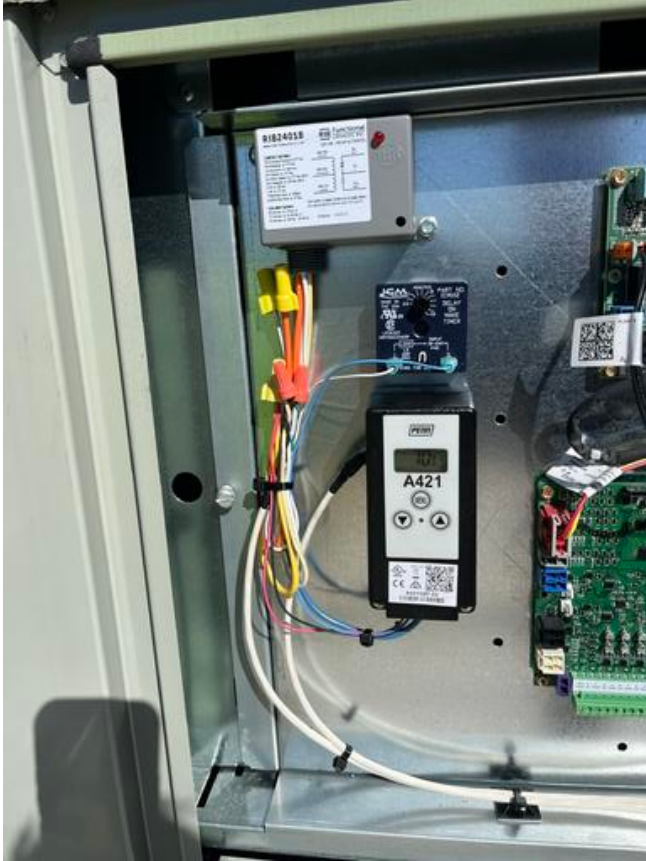
**#581 [UNIT 504][NEW] Equipment Fresh Air Tempering**

FAT installed and wired per plan. Wiring schematic has been updated and a new timer is required. ICM102 timer installed, ICM104 now required. Recommend MC install new timer/review per new schematic.

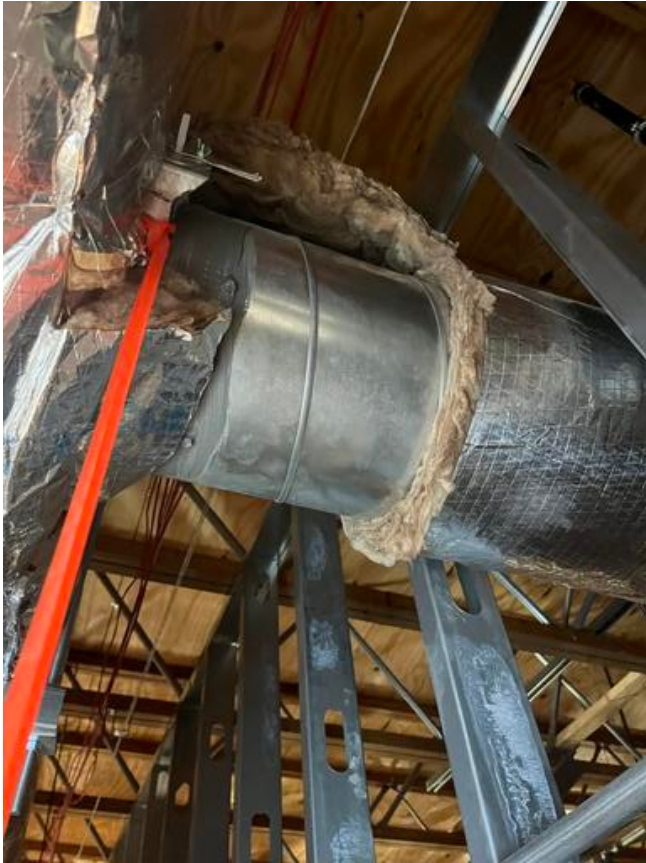
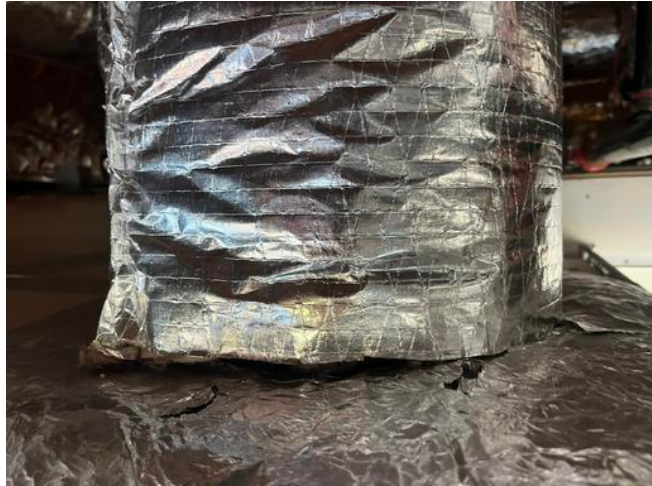
**#579 [DUCT 507][NEW] Not All Ductwork Insulated; seams not taped.**

Insulation needs to be taped to top of diffusers on all systems. Some instances of missing/not taped ductwork

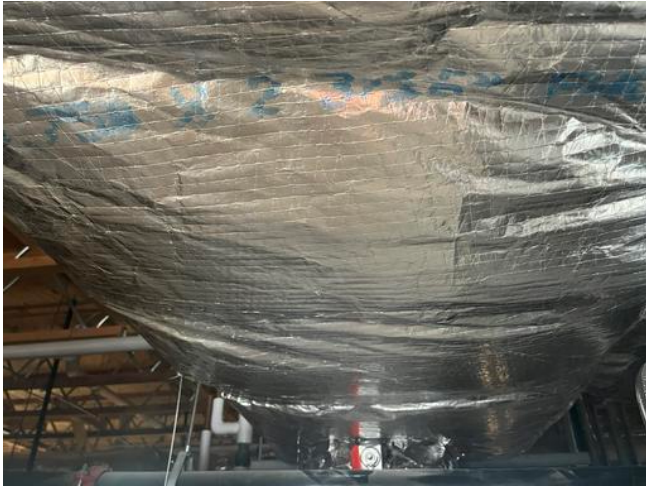
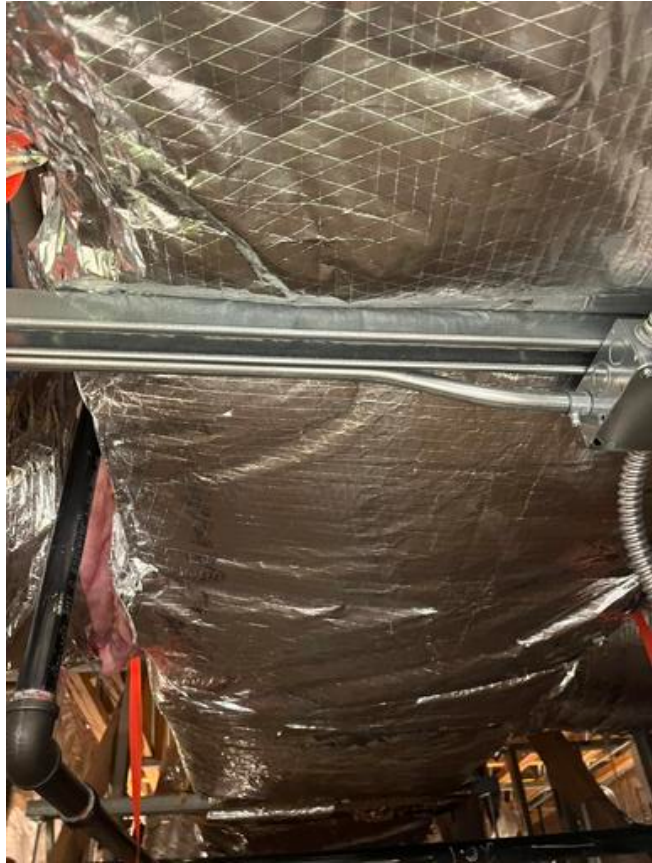
**#578 [DUCT 501][NEW] Insulation Stick Pins**

External insulation on bottom of ducts 24" or wider to be supported by stick pins 18" on center. Cut pins and apply tape over r mastic to cover. AC-2 supply does not appear to have stick pins installed. AC-3 return appears to have some stick pins, but not 18" on center, insulation sagging slightly. Recommend stick pins added.

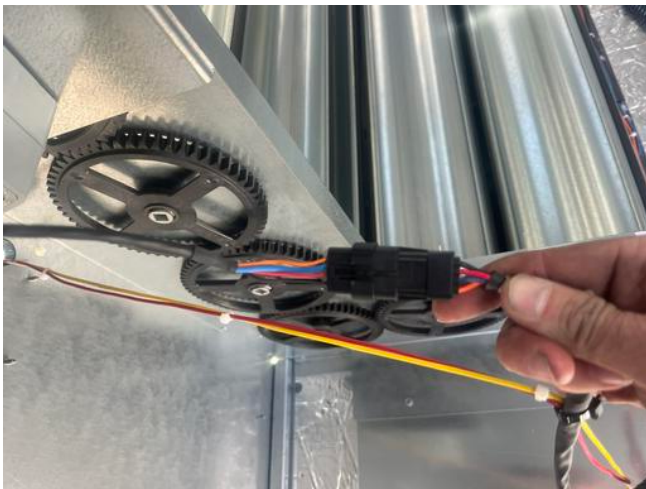
## #575 [UNIT 999][NEW] AC-3 economizer plug backwards from factory

Economizer plug wired backward from factory. Corrected by NTAB. 25% open was 75% open.

Plug cannot be fully secured when rotated to correct orientation.

Recommend plug is secured

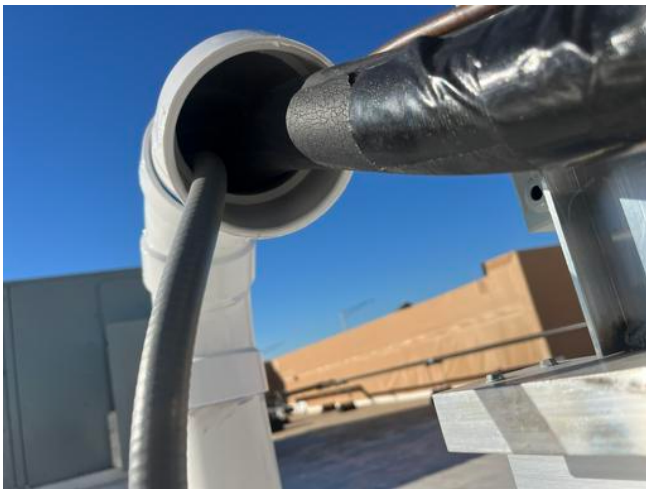
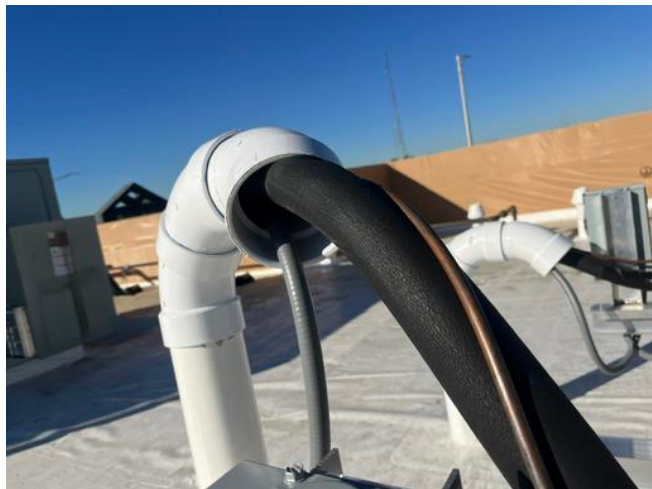
**#574 [REFG 511][NEW] PVC gooseneck installation**

Be sure risers are filled with spray foam once installation is complete.

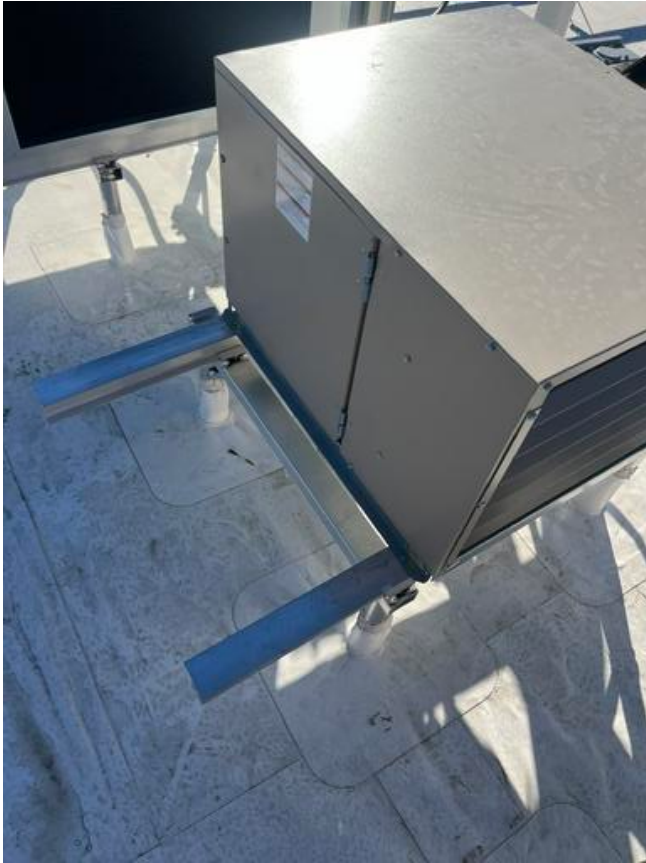
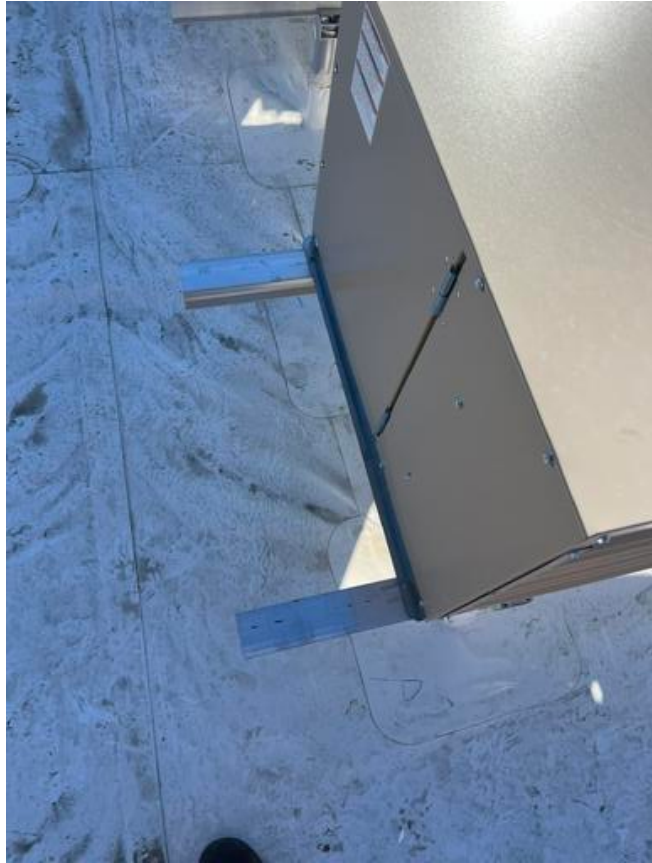
**#573 [REFG 514][NEW] Condenser Anchoring**

Condensers are not properly anchored to equipment stands.

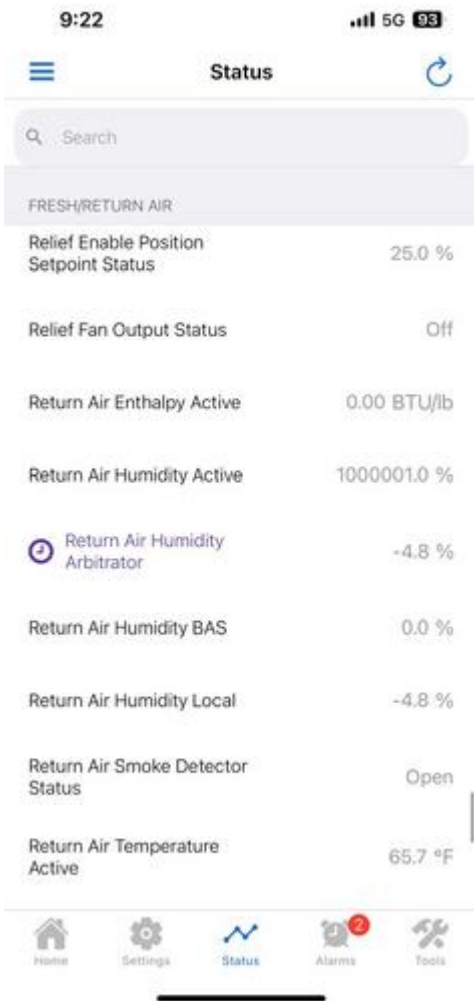
**#572 [UNIT 999][[NEW] (MISC) AC-3 : Return Humidity Sensor Not Installed**

AC-3 is alarmed and does not appear to have a return humidity sensor installed. Recommend TRANE is consulted. This has occurred at multiple locations.
