**Report: Deficiency Report
Function: Test, Adjust, & Balance
Date: 03/09/2026
Completed By: National TAB**

**PROJECT
03-09-26 QT #1022 KANNAPOLIS, NC**

**QUIKTRIP
4705 SOUTH 129TH EAST AVENUE
TULSA, OK 74134**

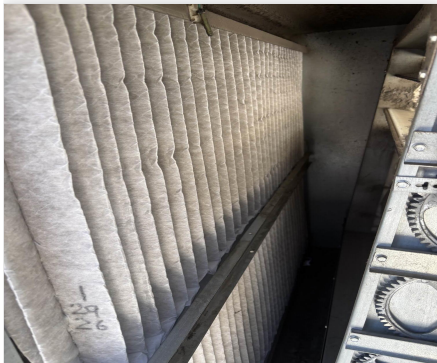
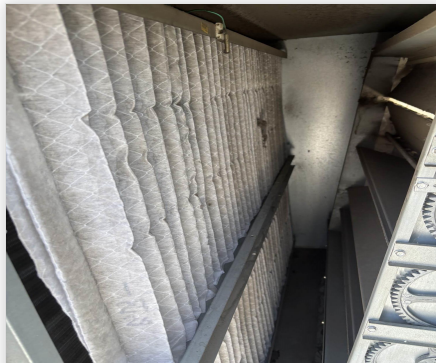
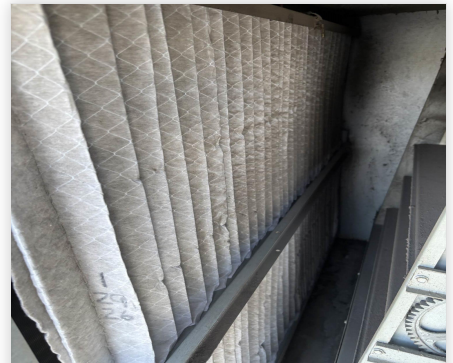
Issue Name : Dirty final filters
Description : All RTU's have dirty final filters, and will need to be changed soon.
Created By : National TAB **Assigned To :** National TAB - Dan Hertenstein
Status : Open
Priority : Medium **Asset Tag :**
Originated Date : 03/09/2026 - Christian Moller - National TAB

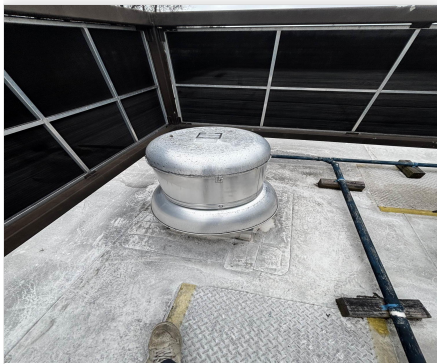
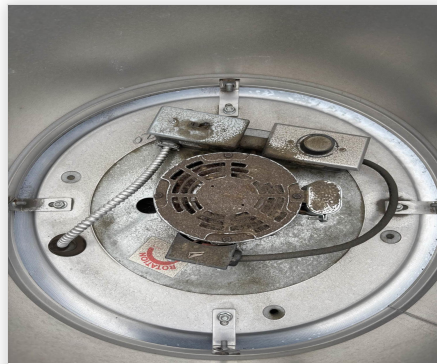
Issue Name : EF-2 not working
Description : Upon arrival EF-2 was not working. May require a motor change.
Created By : National TAB **Assigned To :** National TAB - Dan Hertenstein
Status : Open
Priority : Urgent **Asset Tag :** EF2
Originated Date : 03/09/2026 - Christian Moller - National TAB

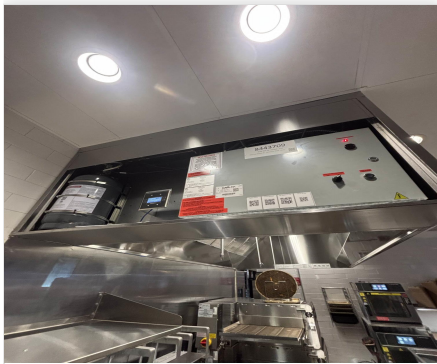
Issue Name : Hood missing access door
Description : The access door to the hood control compartment is missing.
Created By : National TAB **Assigned To :** National TAB - Dan Hertenstein
Status : Open
Priority : High **Asset Tag :** HD1
Originated Date : 03/09/2026 - Christian Moller - National TAB

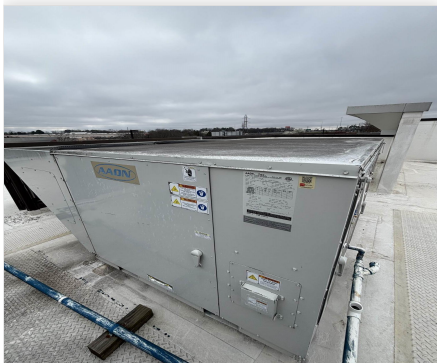
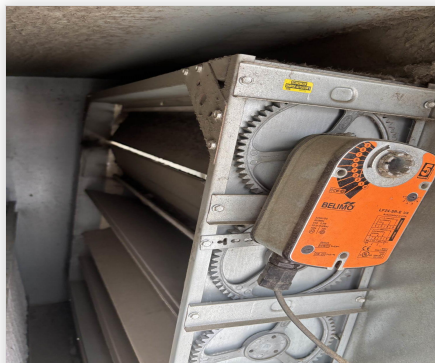
Issue Name : RTU 2 economizer not working.
Description : RTU 2's economizer is not working. Position does not change through the Emerson system nor the dial on the actuator itself. Position was set to 46% manually and left there.
Created By : National TAB **Assigned To :** National TAB - Dan Hertenstein
Status : Open
Priority : Urgent **Asset Tag :** RT-2
Originated Date : 03/09/2026 - Christian Moller - National TAB

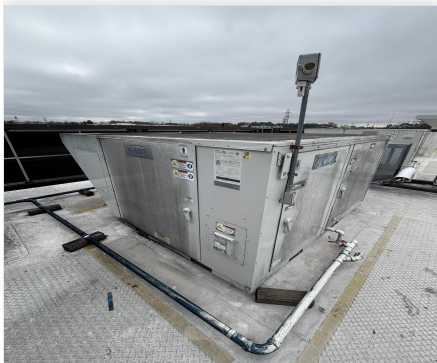
Issue Name : RTU 3 at max amperage
Description : RTU 3 is at max amperage, upon arrival it was set to 100Hz at 18amps, Full Load Amps are 10.6. Fan speed was reduced to meet FLA at 93% of design airflow. Unit airflow is within design, however low.
Created By : National TAB **Assigned To :** National TAB - Dan Hertenstein
Status : Open
Priority : Medium **Asset Tag :** RT-3
Originated Date : 03/09/2026 - Christian Moller - National TAB

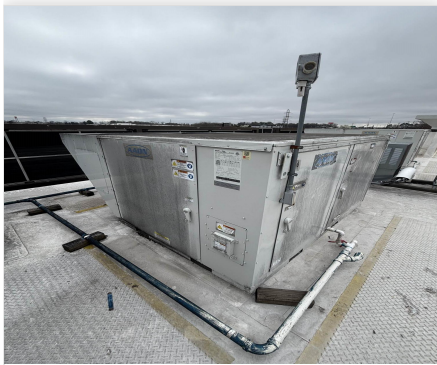
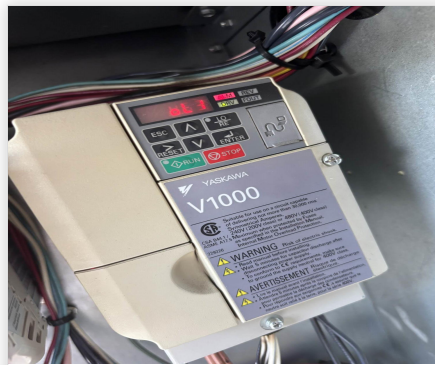
Issue Name : RTU 3 condenser fans in alarm
Description : The VFD controlling the condenser fans is in alarm. It is an oL 1. The unit is able to run cooling.
Created By : National TAB **Assigned To :** National TAB - Dan Hertenstein
Status : Open
Priority : High **Asset Tag :** RT-3
Originated Date : 03/09/2026 - Christian Moller - National TAB

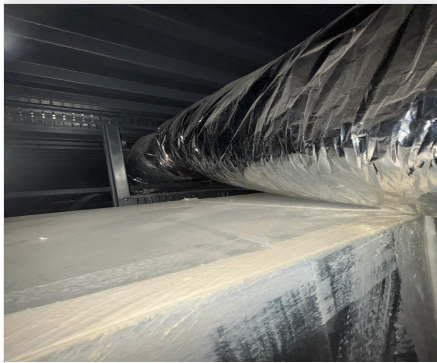
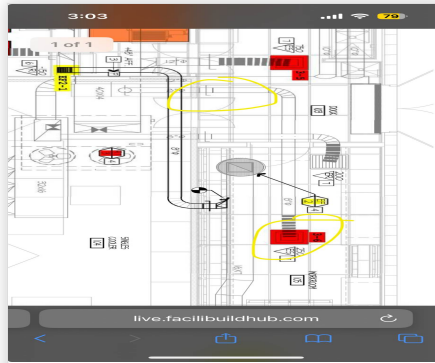
Issue Name : RTU 3 SGRD 6 damper unreachable
Description : the damper for SGRD 6 (work room) is unreachable. The branch runs directly toward and over the cooler instead of how plans describe. The diffuser is at 140% of design, which if dampened would bring the cookline diffusers (SGRD 1&2) into design.
Created By : National TAB **Assigned To :** National TAB - Dan Hertenstein
Status : Open
Priority : High **Asset Tag :** SGRD6
Originated Date : 03/09/2026 - Christian Moller - National TAB

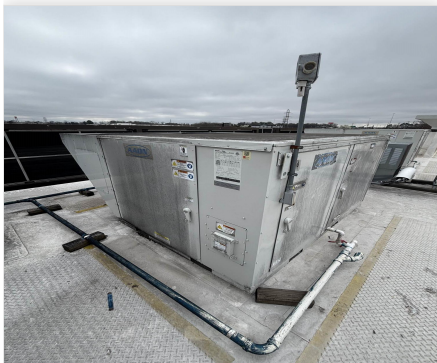
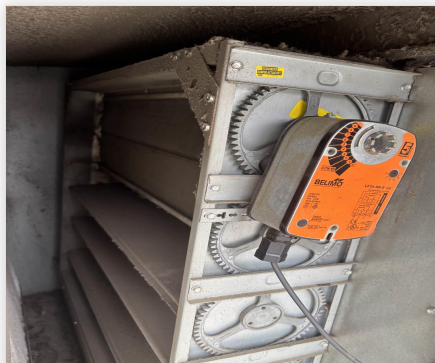
Issue Name : RTU 3's economizer not working
Description : RTU 3's economizer is not working. It will not move with the Emerson system or dial on the actuator itself. Due to the orientation of the actuator outside air could not be manually set, it was left at 0% open.
Created By : National TAB **Assigned To :** National TAB - Dan Hertenstein
Status : Open
Priority : Urgent **Asset Tag :** RT-3
Originated Date : 03/09/2026 - Christian Moller - National TAB
