**National TAB  
1329 E. KEMPER ROAD  
SUITE 4210  
CINCINNATI, OH 45246**

**Report: Final TAB Report  
Function: Test, Adjust, & Balance  
Date: 8/30/2022**

**PROJECT  
08-08 CULVERS - ROGERS, AR**

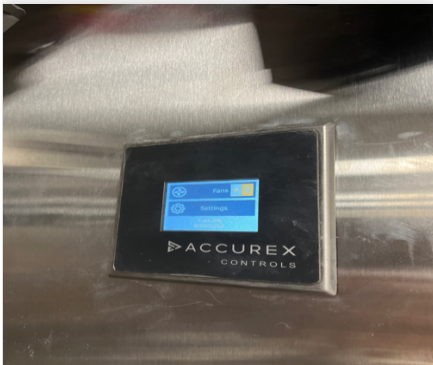
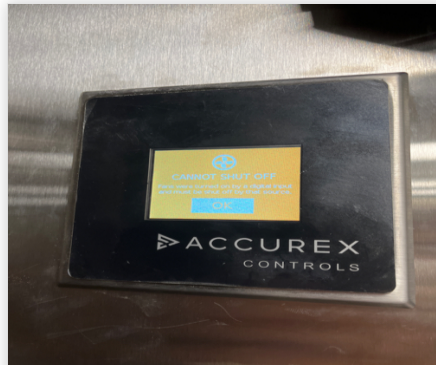
**Issue Name :** HIGH PRIORITY - HD1 and HD2 cannot be turned off via HMI  
**Description :** Responsibility - MC/EC Hoods are turned on and HMI won't allow them to be turned off. Error screen says fans cannot be turned off.  
**Created By :** National TAB **Assigned To :** National TAB - Will Turnbough  
**Status :** Open  
**Originated Date :** 08/12/2022 - Jacob Davidson - National TAB

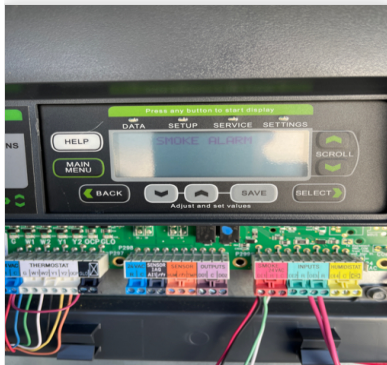
Board.jpeg

**Issue Name :** HIGH PRIORITY - RTU1 "Smoke Alarm" status

**Description :** Responsibility - MC RTU1 is showing a "Smoke Alarm" status and is not running normally as a result. Resetting the unit has not resolved. The unit is still able to be put into test mode with cooling. Unit has already been balanced.

- **08/12/2022 National TAB - Jacob Davidson**
  - Attached photo of prodigy board screen.

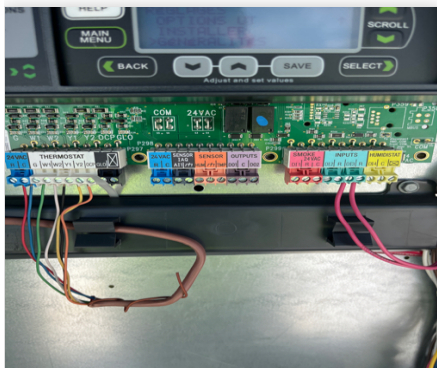
Humidistatmissing.jpeg

**Issue Name :** HIGH PRIORITY - RTU1 and RTU2 humidistat not wired

**Description :** Responsibility - MC Humidistat for each unit has not been landed to unit. I spoke to the MC and this is still on backorder currently.

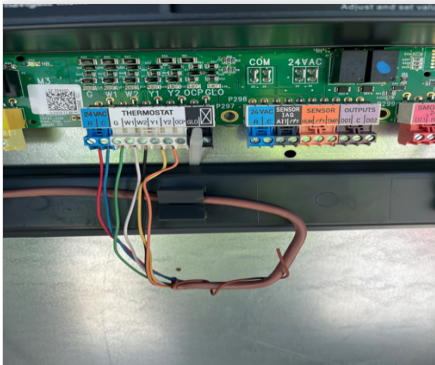
Unitwiring.jpeg

**Issue Name :** HIGH PRIORITY - RTU1 and RTU2 OCP wiring

**Description :** Responsibility - MC Unit not wired for occupancy. This is needed in order for the Economizer to open and function. MC assisted and we have jumped R to OCP in order to open the economizer for our purposes.

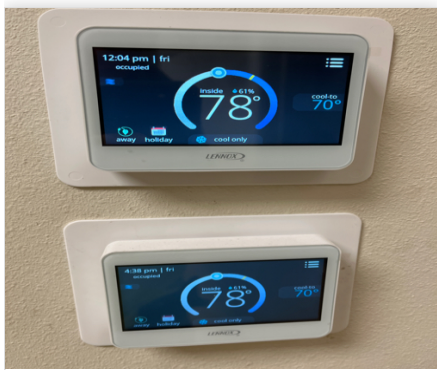
Thermostats.jpeg

**Issue Name :** HIGH PRIORITY - RTU1 RTU2 won't run cooling

**Description :** Responsibility - MC Thermostats are calling for cooling and units say they are cooling but condensers are not running

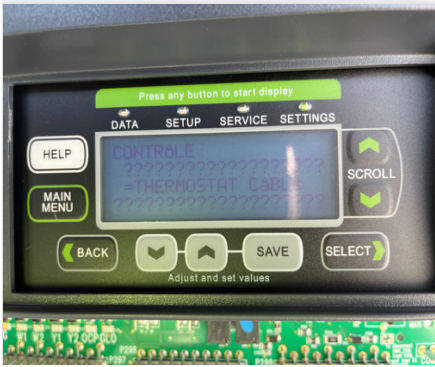
Prodigy.jpeg

**Issue Name :** HIGH PRIORITY - RTU2 prodigy board malfunctioning

**Description :** Board displays options in another language and has mostly question marks on display. Unable to adjust language or change settings.

Notes: [1] PRODIGY BOARD IS DEFECTIVE AND NEEDS TO BE REPLACED. UNABLE TO SET ENTHALPY AND OA POSITION. DAMPER POSITION WILL BE MARKED FOR WHEN NEW BOARD COMES IN.

- **08/10/2022 National TAB - Jacob Davidson**
  - After troubleshooting with LENNOX, we determined that the unit needs a new board, which will be covered under warranty. MC and GC have been made aware.

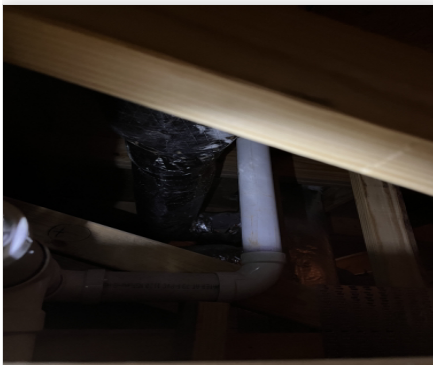
FuselTef67404ed50940.jpeg

**Issue Name :** PRV1 dampers inaccessible

**Description :** Responsibility - MC Dampers for PRV1 are above hard ceiling and cannot be reached. Restrooms are out of design and cannot be put in design until rectified.
