**Report: Final TAB Report
Function: Test, Adjust, & Balance
Date: 8/30/2022**

**PROJECT
08-08 CULVERS - ROGERS, AR**

4204 W NEW HOPE ST

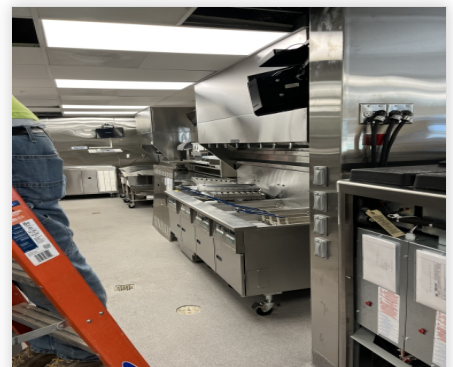
Issue Name : PRV-3 and PRV-2 installed backwards on roof

Description : The fans are in the wrong position on roof and don't coincide with their hood positions in the restaurant. Fans need to be swapped.

- **08/11/2022** **National TAB - Jacob Davidson**
 - MC came to site and swapped fans to their proper positions

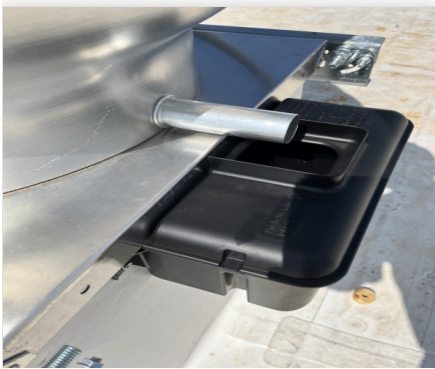
Issue Name : PRV2 and PRV3 grease traps preventing fan from leaning back

Description : Fans cannot lean back all the way because the grease traps are installed too high. These need to be lowered in order to tilt fan back completely.

- **08/11/2022** **National TAB - Jacob Davidson**
 - MC has lowered the traps and fans can be tilted all the way back now.

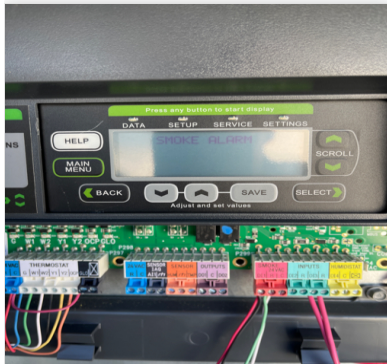
Issue Name : RTU1 "Smoke Alarm" status

Description : Responsibility - MC RTU1 is showing a "Smoke Alarm" status and is not running normally as a result. Resetting the unit has not resolved. The unit is still able to be put into test mode with cooling. Unit has already been balanced.

- Attached photo of prodigy board screen.

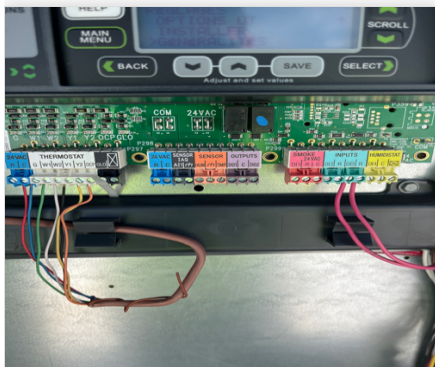
Humidistatmissing.jpeg

Issue Name : RTU1 and RTU2 humidistat not wired

Description : Responsibility - MC Humidistat for each unit has not been landed to unit. I spoke to the MC and this is still on backorder currently.

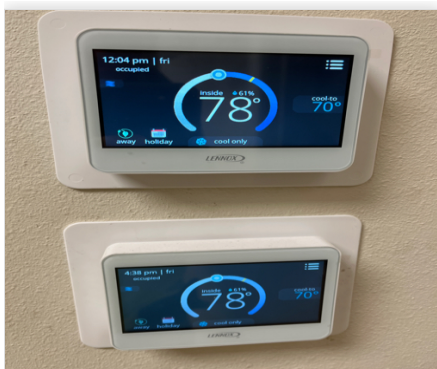
Issue Name : RTU1 RTU2 won't run cooling
Description : Responsibility - MC Thermostats are calling for cooling and units say they are cooling but condensers are not running
Created By : National TAB **Assigned To :** National TAB - Will Turnbough
Status : Open
Originated Date : 08/11/2022 - Jacob Davidson - National TAB

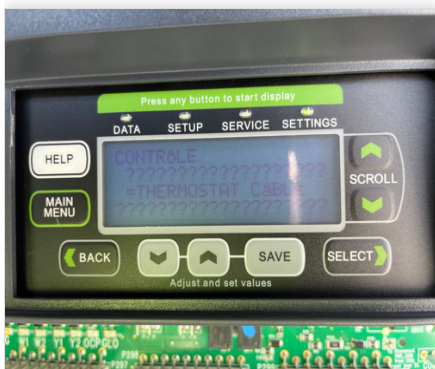
Issue Name : RTU2 prodigy board malfunctioning

Description : Board displays options in another language and has mostly question marks on display. Unable to adjust language or change settings.

Notes: [1] PRODIGY BOARD IS DEFECTIVE AND NEEDS TO BE REPLACED. UNABLE TO SET ENTHALPY AND OA POSITION. DAMPER POSITION WILL BE MARKED FOR WHEN NEW BOARD COMES IN.

- **08/10/2022** **National TAB - Jacob Davidson**
 - After troubleshooting with LENNOX, we determined that the unit needs a new board, which will be covered under warranty. MC and GC have been made aware.

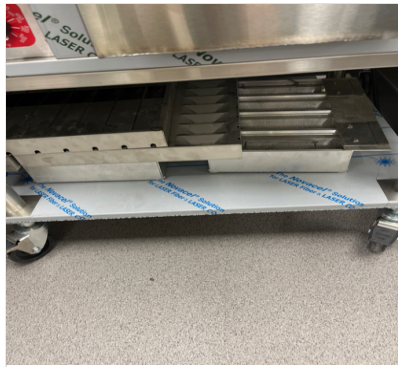
All hood filters installed and accounted for?	NO, FILTERS ACCOUNTED FOR BUT NOT INSTALLED
---	---

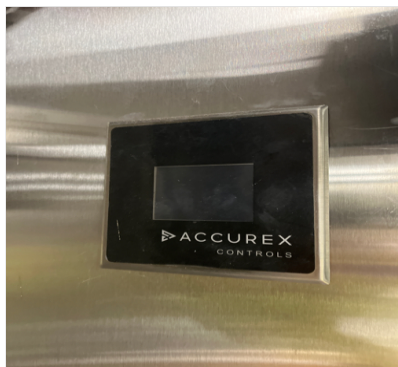
Hoods are wired and have power?

NO, ELECTRICIAN IS WORKING ON AND WILL HAVE POWERED 8/11 or 8/12

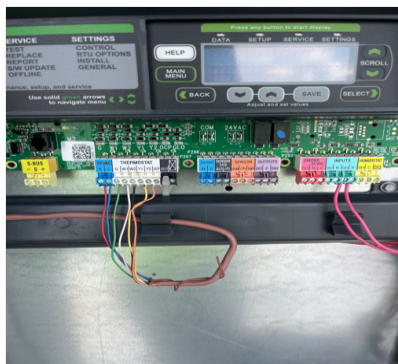
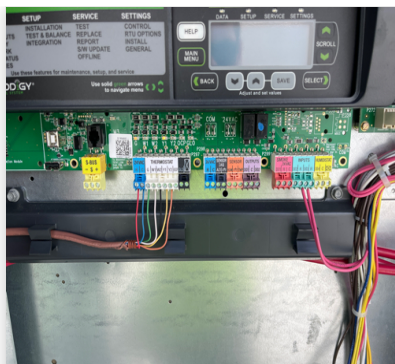
Thermostat wire run from OCP on the RTU to the Ec terminal at the thermostat? If no, jumper can be installed from R to OCP temporarily. (The economizers will not open without OCP being energized.) No.

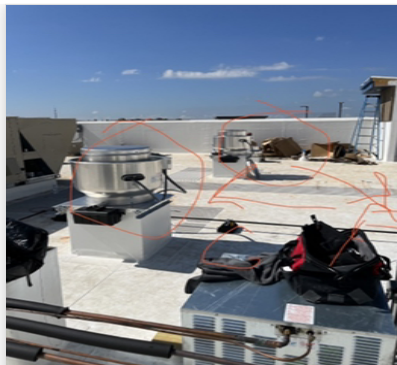
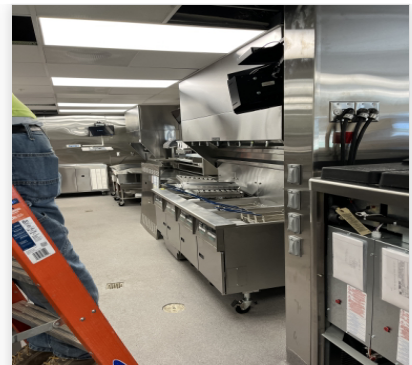
The hood exhaust fans are installed in correct positions and are not switched?

NO. FANS ARE SWITCHED. NEED TO BE SWAPPED

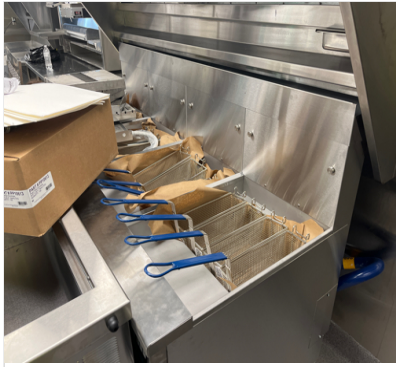
Can kitchen equipment be turned on for final smoke test?

NO, START UPS NOT DONE
