**National TAB  
1329 E. KEMPER ROAD  
SUITE 4210  
CINCINNATI, OH 45246**

**Report: Final TAB Report  
Function: Test, Adjust, & Balance  
Date: 8/25/2022**

**PROJECT  
08-08 CULVERS - ROGERS, AR**

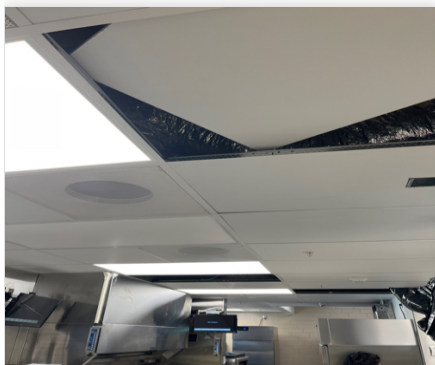
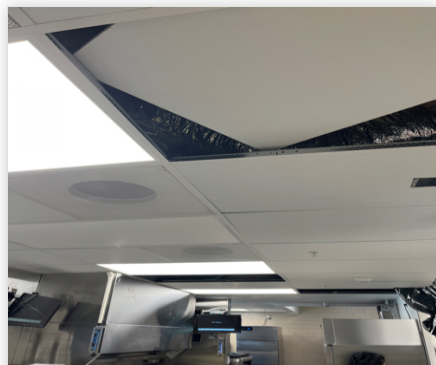
**Issue Name :** Ceiling panels not all installed around hoods

**Description :** Responsibility- GC Ceiling tiles need to be placed around hood to ensure good smoke capture.

- **08/10/2022**    **National TAB - Jacob Davidson**
  - Spoke to GC and the ceiling tiles will be installed by the time we are ready for hood capture.

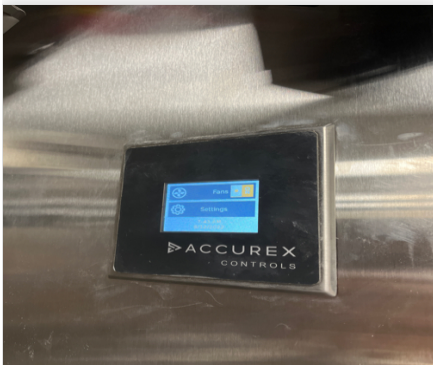
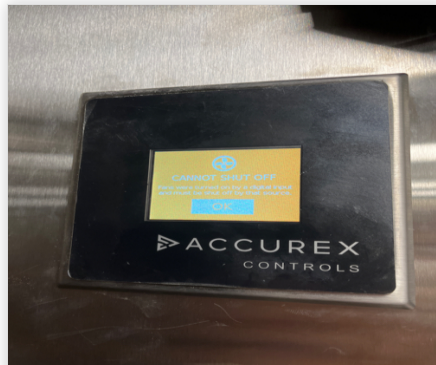
**Issue Name :** HD1 and HD2 cannot be turned off via HMI  
**Description :** Responsibility - MC/EC Hoods are turned on and HMI won't allow them to be turned off. Error screen says fans cannot be turned off.  
**Created By :** National TAB **Assigned To :** National TAB - Will Turnbough  
**Status :** Open  
**Originated Date :** 08/12/2022 - Jacob Davidson - National TAB

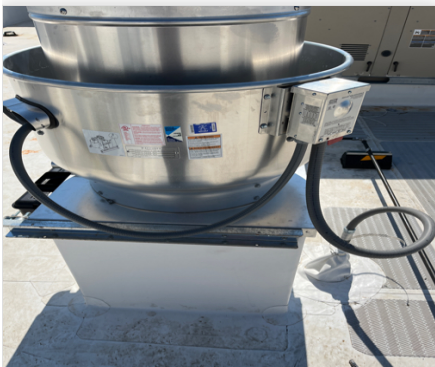
**Issue Name :** PRV 3 fan cannot tilt back

**Description :** Responsibility - MC After MC swapped fans, PRV3 cannot lean back freely. Fan is stuck on curb.

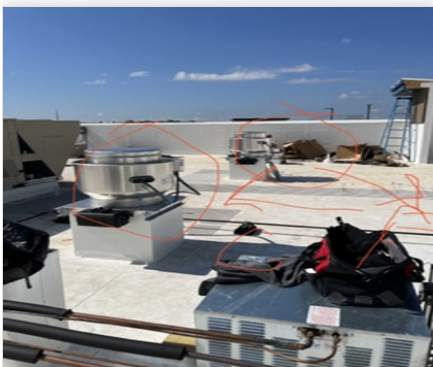
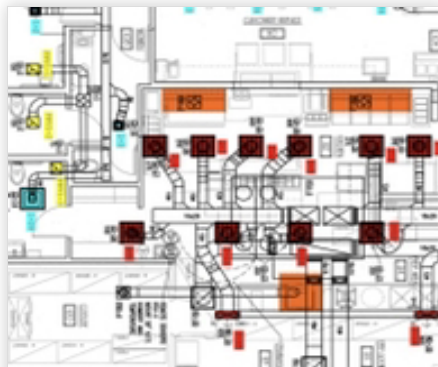
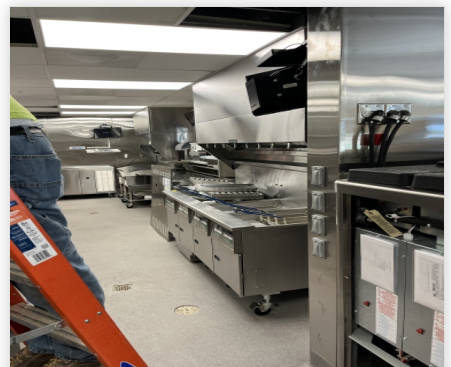
**Issue Name :** PRV-3 and PRV-2 installed backwards on roof

**Description :** The fans are in the wrong position on roof and don't coincide with their hood positions in the restaurant. Fans need to be swapped.

- **08/11/2022**    **National TAB - Jacob Davidson**
  - MC came to site and swapped fans to their proper positions

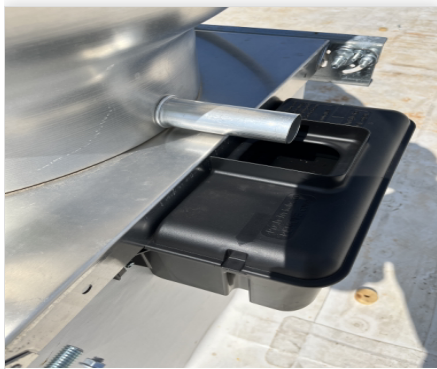
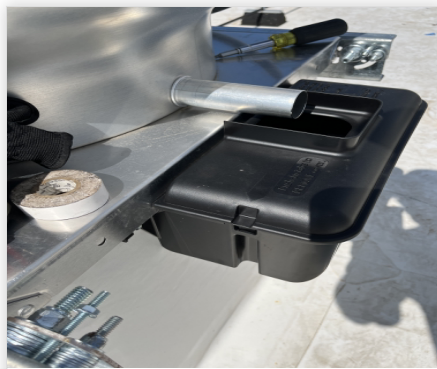
**Issue Name :** PRV2 and PRV3 grease traps preventing fan from leaning back

**Description :** Fans cannot lean back all the way because the grease traps are installed too high. These need to be lowered in order to tilt fan back completely.

- **08/11/2022**    **National TAB - Jacob Davidson**
  - MC has lowered the traps and fans can be tilted all the way back now.

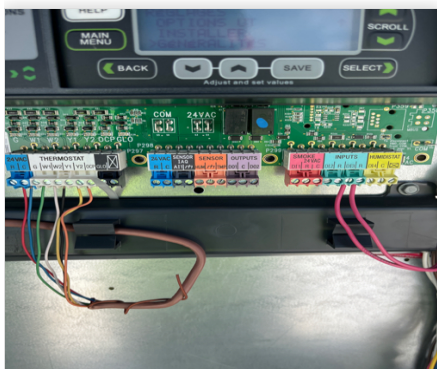
**Issue Name :** RTU1 and RTU2 humidistat not wired

**Description :** Responsibility - MC Humidistat for each unit has not been landed to unit. I spoke to the MC and this is still on backorder currently.

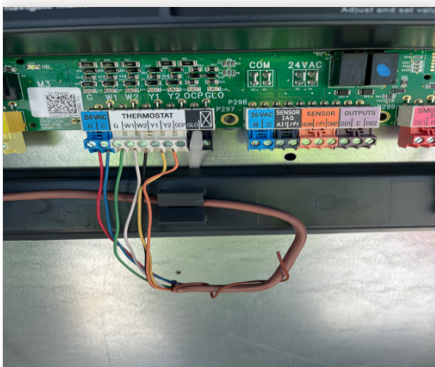
**Issue Name :** RTU1 and RTU2 OCP wiring

**Description :** Responsibility - MC Unit not wired for occupancy. This is needed in order for the Economizer to open and function. MC assisted and we have jumped R to OCP in order to open the economizer for our purposes.

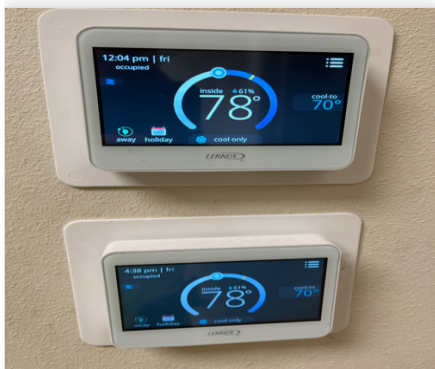
**Issue Name :** RTU1 RTU2 won't run cooling

**Description :** Responsibility - MC Thermostats are calling for cooling and units say they are cooling but condensers are not running

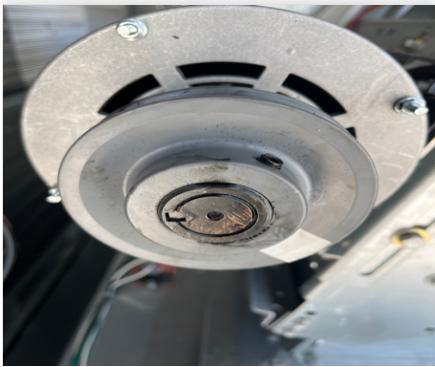
**Issue Name :** RTU2 motor pulley stuck

**Description :** Pulley is stuck in place and needs to be loosened as the unit is overramping at the current speed it is at. // MC was able to loosen pulley.

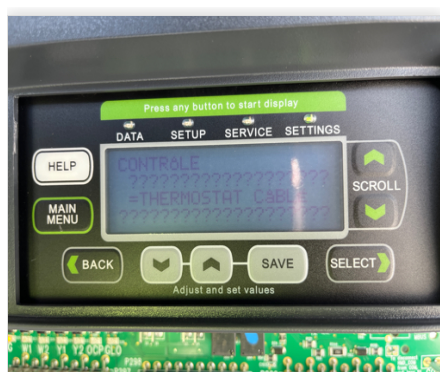
**Issue Name :** RTU2 prodigy board malfunctioning

**Description :** Board displays options in another language and has mostly question marks on display. Unable to adjust language or change settings.

- **08/10/2022 National TAB - Jacob Davidson**
  - After troubleshooting with LENNOX, we determined that the unit needs a new board, which will be covered under warranty. MC and GC have been made aware.

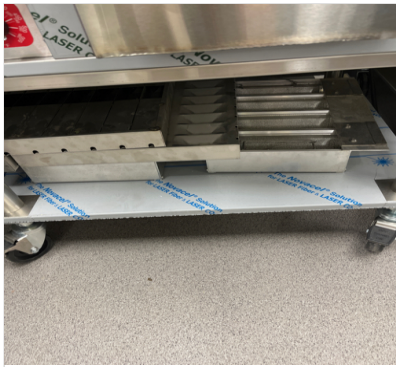
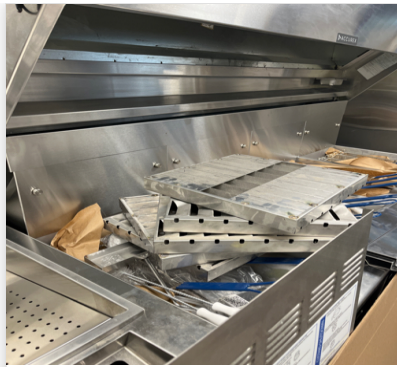
All hood filters installed and accounted for?	NO, FILTERS ACCOUNTED FOR BUT NOT INSTALLED
---	---

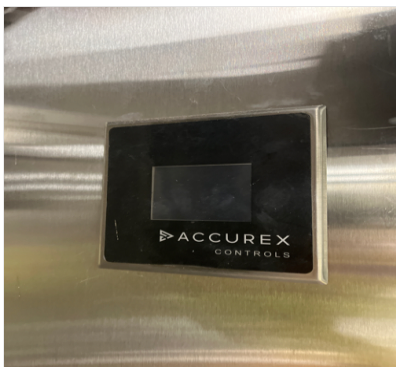
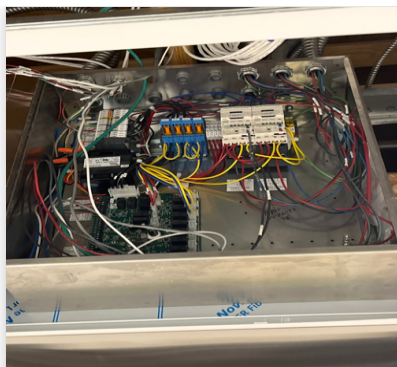
Hoods are wired and have power?

NO, ELECTRICIAN IS WORKING ON AND WILL HAVE POWERED 8/11 or 8/12

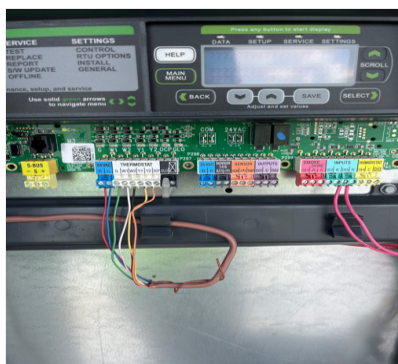
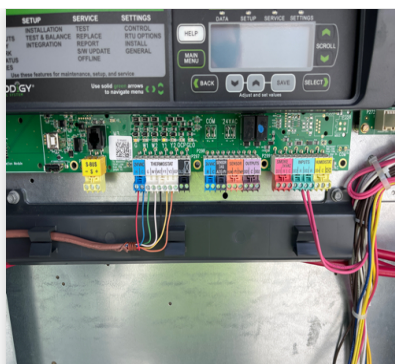
Thermostat wire run from OCP on the RTU to the Ec terminal at the thermostat? If no, jumper can be installed from R to OCP temporarily. (The economizers will not open without OCP being energized.) No.

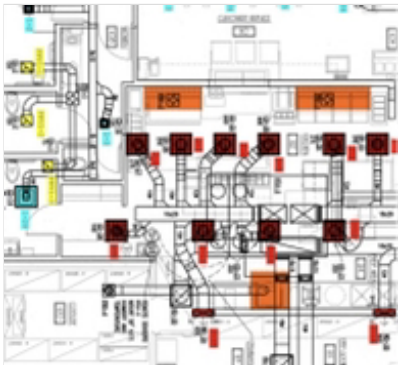
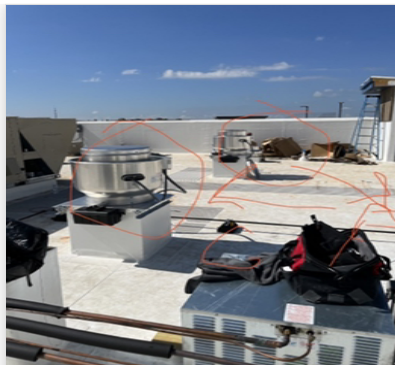
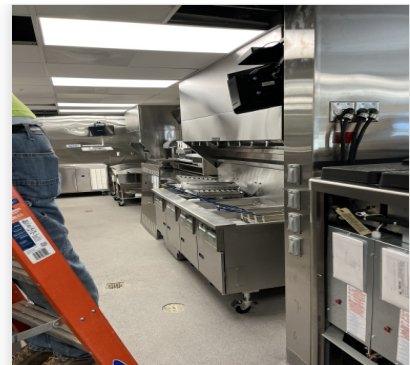
The hood exhaust fans are installed in correct positions and are not switched?

NO. FANS ARE SWITCHED. NEED TO BE SWAPPED

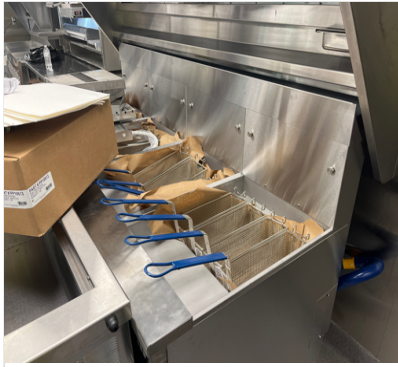
Can kitchen equipment be turned on for final smoke test?

NO, START UPS NOT DONE
