Report: TAB Report
Function: Test, Adjust, & Balance
Date: 06/07/2024

06-03-24 WAWA #8187 TANNERSVILLE, PA

Project: 06-03-24 WAWA #8187 TANNERSVILLE, PA

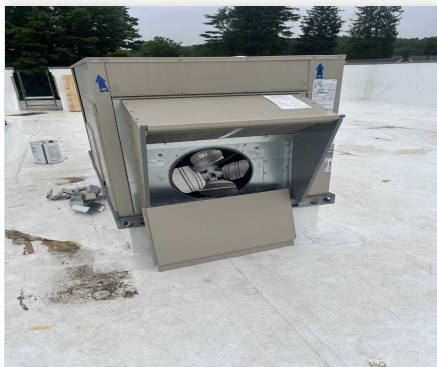
IMG_6802
06/05/2024

Issue Name : RTU-3 Power exhaust Kit
Description : The factory shipping cover is installed on RTU-3 power exhaust. Cover needs to be removed and backdraft louvers installed for proper function and operation of the power exhaust. Recommend contacting Lennox if Backdraft louvers cannot be located. Not TAB Critical
Created By : National TAB **Assigned To :** National TAB - Tyler Youells
Status : Open
Priority : High **Asset Tag :**
Originated Date : 06/05/2024 - Tyler Youells - National TAB

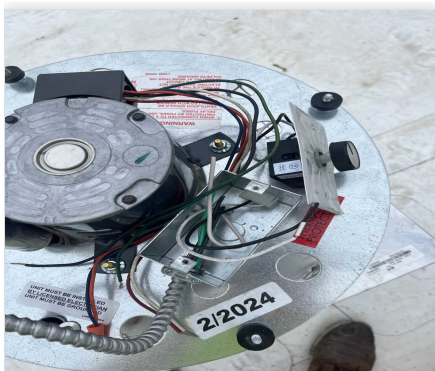
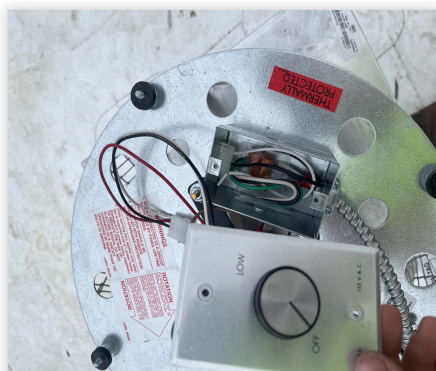
Issue Name : All EF Speed controls
Description : EFS are not wired to power and do not have speed controllers installed. Speed controllers need to be installed ASAP so balance can be completed.
Created By : National TAB **Assigned To :** National TAB - Tyler Youells
Status : Closed
Priority : Urgent **Asset Tag :**
Originated Date : 06/05/2024 - Tyler Youells - National TAB

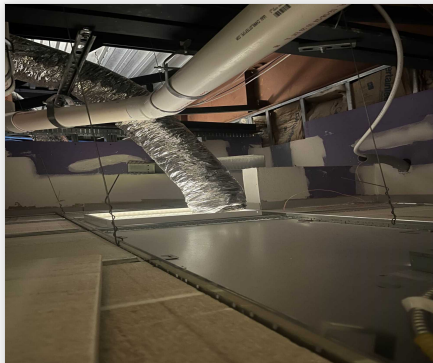
Issue Name : EF-3 Exhaust Grille issue
Description : Plenum box is not installed on the top of the exhaust grille. Plenum box needs to be installed to prevent fan from pulling air from above ceiling.
Created By : National TAB **Assigned To :** National TAB - Tyler Youells
Status : Closed
Priority : Urgent **Asset Tag :**
Originated Date : 06/05/2024 - Tyler Youells - National TAB
