Report: TAB Report
Function: Test, Adjust, & Balance
Date: 06/07/2024

06-03-24 WAWA #8187 TANNERSVILLE, PA

Wawa
260 West Baltimore Pike
Wawa, PA 19063

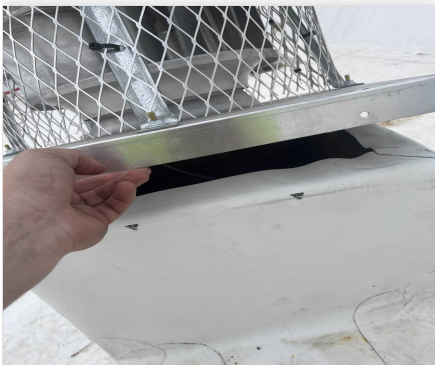
image
06/05/2024

Issue Name : EF Securement
Description : The EFs are not secured to the curbs. Recommend securing to the curbs with proper fasteners. (Applies to all Exhaust fans)
Created By : National TAB **Assigned To :** National TAB - Tyler Youells
Status : Open
Priority : Medium **Asset Tag :**
Originated Date : 06/05/2024 - Tyler Youells - National TAB

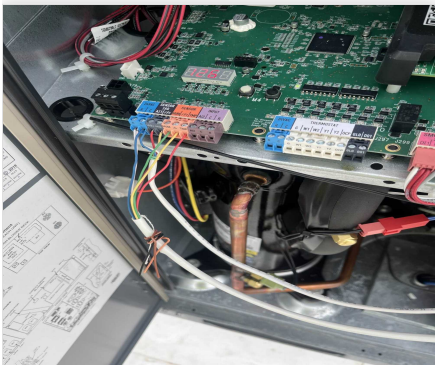
IMG_6803
06/05/2024

Issue Name : RTU Sensor Wiring
Description : RTU sensor wiring is not run per manufacturers specifications. Typical thermostat wiring was used. Spec calls for separate sets of two wire shielded for the humidity sensor and temperature sensor. Recommend replacing wire to ensure sensor will read correctly preventing any space comfort issues.

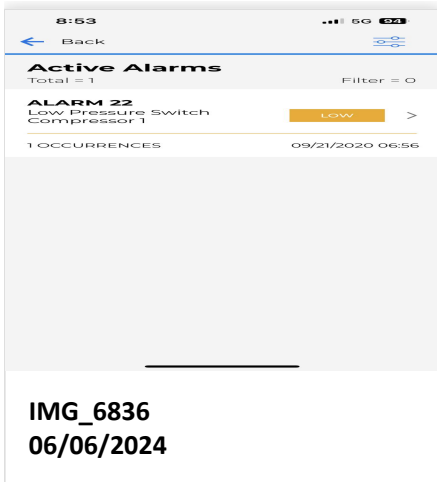
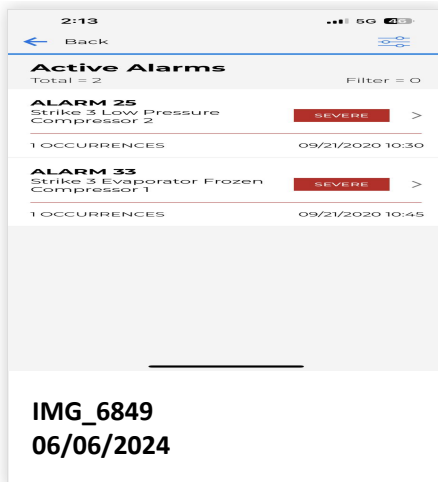
Issue Name : RTU- Alarms
Description : RTU-1 has an alarm for compressor 1 low pressure causing compressor one to not run and subsequently dehumidification is disabled. Rtu-2 was running normally during the second day until it had a few alarms for cooling causing the unit to complete shut down. Recommend MC go through cooling systems of all RTUs to ensure proper health
Created By : National TAB **Assigned To :** National TAB - Tyler Youells
Status : Open
Priority : High **Asset Tag :**
Originated Date : 06/06/2024 - Tyler Youells - National TAB

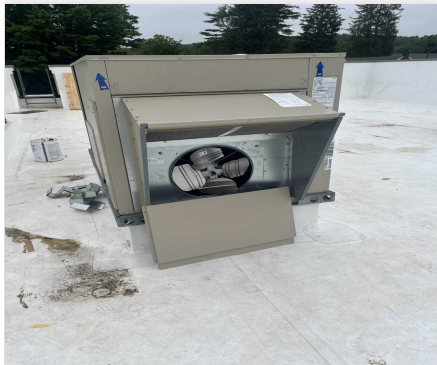
IMG_6802
06/05/2024

Issue Name : RTU-3 Power exhaust Kit
Description : The factory shipping cover is installed on RTU-3 power exhaust. Cover needs to be removed and backdraft louvers installed for proper function and operation of the power exhaust. Recommend contacting Lennox if Backdraft louvers cannot be located. Not TAB Critical
Created By : National TAB **Assigned To :** National TAB - Tyler Youells
Status : Open
Priority : High **Asset Tag :**
Originated Date : 06/05/2024 - Tyler Youells - National TAB

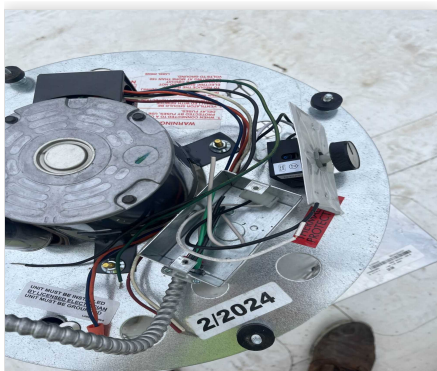
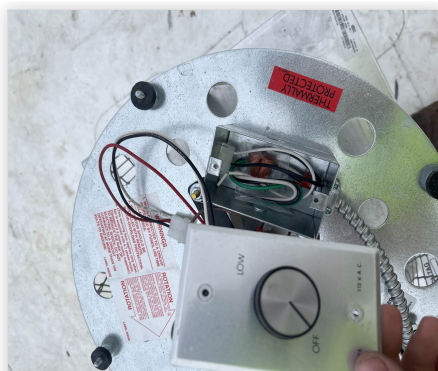
Issue Name : All EF Speed controls
Description : EFS are not wired to power and do not have speed controllers installed. Speed controllers need to be installed ASAP so balance can be completed.
Created By : National TAB **Assigned To :** National TAB - Tyler Youells
Status : Closed
Priority : Urgent **Asset Tag :**
Originated Date : 06/05/2024 - Tyler Youells - National TAB

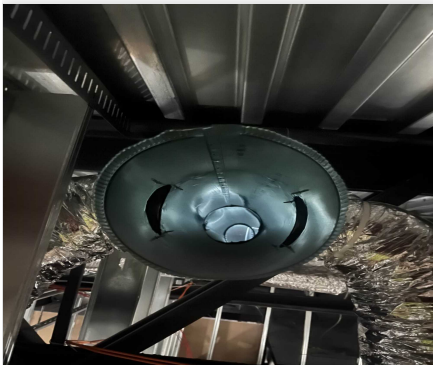
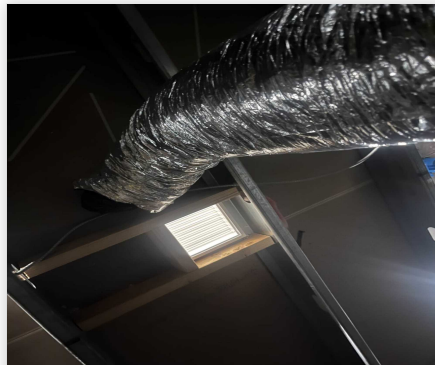
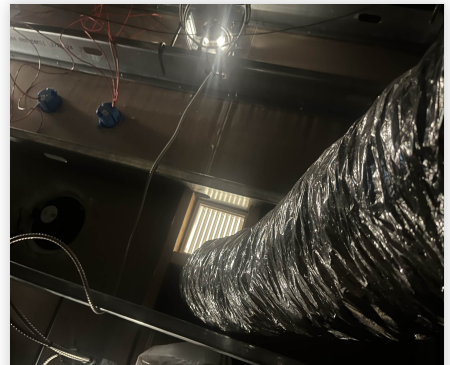
Issue Name : EF-2 Ductwork Issues
Description : End cap needs to be installed and sealed at the end of the duct run(picture1). Flex connection boxes need to be installed to the tops of the exhaust grilles to prevent from pulling from above ceiling, men's and women's RR pics 2/3
Created By : National TAB **Assigned To :** National TAB - Tyler Youells
Status : Closed
Priority : Urgent **Asset Tag :**
Originated Date : 06/05/2024 - Tyler Youells - National TAB

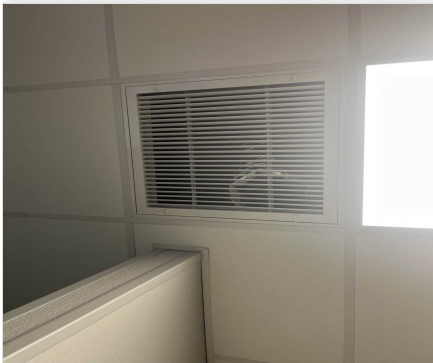
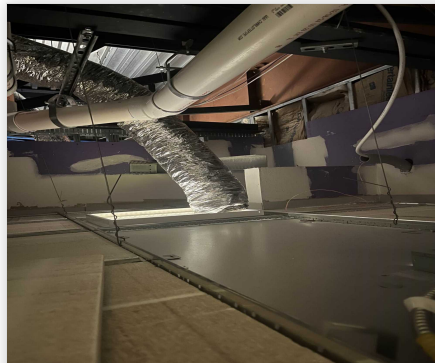
Issue Name : EF-3 Exhaust Grille issue
Description : Plenum box is not installed on the top of the exhaust grille. Plenum box needs to be installed to prevent fan from pulling air from above ceiling.
Created By : National TAB **Assigned To :** National TAB - Tyler Youells
Status : Closed
Priority : Urgent **Asset Tag :**
Originated Date : 06/05/2024 - Tyler Youells - National TAB

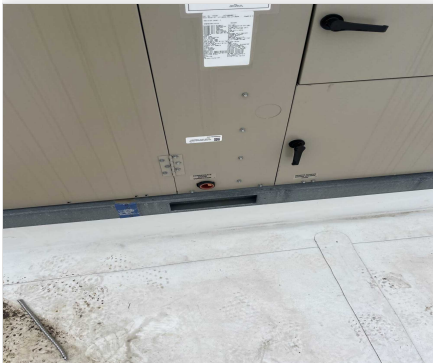
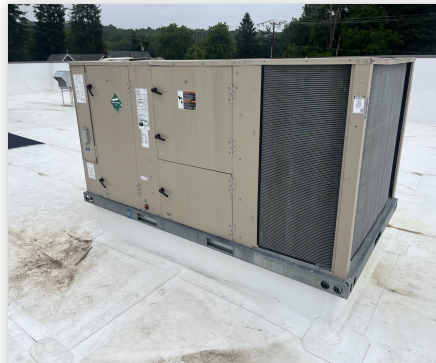
Issue Name : RTU- Condensate Drains
Description : RTUs do not have condensate piping installed yet. Recommend installing ASAP so water does not start leaking into space
Created By : National TAB **Assigned To :** National TAB - Tyler Youells
Status : Closed
Priority : High **Asset Tag :**
Originated Date : 06/05/2024 - Tyler Youells - National TAB

- **06/05/2024 National TAB - Tyler Youells**
 - Plumber installed temporary condensate drains, due to limited parts. will come back later and final install them

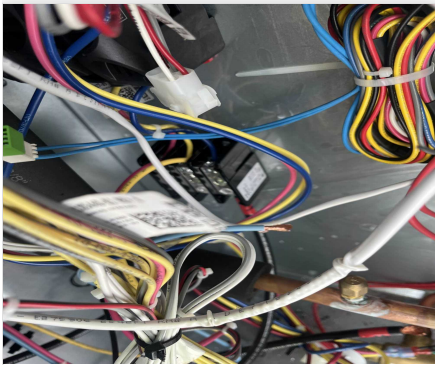
IMG_6804
06/05/2024

Issue Name : RTU-3 leg of power not connected
Description : Rtu-3 has a leg of power that is not secured. EC to ensure power is off and resecure the loose connection
Created By : National TAB **Assigned To :** National TAB - Tyler Youells
Status : Closed
Priority : Urgent **Asset Tag :**
Originated Date : 06/05/2024 - Tyler Youells - National TAB

- **06/05/2024 National TAB - Tyler Youells**
 - Electrician has resolved issue and unit is now running.
